DETAILED SEISMIC ASSESSMENT
FOR WAIKARAKA PARK

DETAILED SEISMIC ASSESSMENT OF WAIKARAKA PARK GRANDSTAND

Prepared For: AUCKLAND COUNCIL

Date: 6 October, 2015
Project No: 113123
Revision No: 1

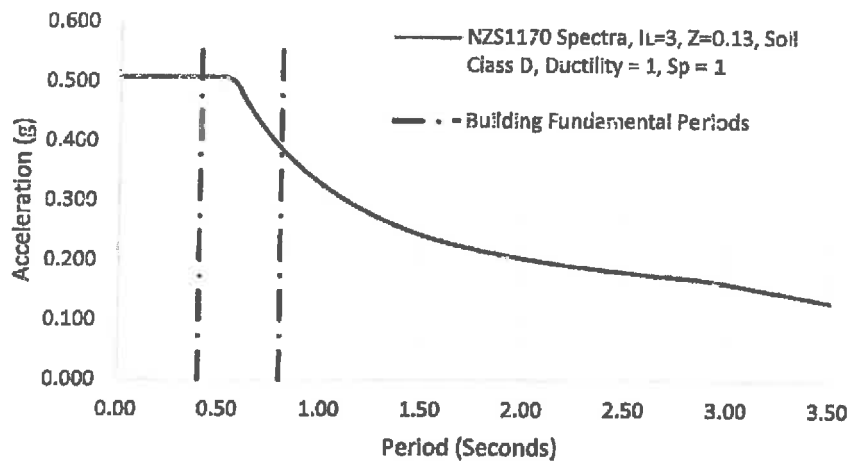
Figure 2-2 Example Seismic Response Spectra

For each load case investigated, equivalent static forces are applied to individual elements to represent a horizontal acceleration which results from a seismic excitation applied at the base of the building. The amplitude of the acceleration is dictated by the fundamental period of vibration of the building along its two principal axes. Tall flexible structures have long periods, whilst short stiff buildings have short periods. As can be seen in Figure 2-2 following, the longer the period of a structure is, the lower the corresponding horizontal acceleration. For a building period of less than 0.4 seconds the corresponding horizontal ground acceleration in accordance with NZS1170:2002 is 0.51g, compared to a building period of 0.8 seconds where the horizontal acceleration is approximately 0.39g.
