## Royal Oak Roundabout Safety Improvements

**Road Safety Review  
Scheme/Preliminary Design**

May 2018

This report presents the findings of a scheme/preliminary design stage safety review of the proposed safety improvements to the Royal Oak roundabout intersection in Auckland.

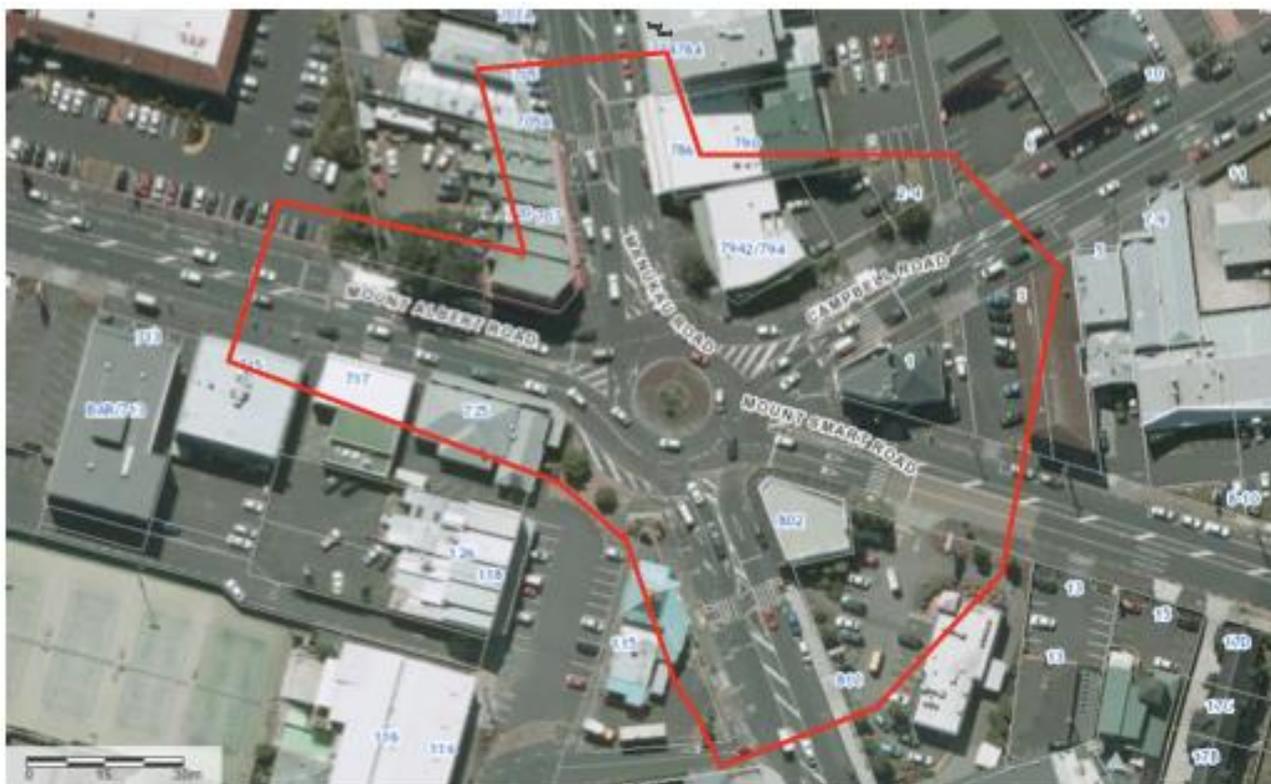
**Figure 1 Approximate extent of project**

The project extent is indicated on Figure 1. The proposed preliminary design has been prepared by GHD, Auckland on behalf of the Auckland Transport (see Appendix A: Roundabout Improvements Concept Design). The primary proposed improvements to the existing roundabout is to add raised pedestrian crossings across all legs of the roundabout, reshaping of the central island, extensions to the splitters islands, additional spiral markings within the circulatory roadway and advanced directional signs.

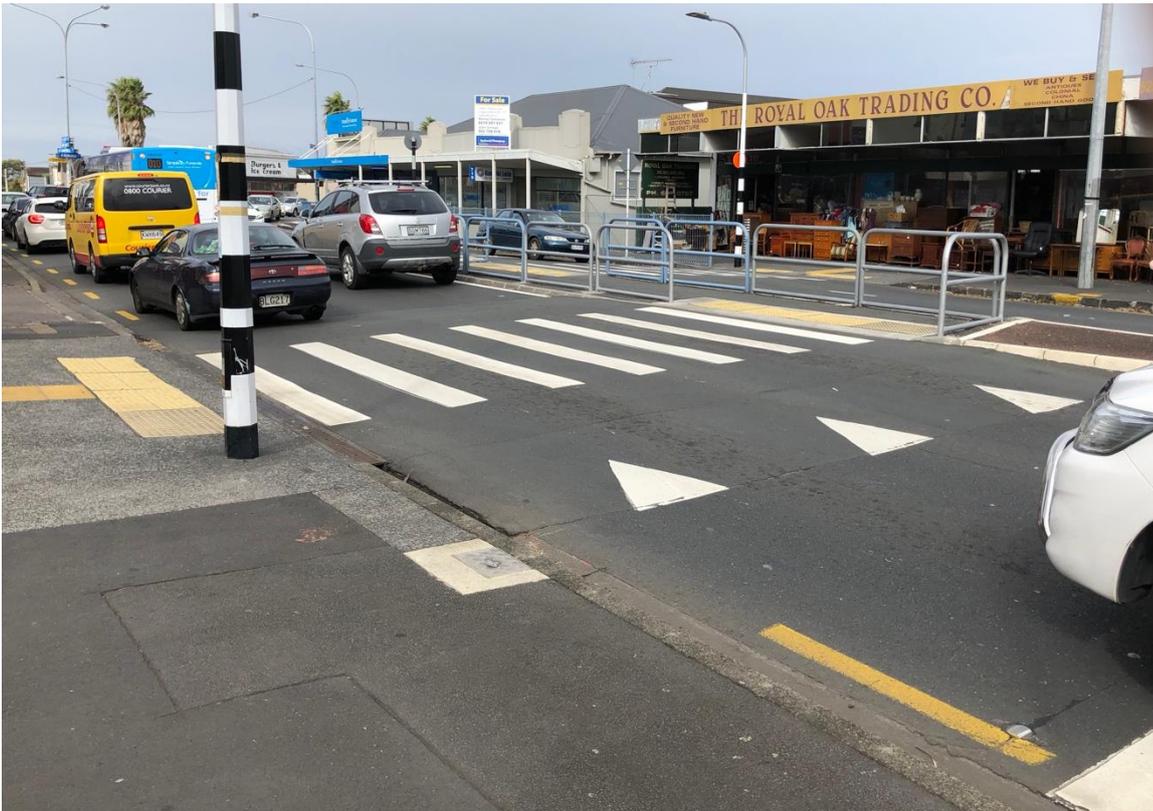
**Figure 2 Vertical deflection at raised pedestrian crossing of Mount Albert Road**

At this site a fatal crash involving a pedestrian crossing has resulted in a raised crosswalk being installed on Mount Smart Road, with a supplementary in-pavement active road stud system which are activated by pedestrians present at the crossing. The active road studs have also been implemented on the Campbell Road leg, albeit without a raised crosswalk. During the site visit, it was noted that these road studs tended to de-activate quite a while after pedestrians had passed through the crosswalk. Many of them are also becoming pressed into the asphalt concrete surround, possibly making them less visible. It is important that their operation is tuned and maintained so that, over time, drivers do not become desensitised and disregard such warning lights as seemingly unresponsive to actual conditions at the crosswalks. As a result of these retro-fitted treatments, there are now a variety of inconsistent pedestrian and driver user experiences across the various legs of this roundabout. The proposed design aims to provide greater consistency at these crosswalks.

- a) *Consider the appropriateness of the 50km/h posted speed limit on all roundabout legs though the Royal Oaks commercial area and whether it should be reduced to encourage safer crossings and consecutive roundabout entry and negotiation speeds that are safe and consistent with the road environment.*
- b) *Design raised crosswalks to be adequately signed and marked, longitudinal profiles of the vertical deflection zones that are comfortably traversable by buses and emergency vehicles, appropriate to the flow function of an arterial street.*
- c) *Ensure that active road studs are correctly timed and maintained to maximise their effectiveness. For consistency consider installing them on all crosswalks to the roundabout.*

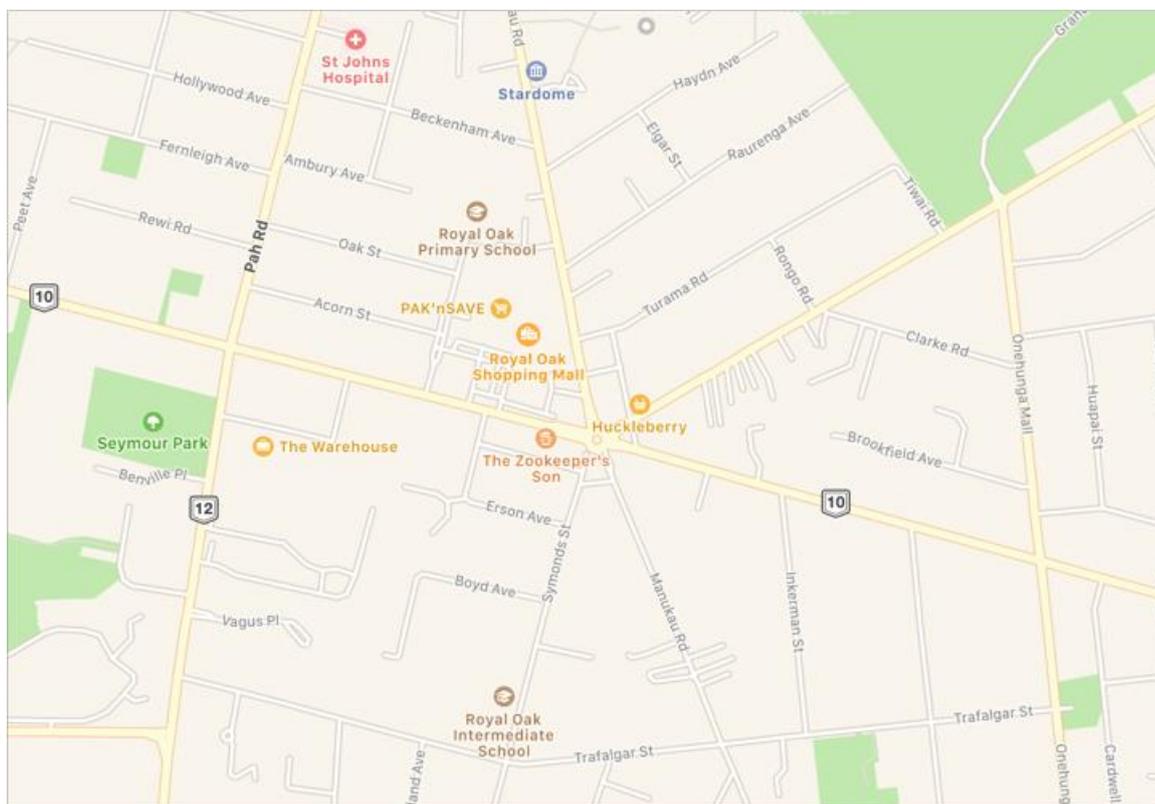
**Figure 3 Vicinity map showing wider network route options**

At a conceptual design stage, it is also appropriate to consider alternative forms of access or control and their relative safety performance. For example, other treatments could include reconfiguration to a signalised intersection, alternative roundabout configurations or alternative routes and way-finding measures to bypass this site and divert some traffic demand.

*At an appropriate time, consider a project scoped to focus on urban design and the relative merits of alternative roundabout configurations and/or alternative network options and/or control, to improve safety performance.*

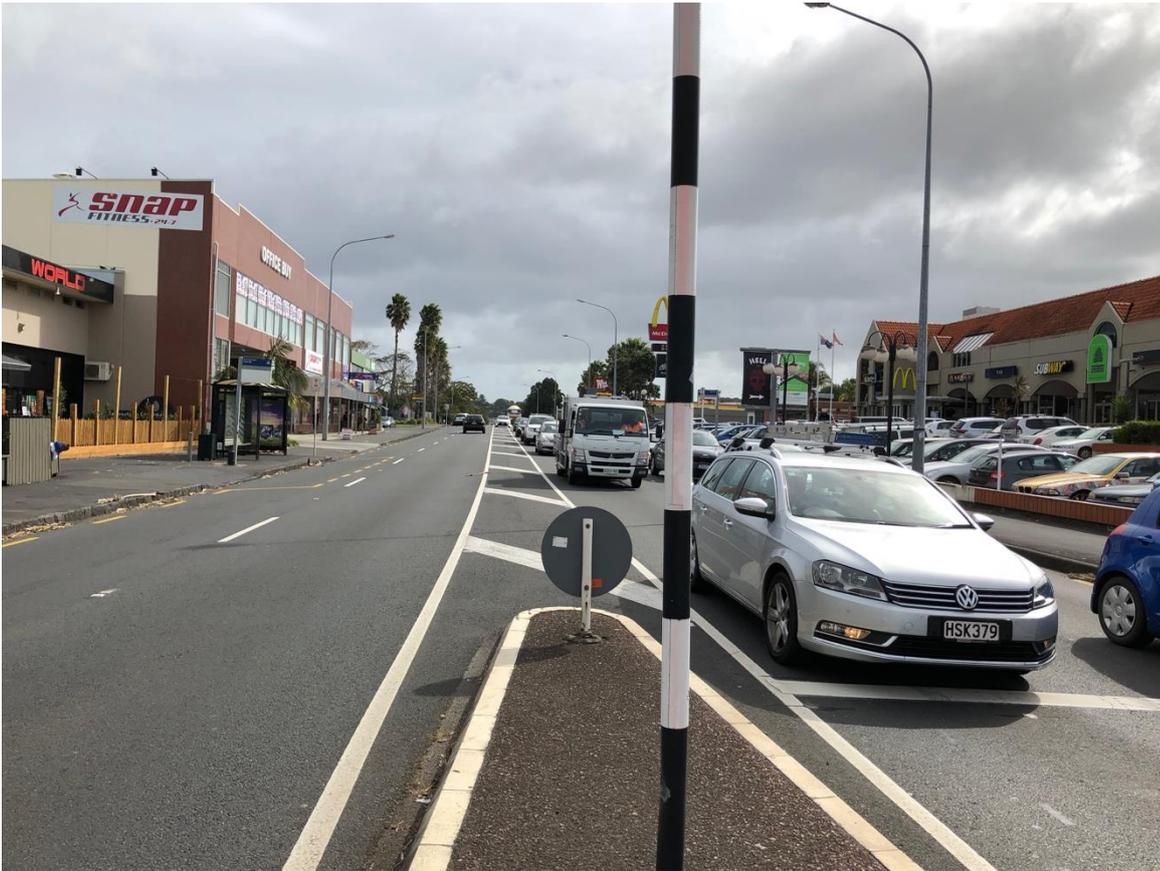
**Figure 4 Queue backup on Mount Albert Road**

However, the positions of the ADS in terms of upstream location distance appear to be shorter than optimal, given the extensive queuing that occurs on the approaches during peak periods. Ideally, drivers should not be required to change lanes in-queue but rather be forewarned with enough time and space in terms of lane changing indications or gaps to pre-segregate their vehicles prior to joining the back-of-queue.

- a) Re-locate the ADS signs as far upstream on each approach as required to allow for safe lane changing prior to joining the back of queues during peak periods;*
- b) Provide repeated turn lane markings upstream of peak period queues on each approach to encourage pre-segregation;*
- c) Extend solid lane lines on Mount Albert Road approach upstream of the pedestrian crosswalk to discourage late lane changes.*

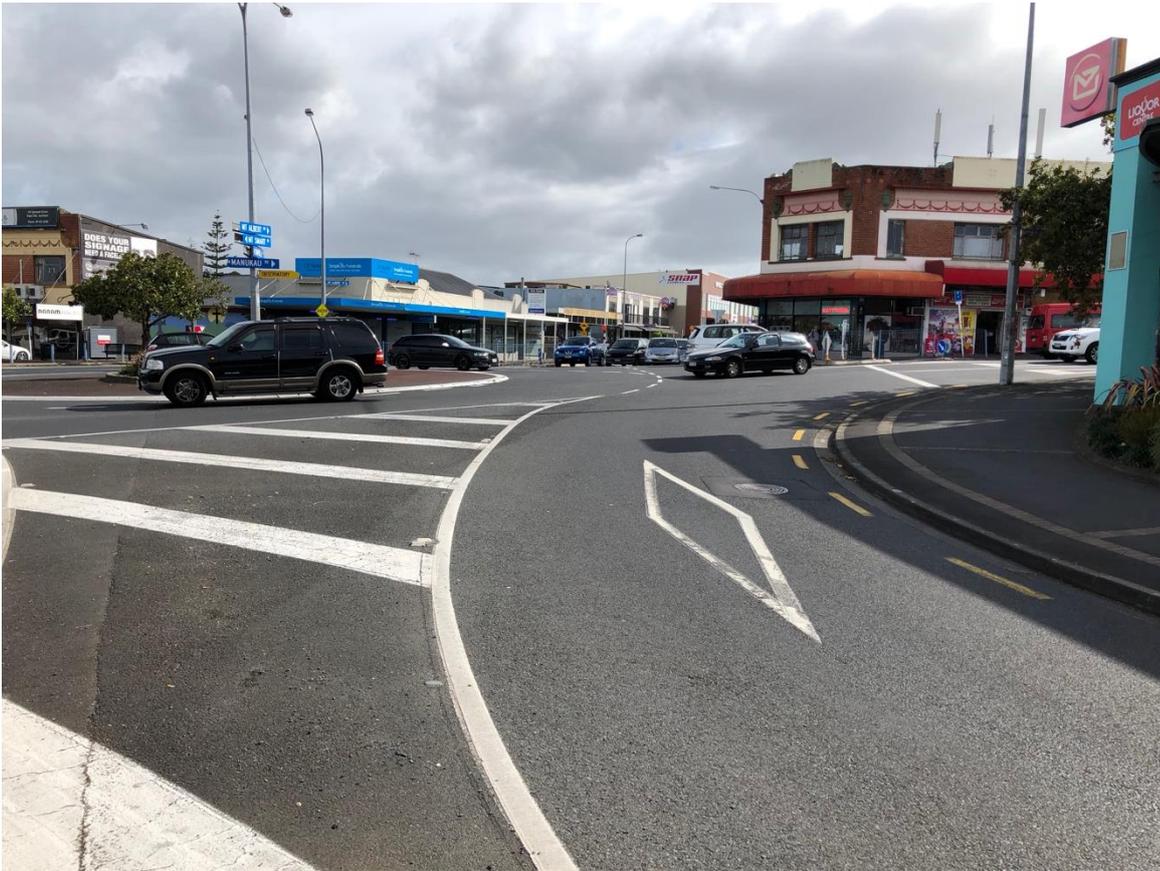
**Figure 5 Trap lane from Mount Albert Road entry to Campbell Road exit**

Particularly on multi-lane arterial routes, drivers reasonably expect to continue through an intersection in either lane. Specifically, on Mount Albert Road which is four lanes wide, the design lane arrangement would result in a left lane “trap” for drivers who may expect to optionally proceed straight through the roundabout to Mount Smart Road from this lane (although Mount Smart only has one exit lane). This could cause unsafe late lane changes to avoid the trap. Of note is that the proposed design extends the raised splitter island on Campbell Road into the currently white-hatched circulatory roadway which more clearly differentiates the Campbell Road exit from the Mount Smart Road exit for Mount Albert Road and Manukau Road (southbound) entrants. While eliminating this acute-angled adjacent exit confusion, it also foreshortens the room for late lane changes, thus accentuating the need for clear and timely lane per-segregation cues on Mount Albert Road and Manukau Road (southbound).

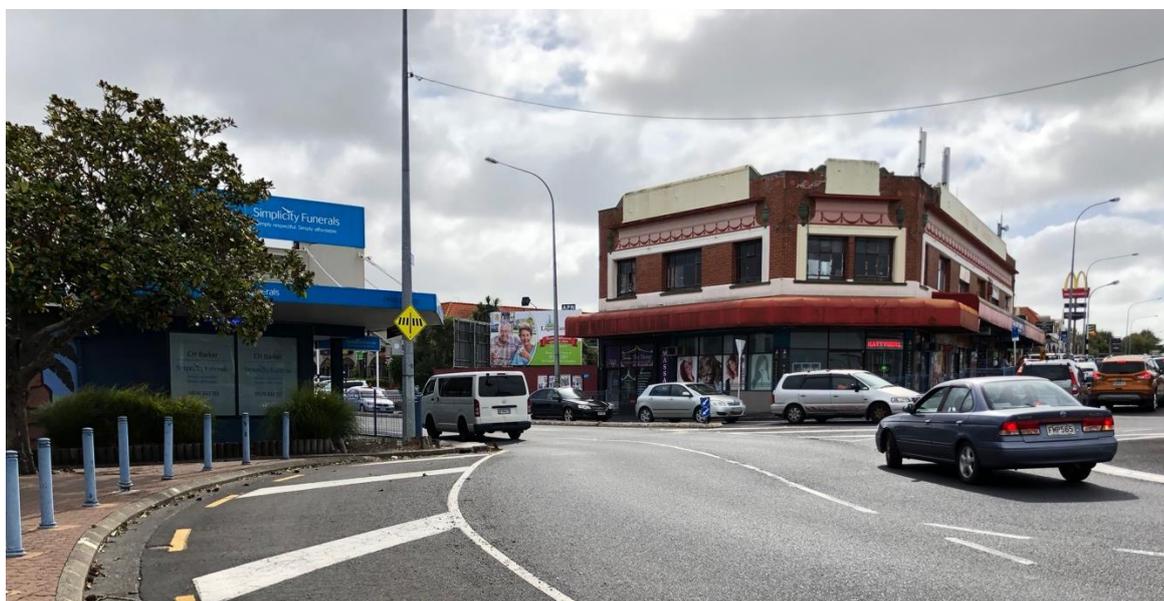
**Figure 6 Constrained exit to Mount Albert Road**

On the other hand, on multi-lane exits, perpendicular exits can cause exit path overlap, particularly for heavy vehicles. For example, the double lane exit to Mount Albert Road has a severe left turn on exit arrangement which adjacent trucks or buses are unable to negotiate without crossing the exit lane markings (see swept paths in Appendix B). This will lead to side-swipe conflicts and crashes.

- a) *At detailed design stage, assess the speed path profiles through the roundabout and provide for safe speeds: through both the entry and circulatory path, with the inner entry lanes being sufficiently offset from and as tangential to the central island as possible; to reduce path overlap for through traffic entering at Campbell Road and Mount Smart Road, and to reduce speeds on the tangential exit lanes at Campbell Road and Manukau Road south exit.*
- b) *Design the mountable central island apron kerb to be sufficiently offset from the fastest travel paths and flush with the pavement surface to minimise the tripping hazard for motorcyclists;*
- c) *Correct the geometry to avoid an exit lane path overlap conflict point for heavy vehicles at Mount Albert Road exit;*

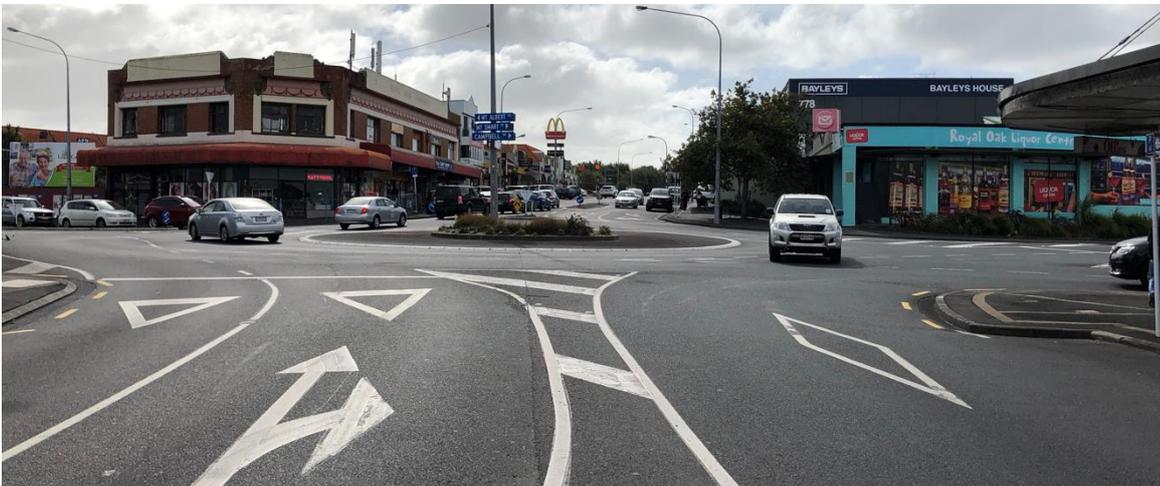
**Figure 7 Inconspicuous central island**

The central island currently consists of a small diameter, relatively wide mountable apron, with a lamppost in the centre and street name signs indicating each exit leg. However, it is evident from the lack of wheel tracks that the apron is not used much and indeed the whole island is very inconspicuous and unreadable with no target value, being almost flush with the circulatory roadway.

- a) *Incorporate heightened visual elements into the enlarged central island to provide a terminal vista from each roundabout approach to improve legibility and recognition that this is a roundabout intersection as well as clearly demarcating the location of the island that must be circulated.*
- b) *Provide the minimum truck apron or vertical elements that are necessary to provide adequate forward stopping sight distance on the circulatory roadway.*

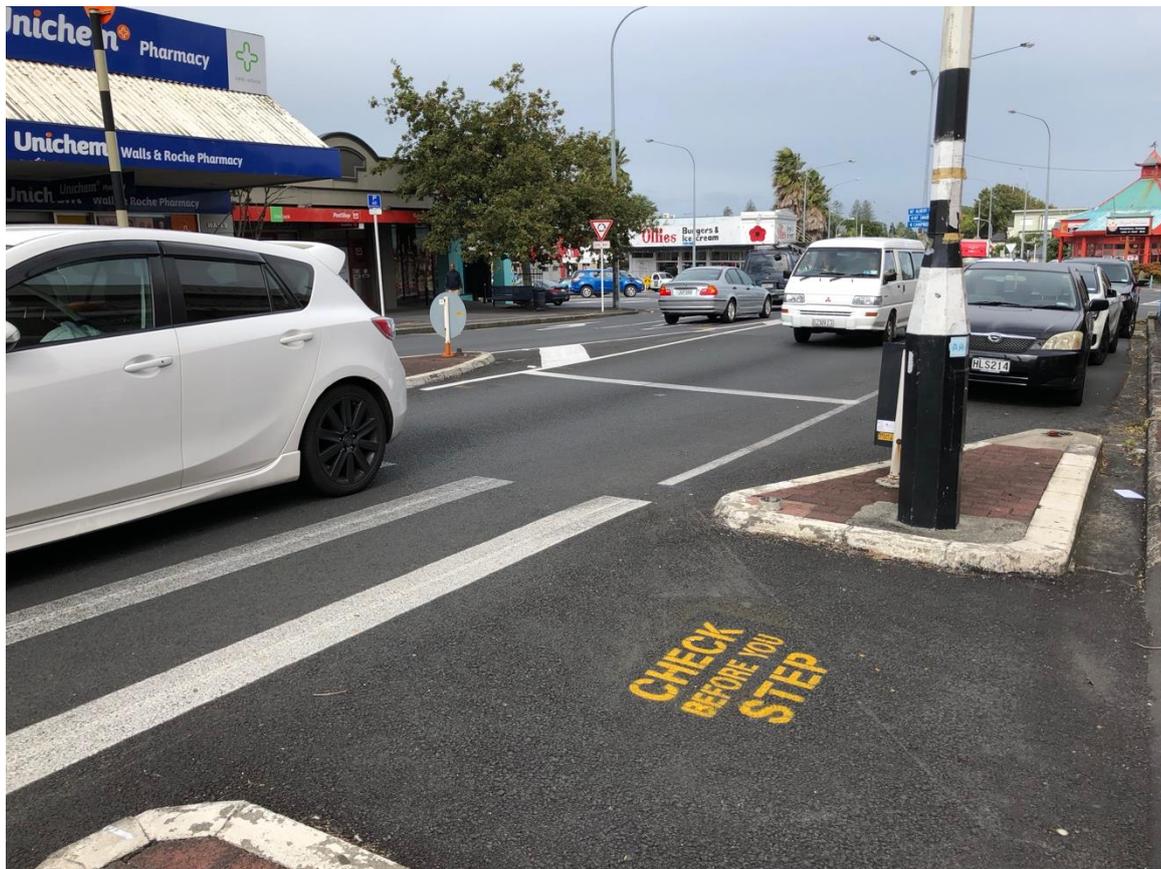
**Figure 8 Car parking obfuscation**

On Manukau Road north and south legs there are some parking spaces either within the functional area of the intersection between the crosswalks and the giveway lines, or upstream that are limiting pedestrian sight distance and resulting in conflicts (side-friction) with through traffic when parking or leaving. It is suggested that any parking spaces that are within the functional area of the intersection or limiting sight distances to the crosswalks be removed (Appendix E).

- a) *Remove all parking spaces within the functional intersection areas between the crosswalks and giveaway lines on Manukau Road exits and Manukau Road northbound entry.*
- b) *Provide adequate dynamic sight distance of pedestrians by removing any parking space within 1 car length from the crosswalk on each approach on Manukau Road north and south.*
- c) *Retrofit the existing Mount Albert Road crosswalks to have a consistent design and marking treatments to the new raised crossings on the other legs.*
- d) *Consider providing active road studs at all crosswalks for safety and consistency.*
- e) *Design a solution for the queue spillback from the Manukau Road northbound exit due to the high pedestrian crossing activity during peak periods.*

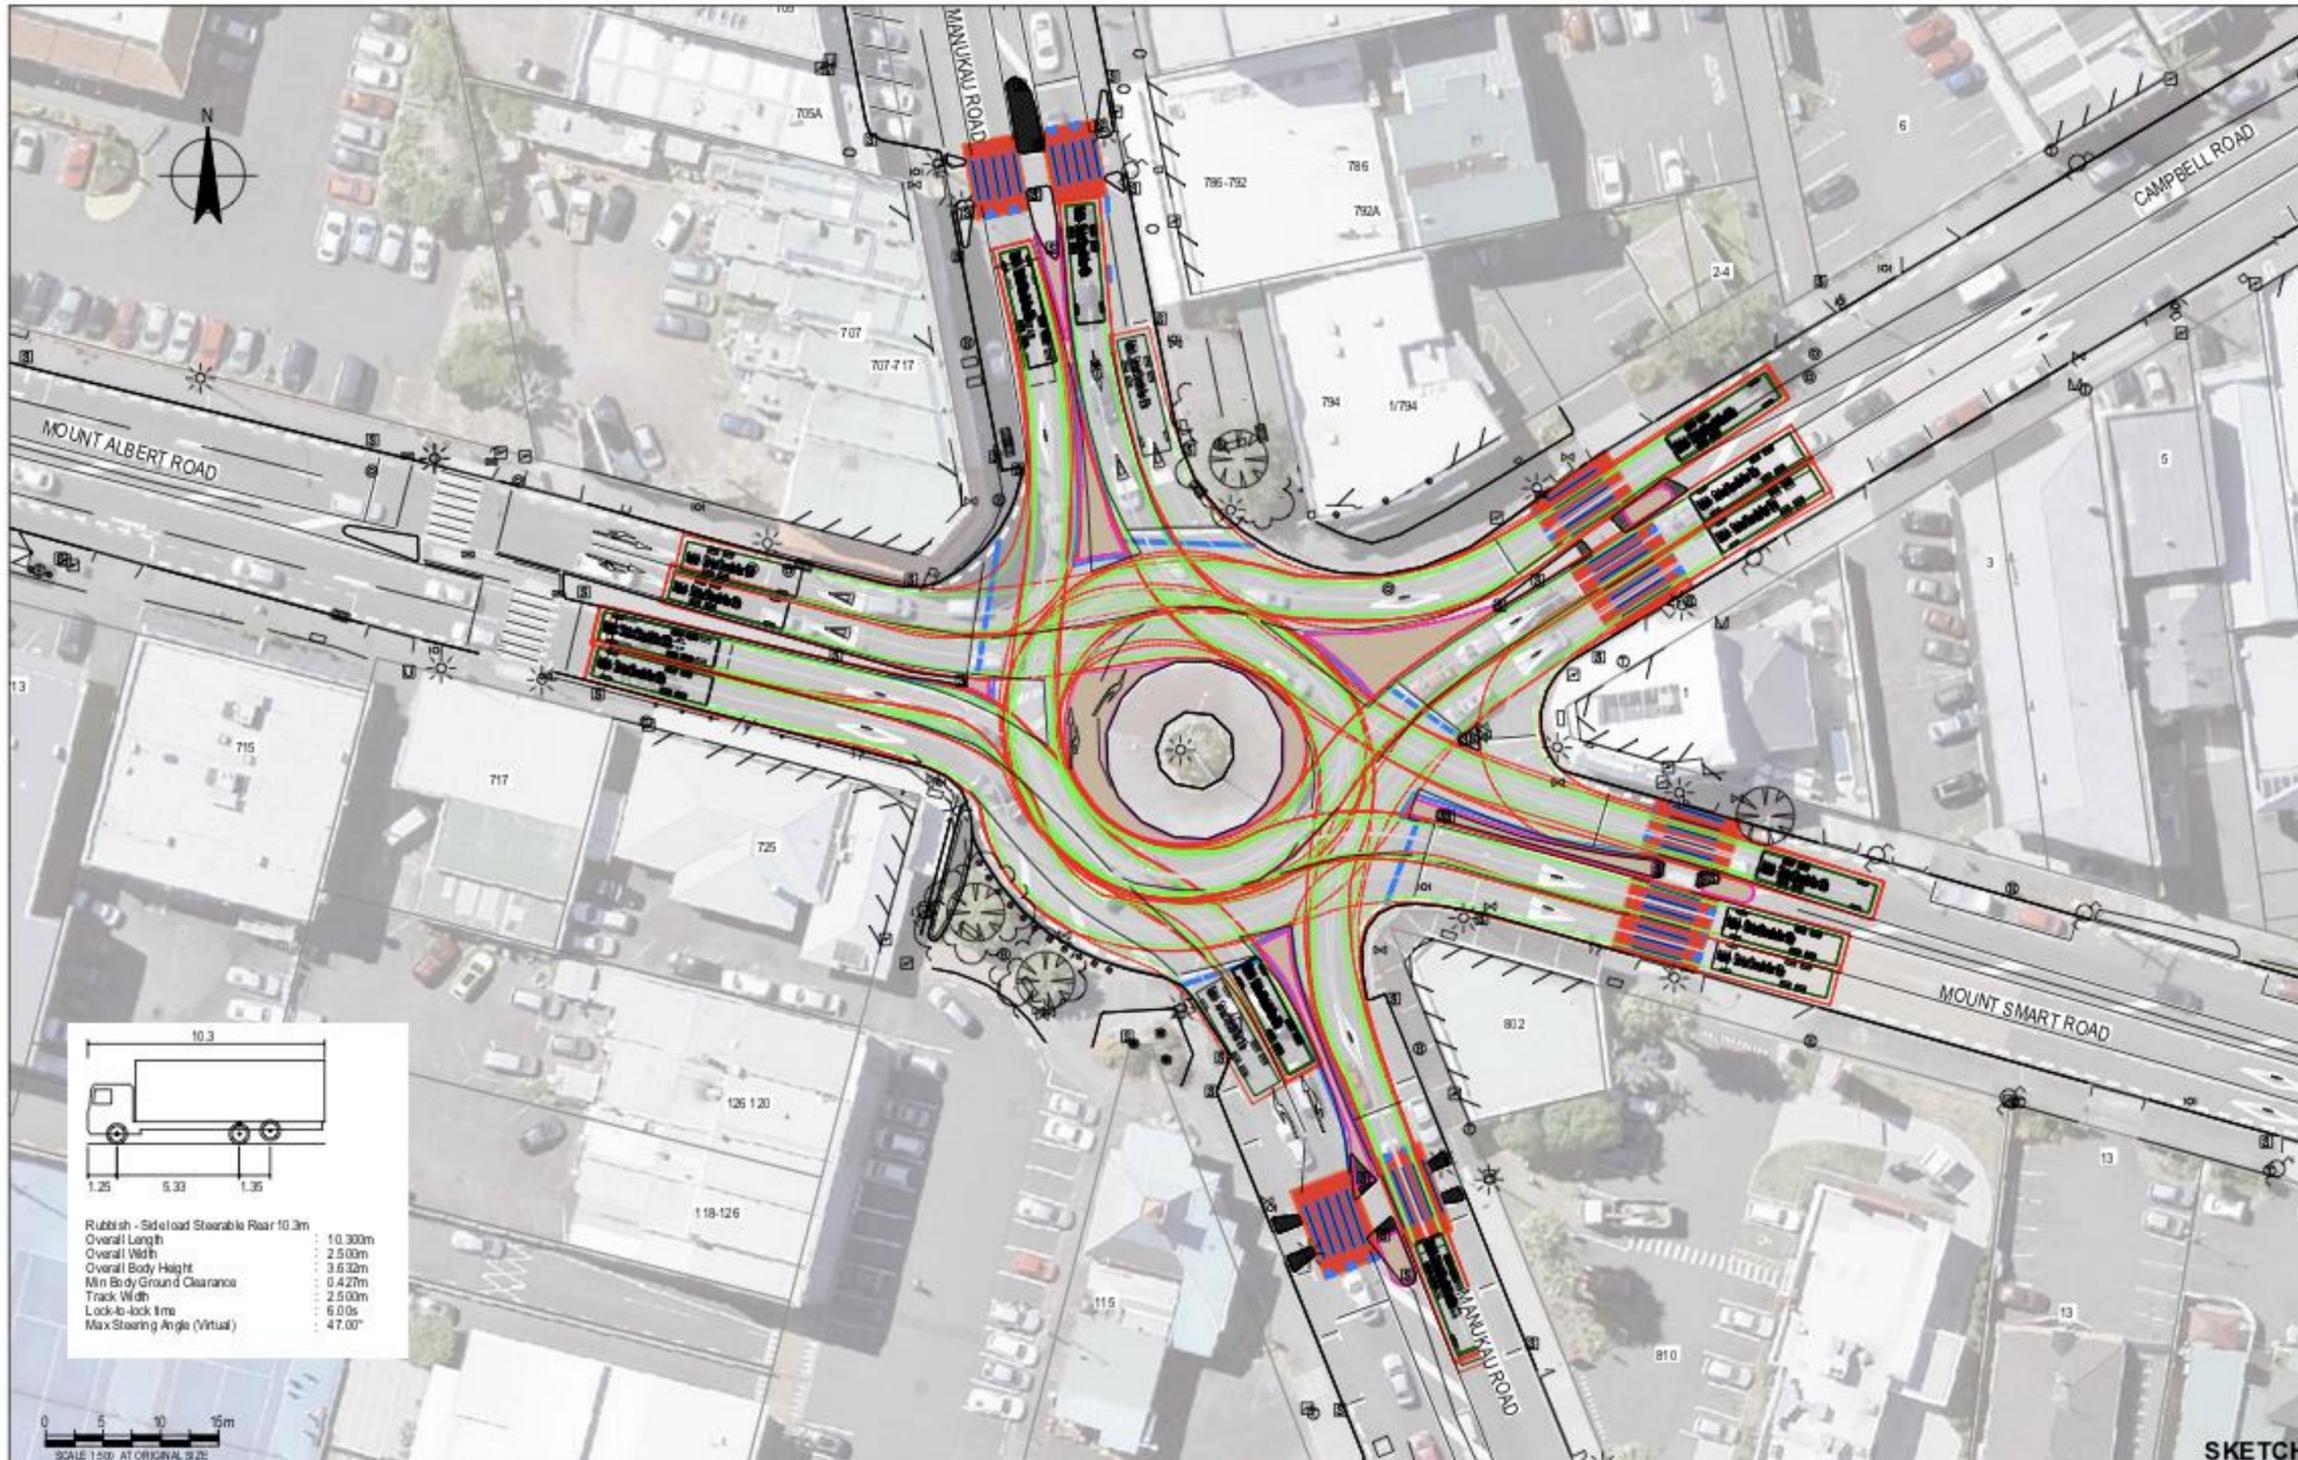
Appendix B: Tracking Curves (Rubbish Trucks)

The proposed design will increase the central island and reshape it with two “cams” to develop right turn spiral lanes from. The exact shape has been determined from the non-traversable “remnant” as indicated by the inside track requirements of the design vehicle swept paths (Appendix B).

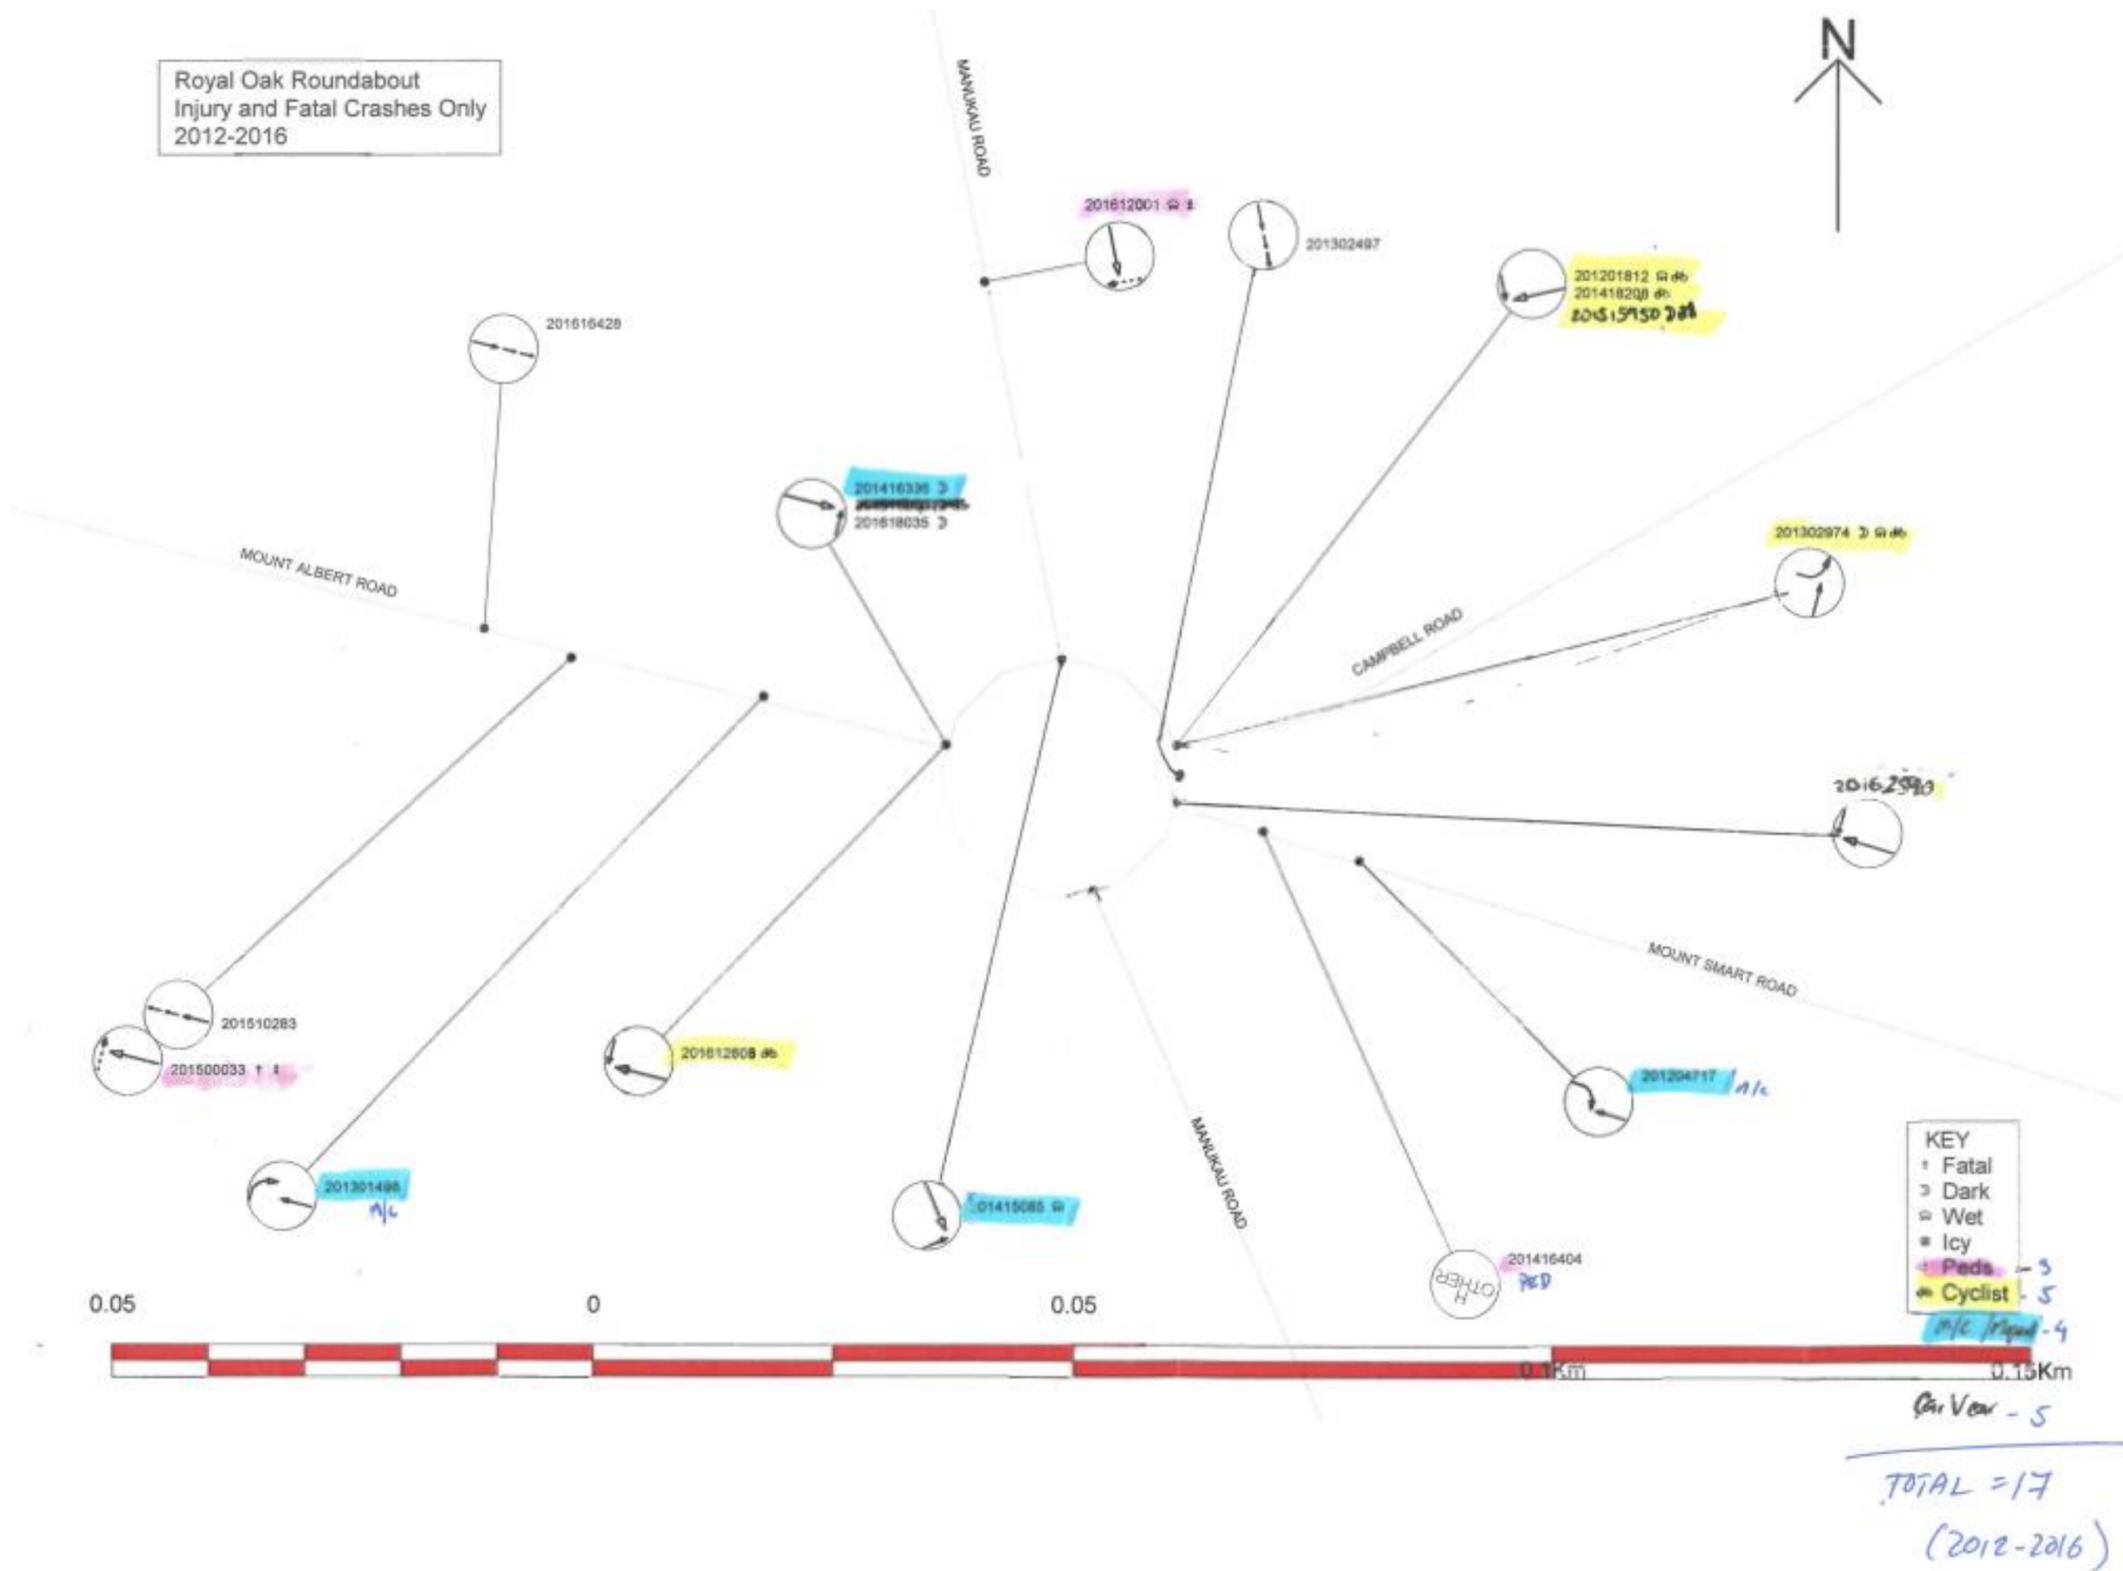
Appendix C: Crash Record (2012-2016)

Pedestrians have been involved in 5 of 17 injury or fatal crashes (Appendix C). Furthermore, the traffic surveys (Appendix D) indicate that there is significant pedestrian activity throughout the day and early evening. Two of the legs (Campbell Road and Royal Albert Road) currently have active road studs at the crossings. At four of the five legs there are currently ramped kerbs off the sidewalk at pedestrian crossing points and flush pedestrian refuges through the splitter islands.

The crash evidence indicates that 5 of 17 crashes involved bicyclists, also noting that a further 4 involved motorcycles or mopeds (Appendix C). Multilane roundabouts are difficult for less confident cyclists to negotiate in the general traffic lanes, particularly if they have more than 4 legs as occurs at Royal Oaks. Therefore, recommended practice is to provide an alternative off-road path for less confident cyclists as multi-lane roundabouts. In this case, the variable circulatory roadway also makes it difficult for cyclists to pre-segregate into the correct lanes to negotiate the intersection by requiring them to claim an inside lane rather than a shoulder lane to certain destinations.

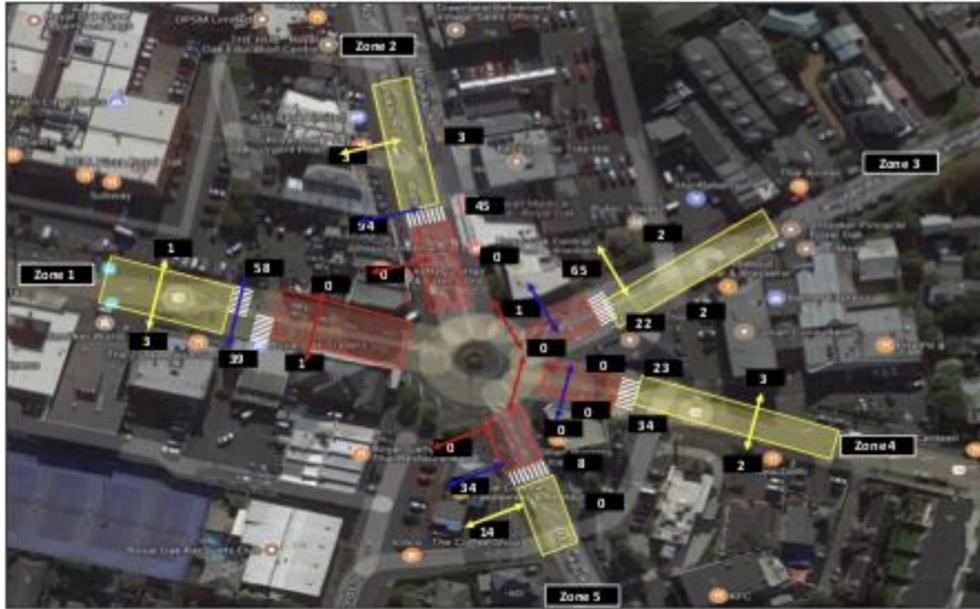
Figure 9 Pedestrians 8-9am

Client: GHD  
 Location: Royal Oak Roundabout  
 Date: Thursday, 19 October 2017  
 Survey Time: 07:30 - 09:30 & 15:00 - 18:00  
 Description: Royal Oak Roundabout Pedestrian Crossing Survey

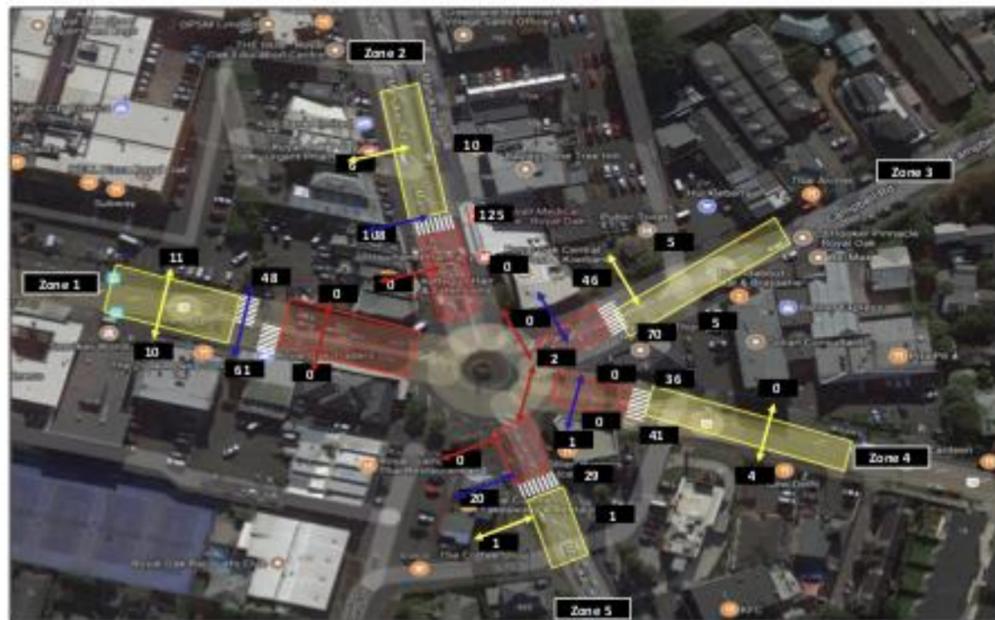
Figure 10 Pedestrians 4-5pm

Client: GHD  
 Location: Royal Oak Roundabout  
 Date: Thursday, 19 October 2017  
 Survey Time: 07:30 - 09:30 & 15:00 - 18:00  
 Description: Royal Oak Roundabout Pedestrian Crossing Survey

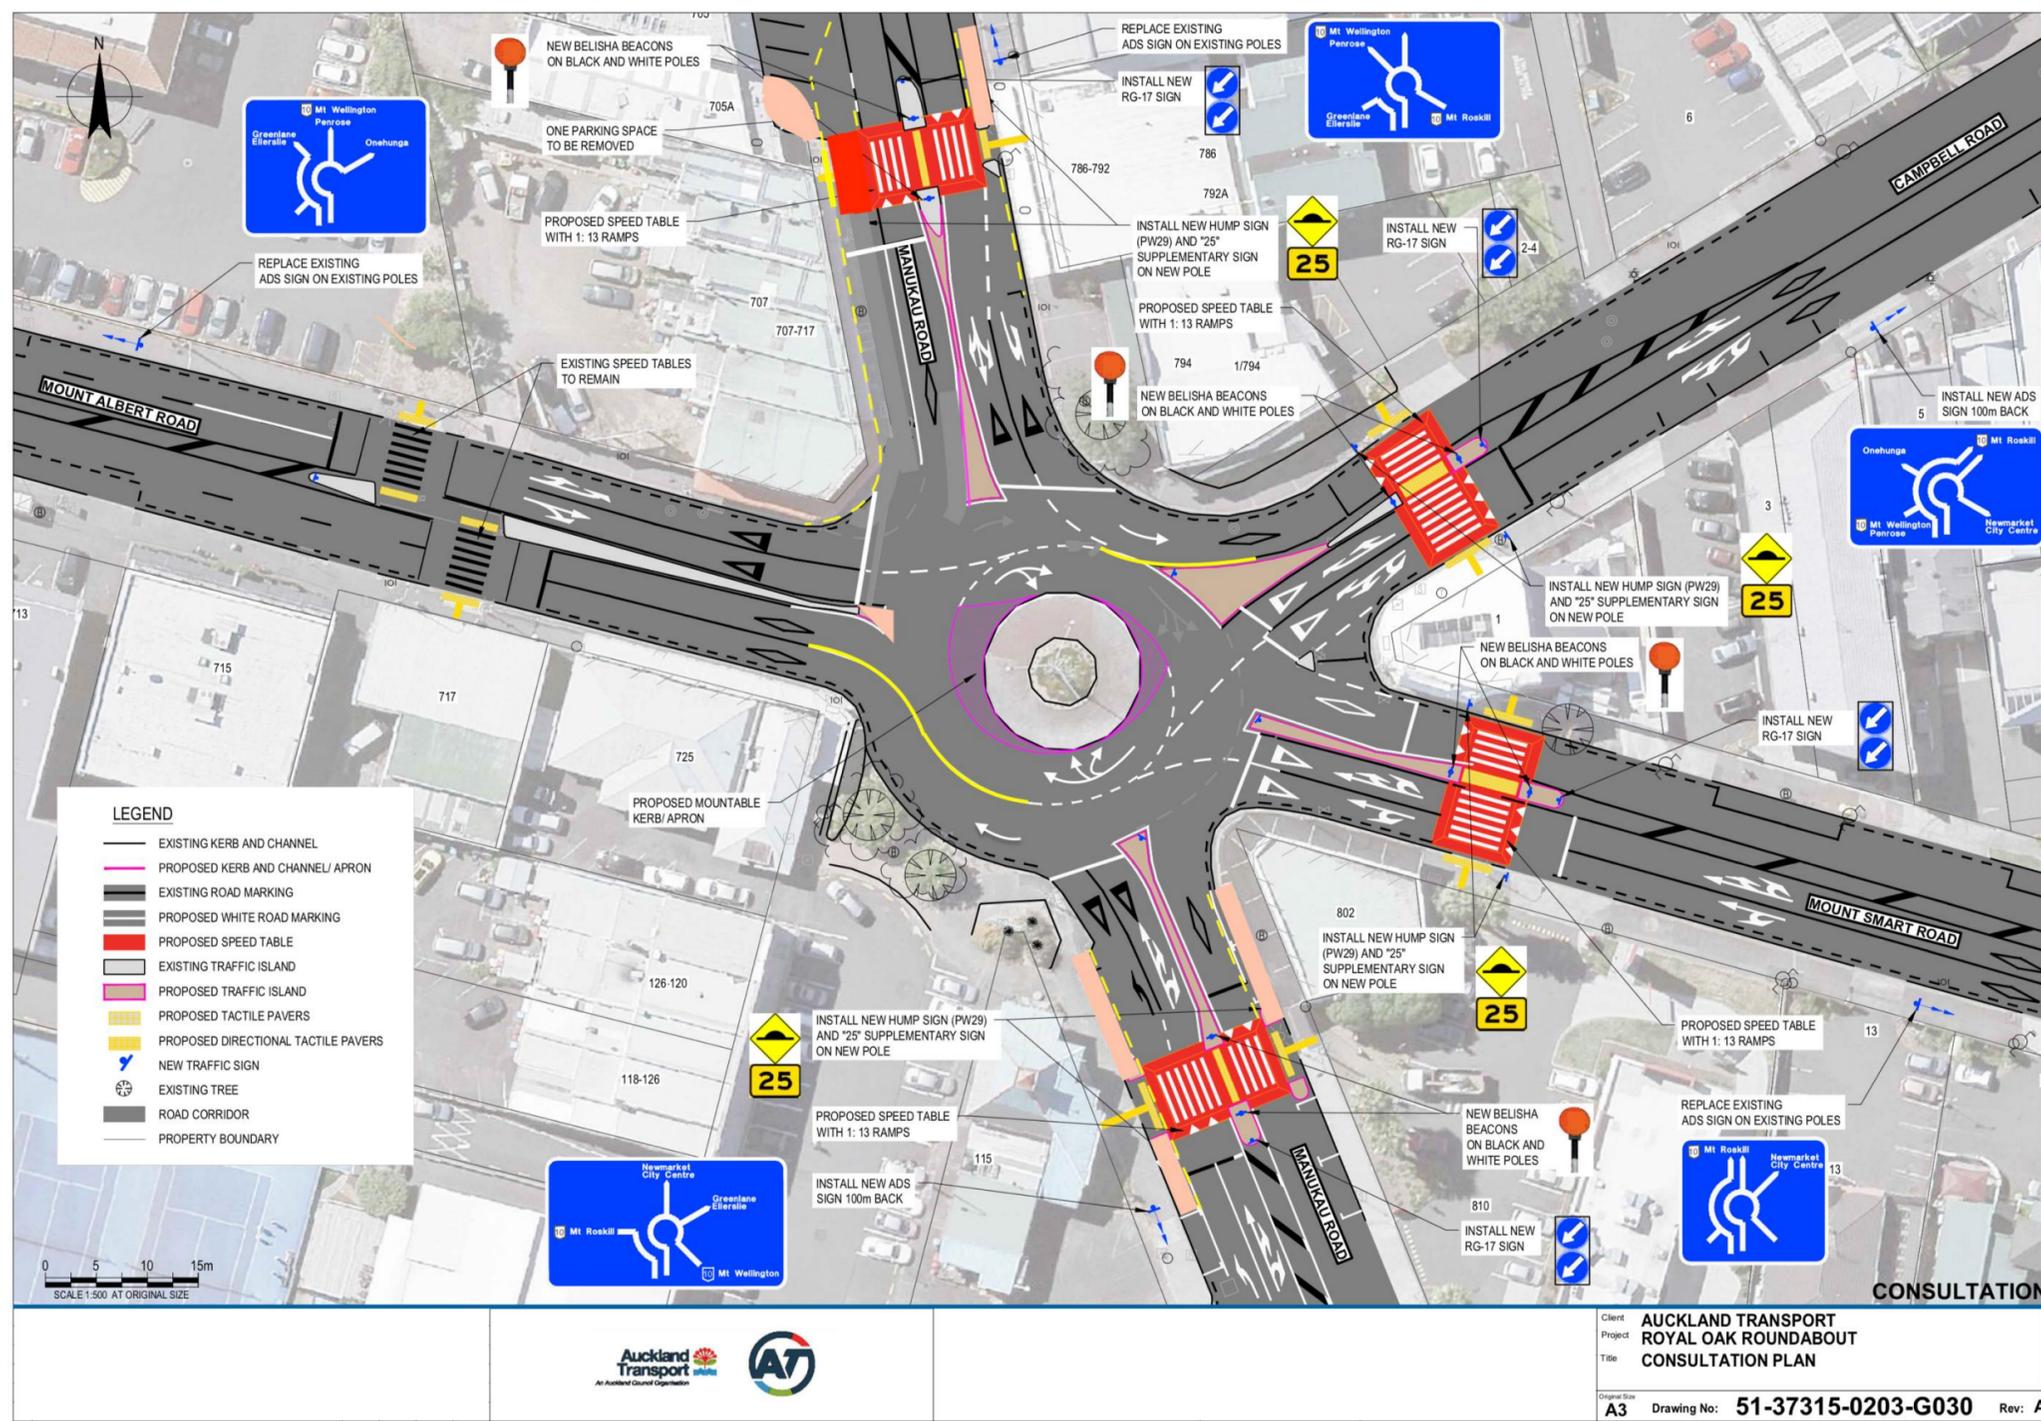
### Appendix E: Review Markup\* of Roundabout Improvements Concept Design

As a further visual cue, the inner circulatory lane could benefit from having the turn arrows repeated opposite splitter islands where there are two circulatory lanes at Manukau Road north and south. The exclusive left exit lanes to Mount Albert Road and Campbell Road would also benefit from repeater directional markings on the outer circulatory lanes between the entry and exits. A graphical summary of these lane marking recommendations is provided as Appendix E.

- a) *Consider providing guidelines for the median entry lanes from the giveway line into the correct inside circulatory lane for critical movements.*
- b) *Consider providing turning lane arrow markings in front of the splitter islands in the multi-lane circulatory roadway.*
- c) *The solid spiral lane markings in the southwest and northeast quadrants of the circulatory roadway could be made more conspicuous through a combination of wider and different colour and/or by including audio tactile pavement markings.*
