FILE NOTE

compliance visit13/14 **SUBJECT**

FILE NUMBER WGN/11/0357/1-v1

Compliance monitoring report 2013/2014 for WGN110357 [31060]

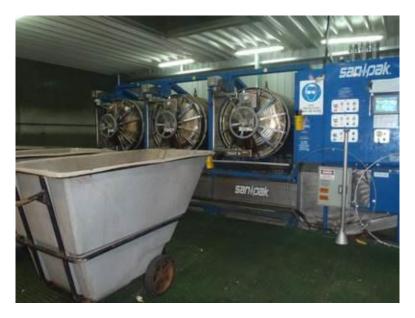
3 autoclaves all currently in the porcess of sterilising medical waste at a temperature of 140c. There was a slight odour inside the building that was fairly unpleasant.

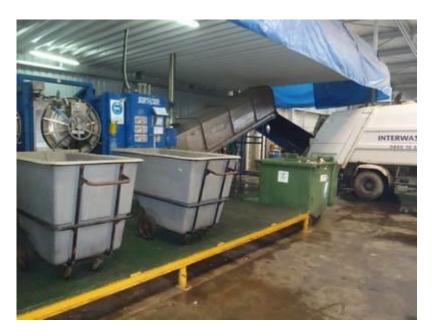
After finishing the cycle inside the autoclaves the contents were put onto a conveyor belt which carryed the waste to the truck which would take the waste to the porirua landfill which is on the same road.

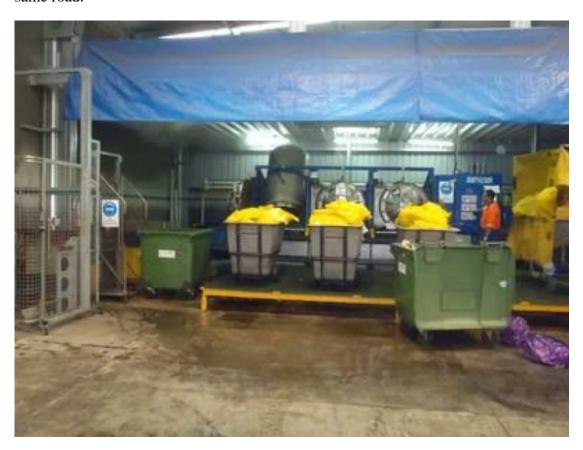
The autoclave being tipped has just emptied its contents onto the conveyor belt. This is the portion of the process which has the history of creating odours. In the photo it is possible to see the steam from the autoclave being trapped by the blue tarp and being sucked in by the filtration system. I inspected the filtration system out the back while the autoclaves were running and I could detect no odour.
