Unit B

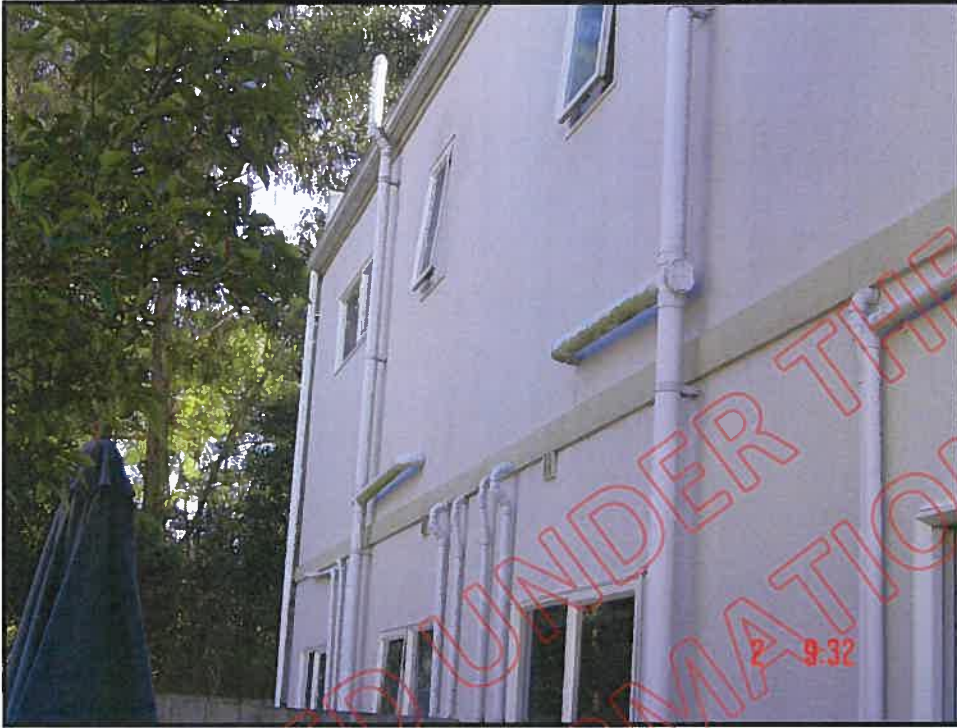
Unit B
Photograph 3b-75

General view- rear elevation (west) units B and C

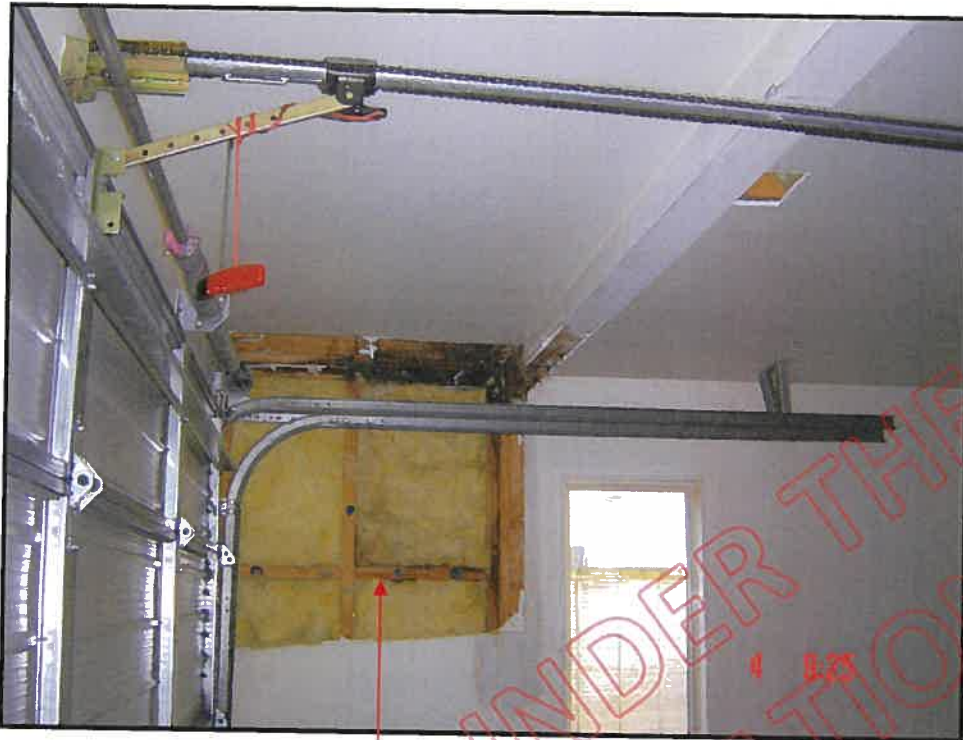
Photograph Internal- c 129

Location of cut out by others

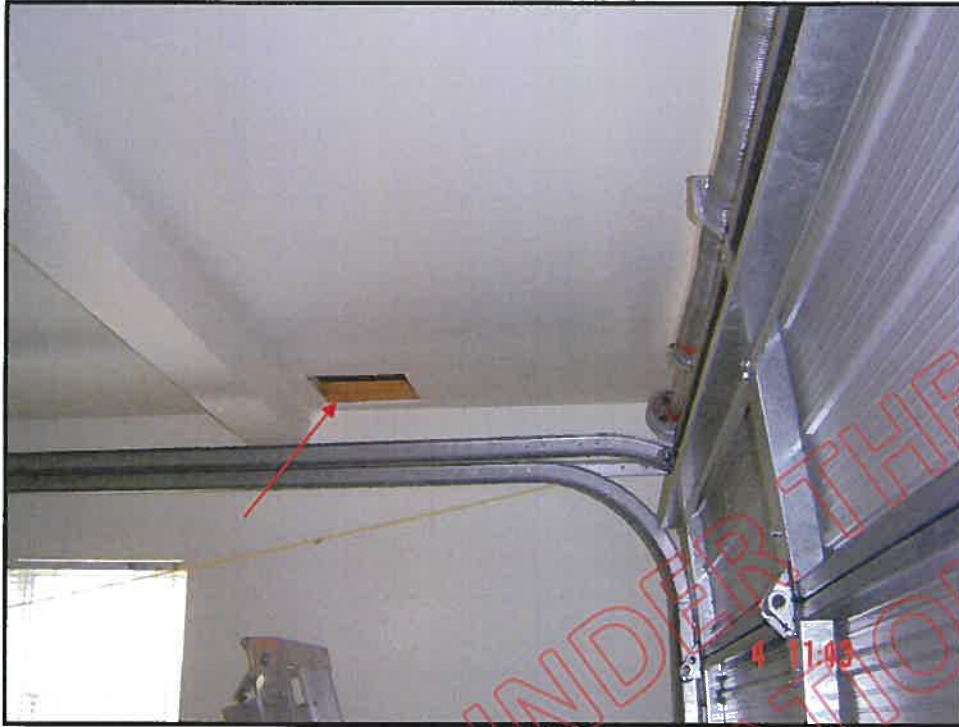
Photograph Internal- d 131

Location of garage ceiling cut out
