ASBESTOS MANAGEMENT PLAN & SITE MANAGEMENT SURVEYS

Site: South Canterbury DHB
Queen Street, Parkside, Timaru

Prepared for: South Canterbury District Health Board

Project Ref: C-00727

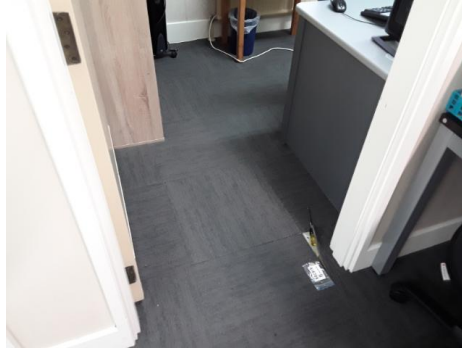
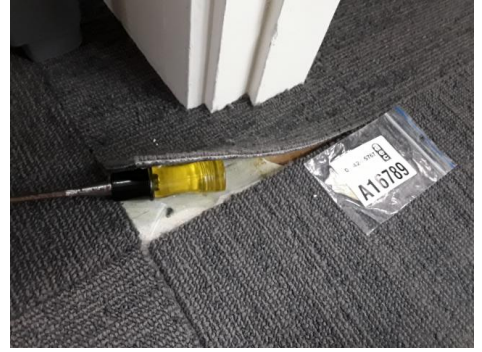
7 Queen Street, Kensington
Ground Floor G121 Store (021)

Vinyl floor covering - Grey -
Vinyl Products

Sample No. A16790

No Asbestos Detected

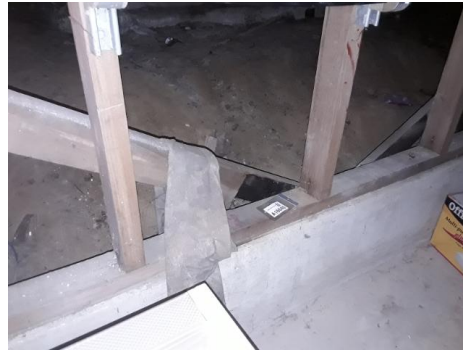
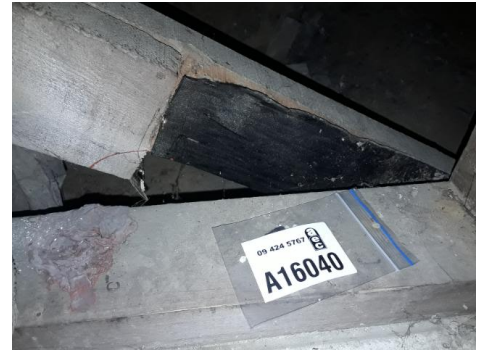
Basement Northern perimeter
wall (108)

Sample No. A16041

No Asbestos Detected

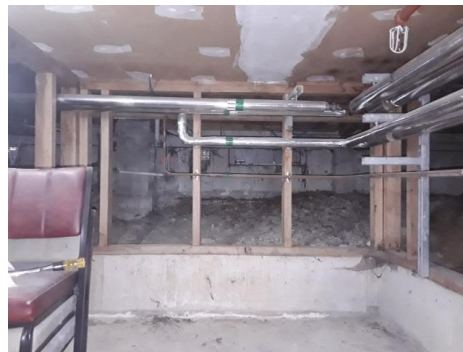
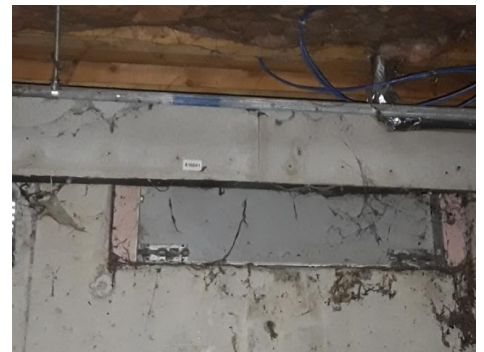
Basement Central passage,
South side pipe run, 5m east of
access stairs (109)

Sample No. A16042

No Asbestos Detected

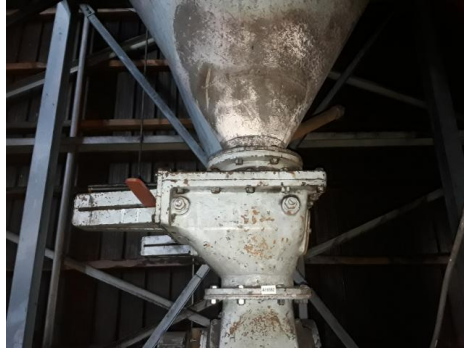
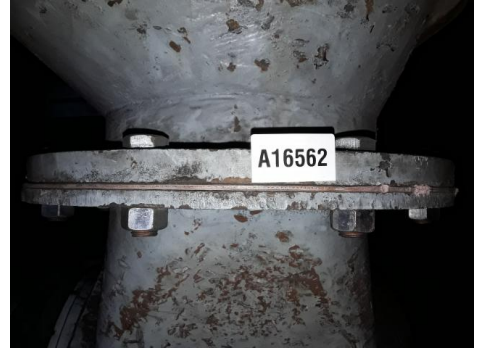
2nd Floor Stack platform below silos (006)

Sample No. A16562

Chrysotile

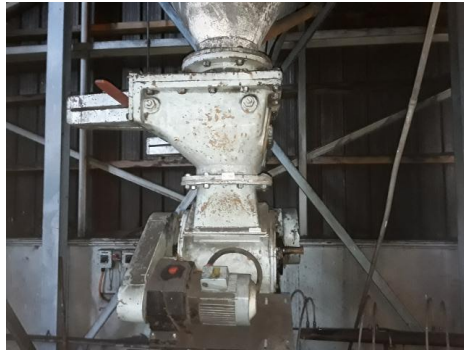
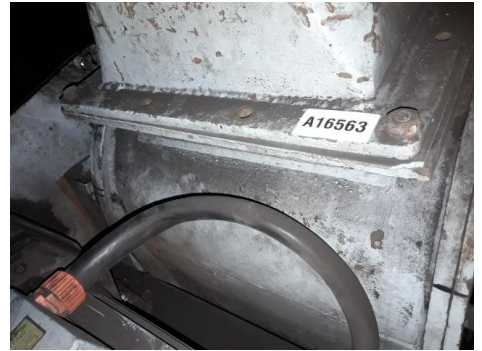
2nd Floor Stack platform below silos (007)

Sample No. A16563

No Asbestos Detected

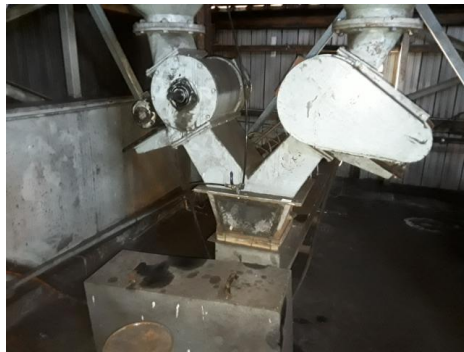
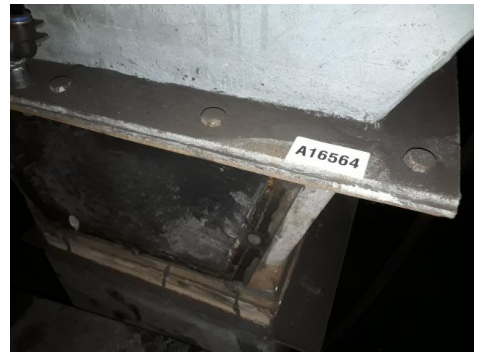
1st Floor Access Room (008)

Sample No. A16564

Chrysotile

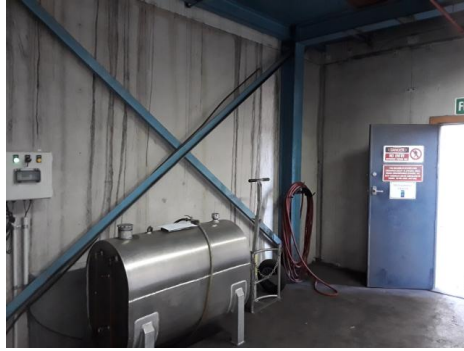
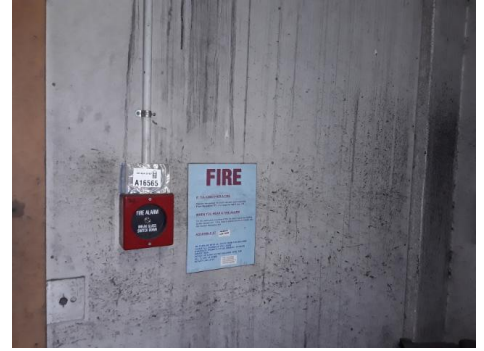
1st Floor Access Room (009)

Sample No. A16565

No Asbestos Detected

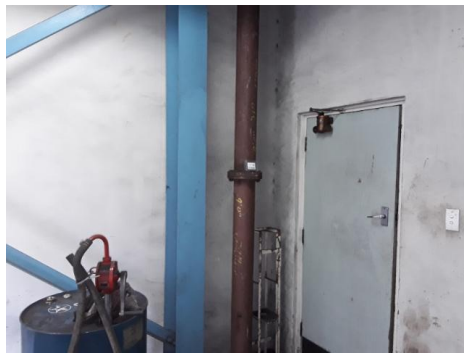
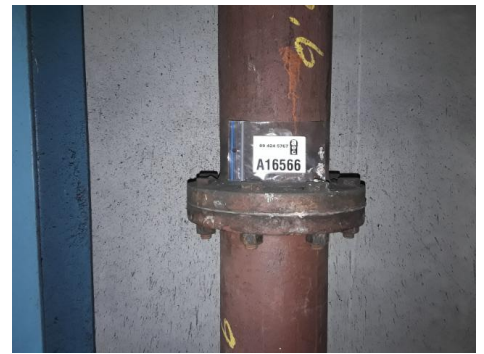
1st Floor Plant Room (010)

Sample No. A16566

Chrysotile

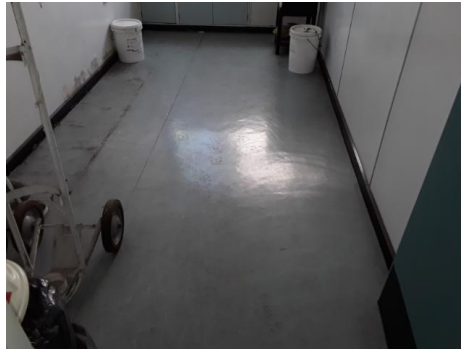
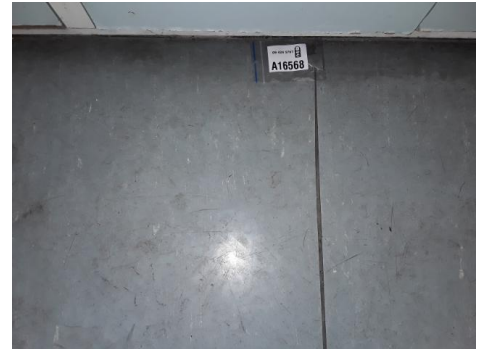
Ground Floor Incinerator Room
(015)

Sample No. A16568

No Asbestos Detected

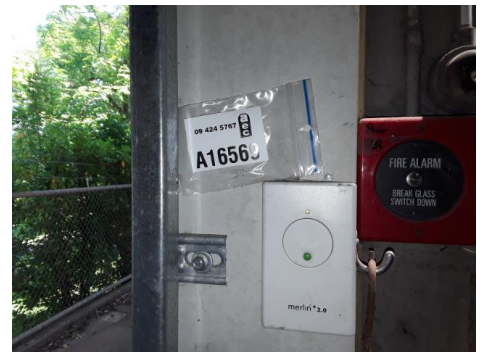
Ground Floor Small boiler room,
Southwest corner (018)

Sample No. A16569

No Asbestos Detected

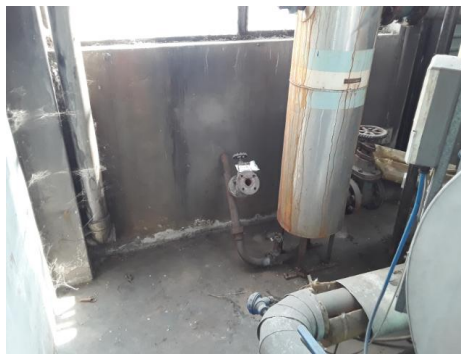
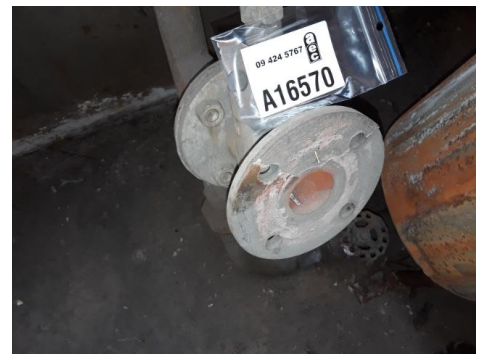
Ground Floor Small boiler room,
Northeast corner (020)

Sample No. A16570

Chrysotile

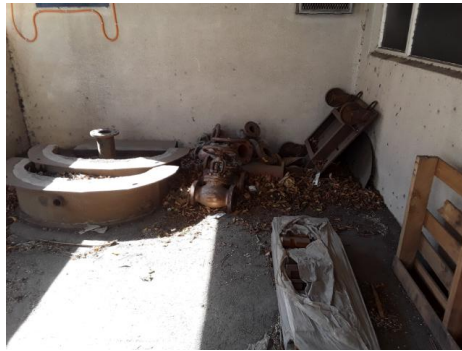
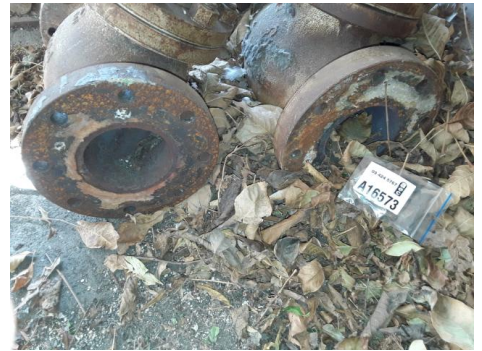
External Trench to front of roller door (025)

Sample No. A16573

Chrysotile

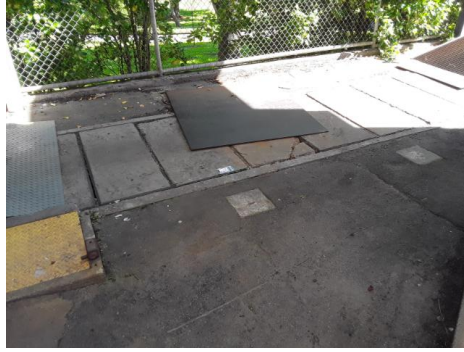
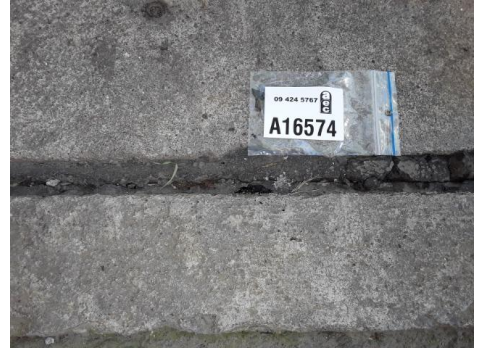
External Access Room external wall (026)

Sample No. A16574

No Asbestos Detected

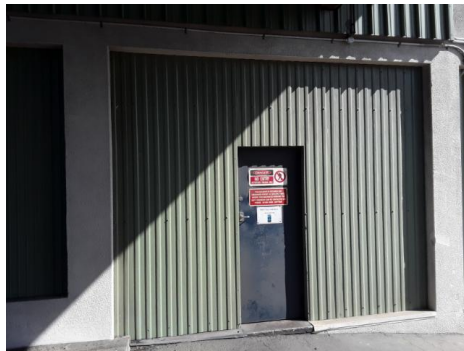
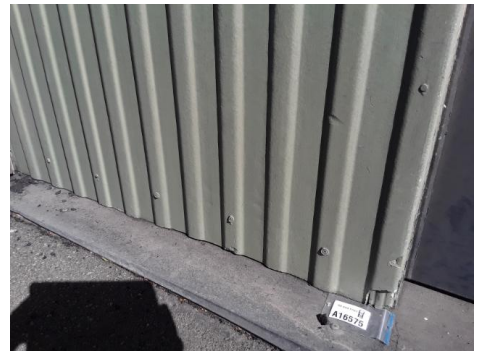
Sample No. A16575

Amosite & Chrysotile

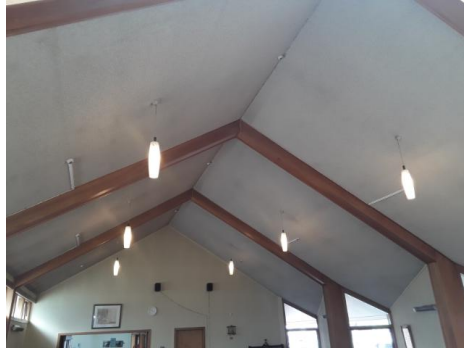
Chapel, Timaru Hospital
Ground Floor Chapel, rear section (002)

Textured coating to walls - Decorative Finishes

Sample No. A16592

Chrysotile

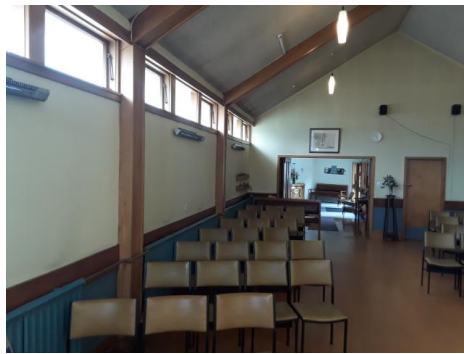
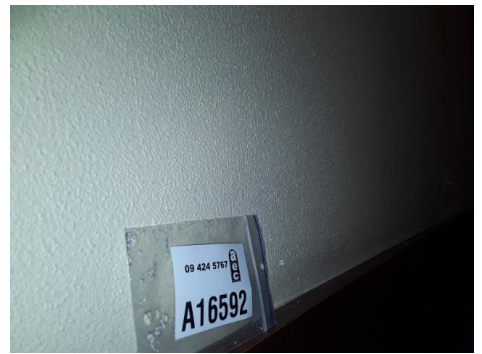
Chapel, Timaru Hospital
Ground Floor Chapel, Alter (003)

Textured coating to walls - Decorative Finishes

Sample No. A16593

No Asbestos Detected

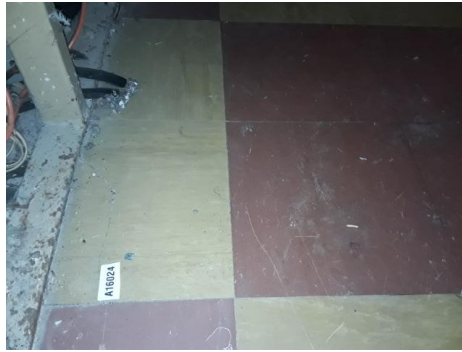
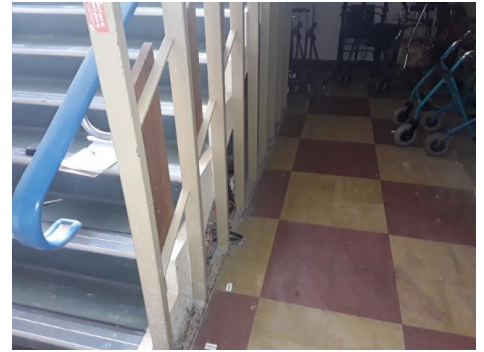
Ground Floor North End
Stairwell (007)

Sample No. A16025

Chrysotile

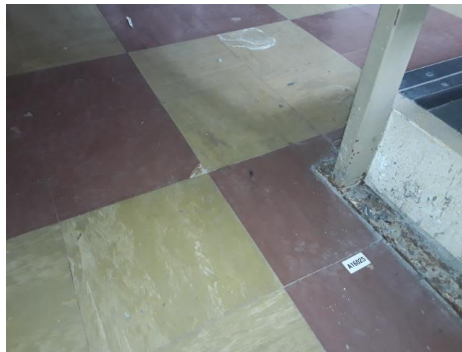
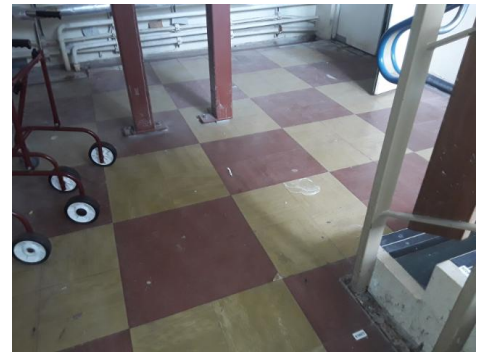
Ground Floor North End
Stairwell (008)

Sample No. A16026

Chrysotile

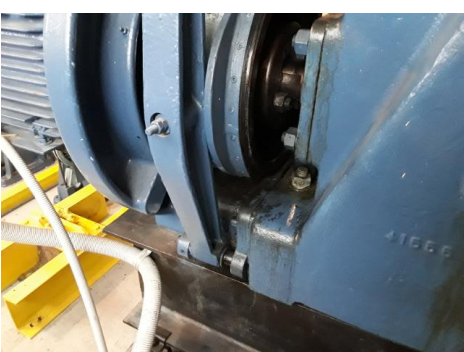
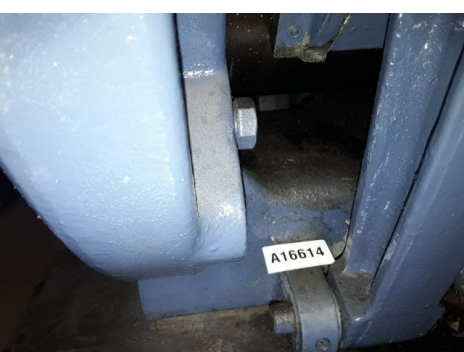
<p>Clinical Services Building, Timaru Hospital</p> <p>6th Floor Lift Motor Room (021)</p> <p>Dust to horizontal surfaces below southwest lift motor brake pads - Friction Material</p> <p>Sample No. A16614</p> <p>No Asbestos Detected</p>

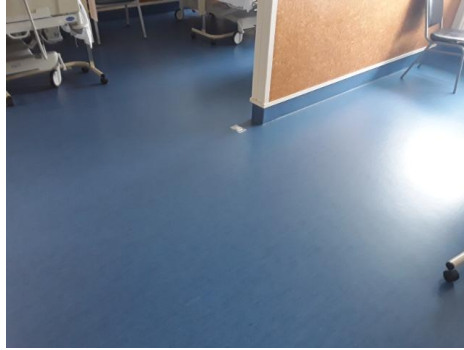
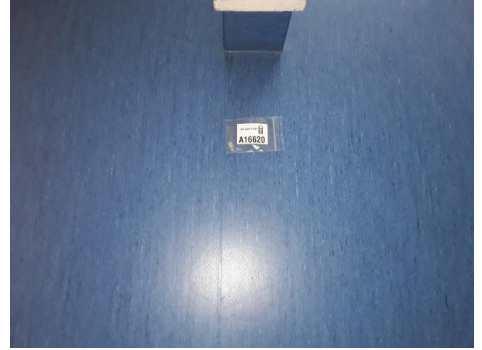
Sample No. A16620

No Asbestos Detected

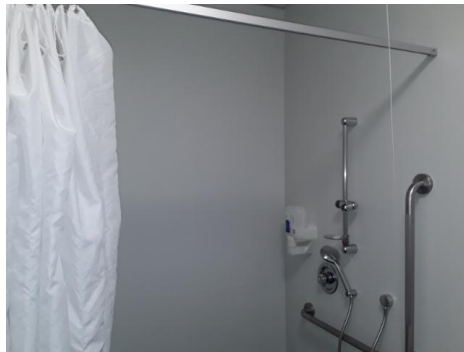
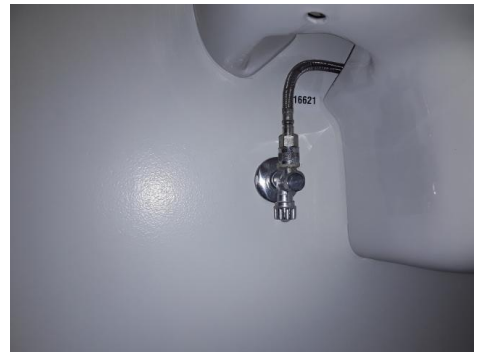
5th Floor 523b Toilet (056)

Sample No. A16621

No Asbestos Detected

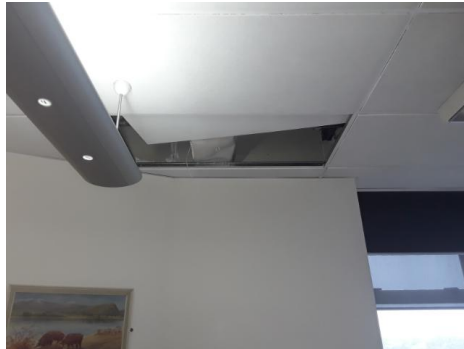
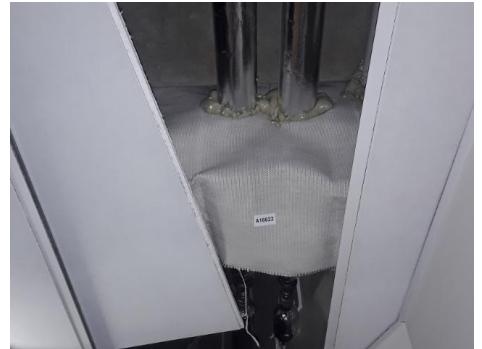
5th Floor 514a - Ceiling Void
(074)

Sample No. A16622

No Asbestos Detected

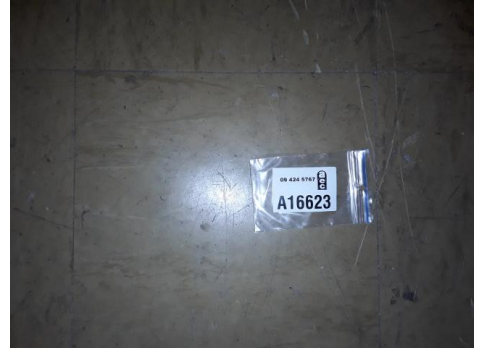
5th Floor 540 / 541 Plant Room
(085)

Sample No. A16623

Chrysotile

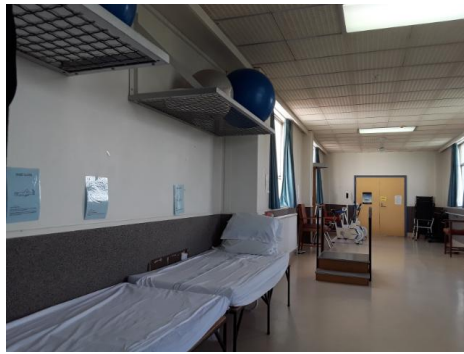
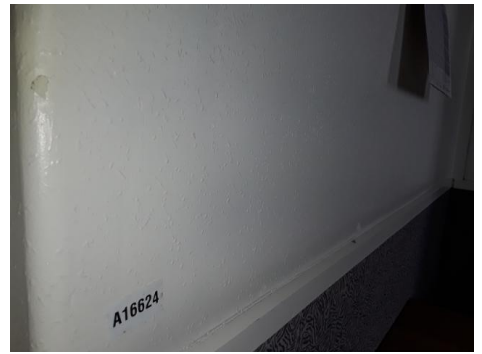
5th Floor Gym (087)

Sample No. A16624

No Asbestos Detected

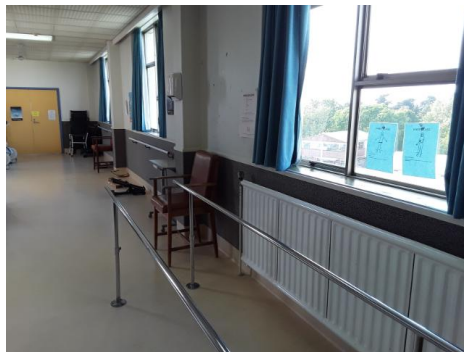
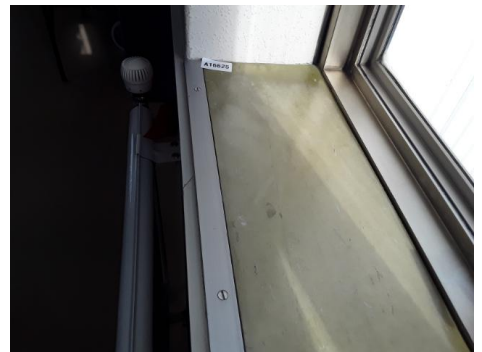
5th Floor Gym (089)

Sample No. A16625

No Asbestos Detected

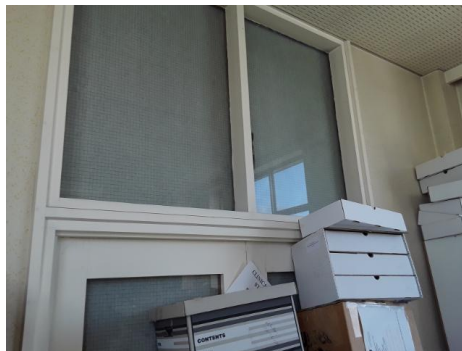
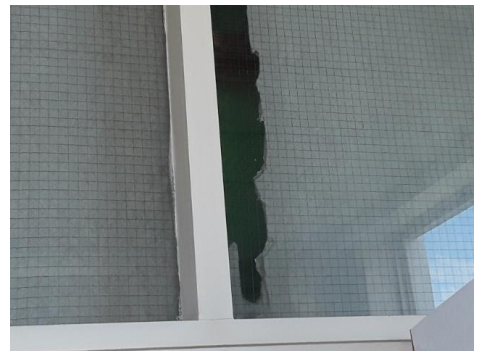
5th Floor Gym Store - Rear
Space (095)

Sample No. Presumed

Amosite & Chrysotile

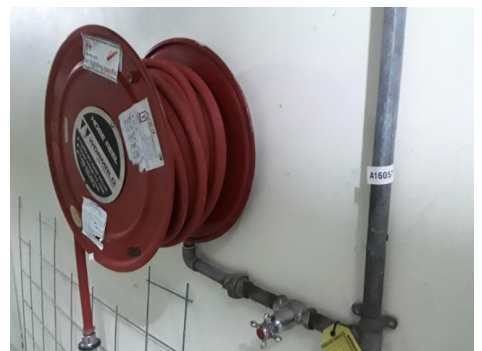
Ground Floor Basement
Corridor Adjacent to Access into
Undercroft (704)

Sample No. A16057

No Asbestos Detected

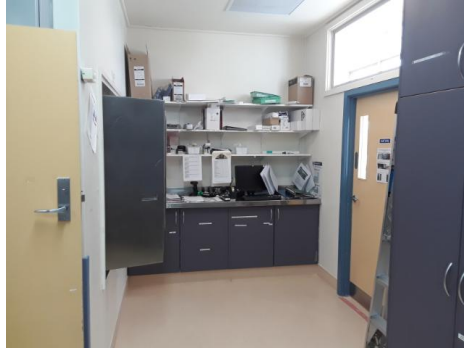
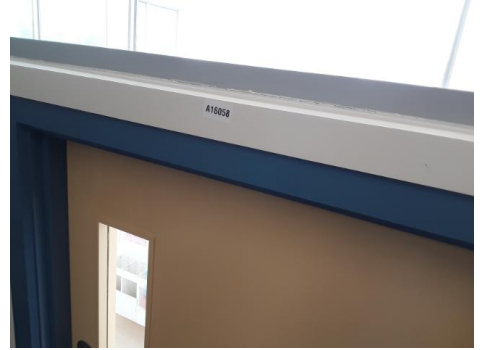
4th Floor 441, Theatre Prep,
Adjacent Equipment Lift (705)

Sample No. A16058

No Asbestos Detected

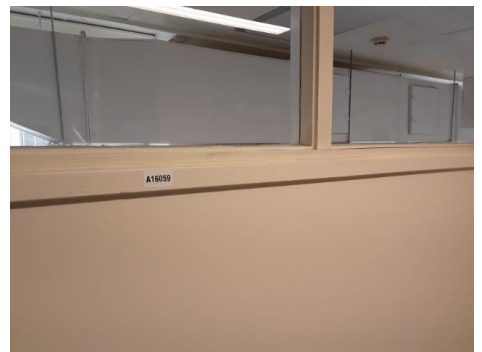
3rd Floor Sterile Prep, Adjacent
Equipment Lift (706)

Sample No. A16059

No Asbestos Detected

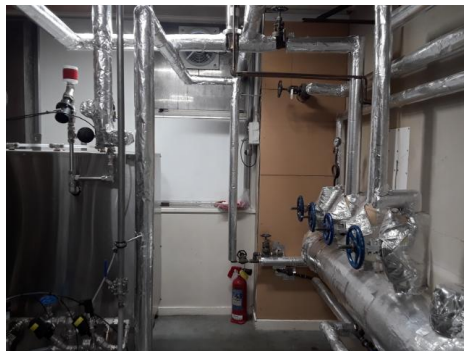
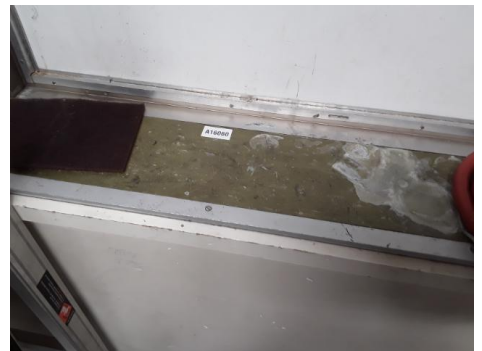
3rd Floor Sterile Prep Plant
Room, Window Ledge Adjacent
Riser Boxing (707)

Sample No. A16060

No Asbestos Detected

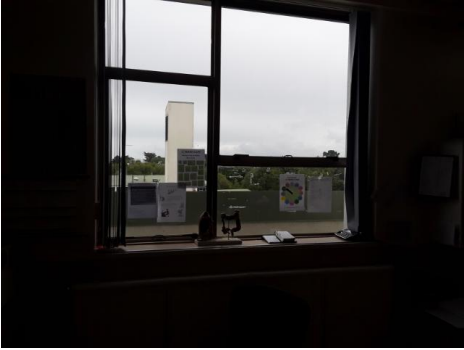
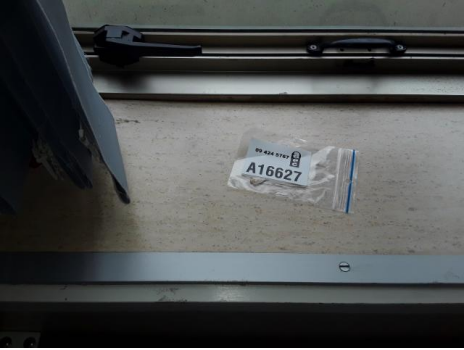
<p>Clinical Services Building, Timaru Hospital</p> <p>4th Floor Southward (161)</p> <p>Vinyl window sill - Vinyl Products</p> <p>Sample No. A16627</p> <p>No Asbestos Detected</p>

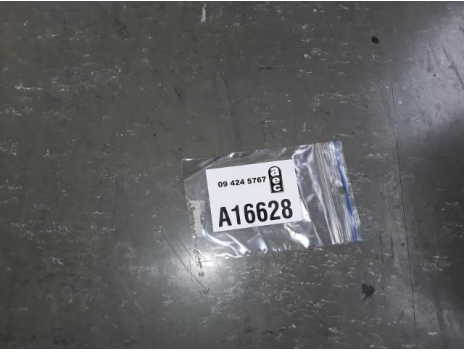
<p>Clinical Services Building, Timaru Hospital</p> <p>4th Floor South Ward Office (163)</p> <p>Vinyl floor covering - green - Vinyl Products</p> <p>Sample No. A16628</p> <p>No Asbestos Detected</p>

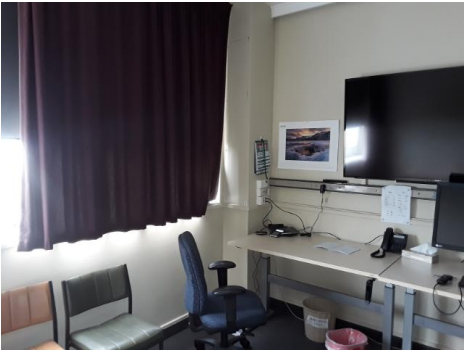
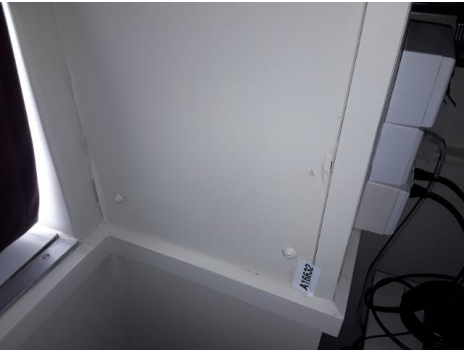
<p>Clinical Services Building, Timaru Hospital</p> <p>3rd Floor 346 (187)</p> <p>Paper backing to vinyl covering to vertical boxing to wall corner - Paper Product</p> <p>Sample No. A16632</p> <p>Chrysotile</p>

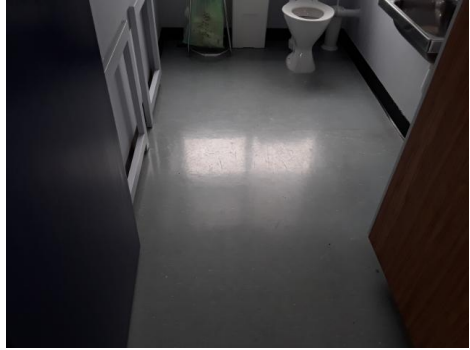
<p>Clinical Services Building, Timaru Hospital</p> <p>3rd Floor 351 Toilet (191)</p> <p>Vinyl floor covering - turquoise / grey - Vinyl Products</p> <p>Sample No. A16633</p> <p>No Asbestos Detected</p>

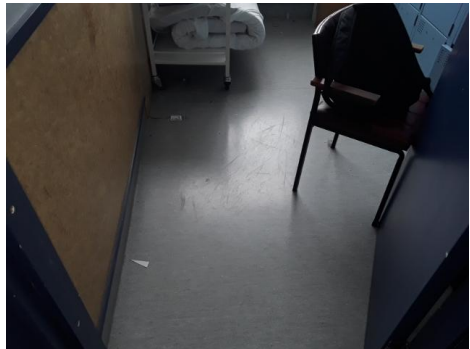
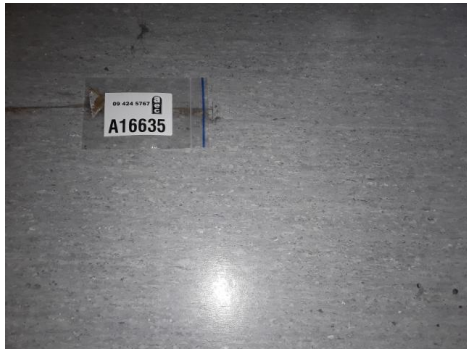
<p>Clinical Services Building, Timaru Hospital</p> <p>3rd Floor 352 (201)</p> <p>Vinyl floor covering - grey streak - Vinyl Products</p> <p>Sample No. A16635</p> <p>No Asbestos Detected</p>

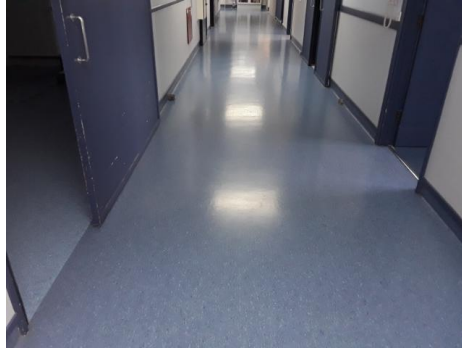
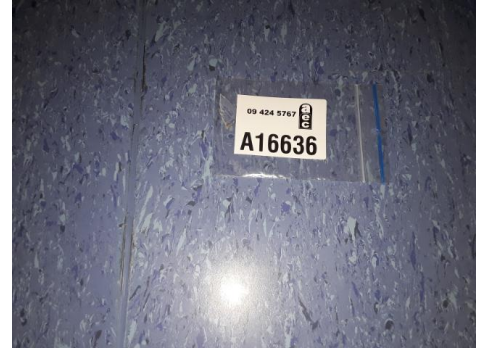
Sample No. A16636

No Asbestos Detected

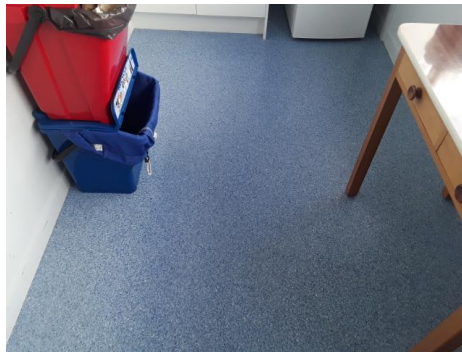
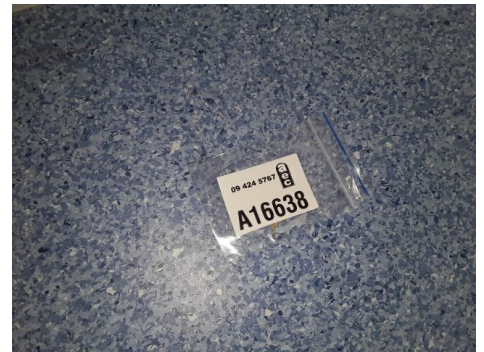
3rd Floor 355c (213)

Sample No. A16638

No Asbestos Detected

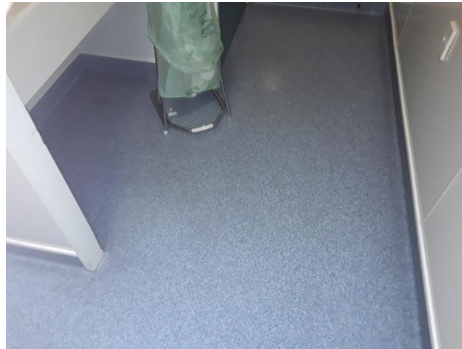
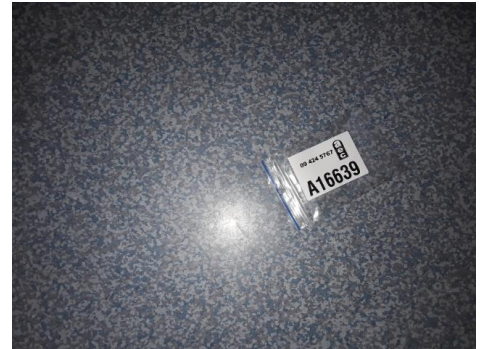
3rd Floor Male Public Toilets
(230)

Sample No. A16639

No Asbestos Detected

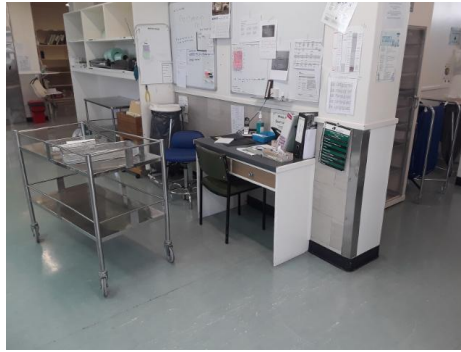
Clinical Services Building,
Timaru Hospital

Sample No. A16649

Chrysotile

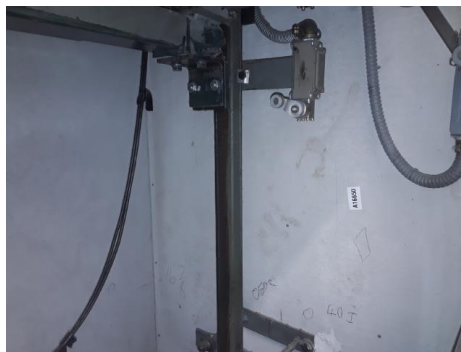
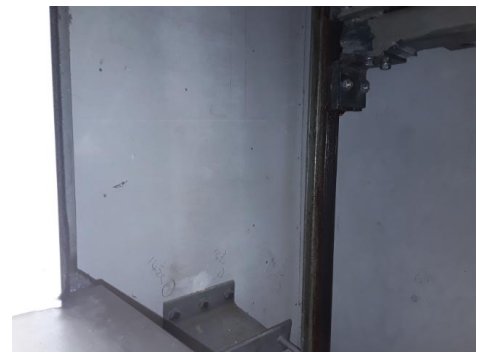
Clinical Services Building,
Timaru Hospital

Sample No. A16650

Amosite & Chrysotile

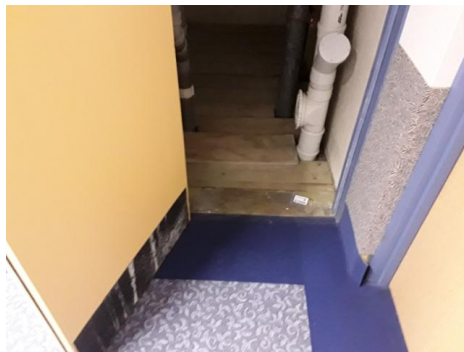
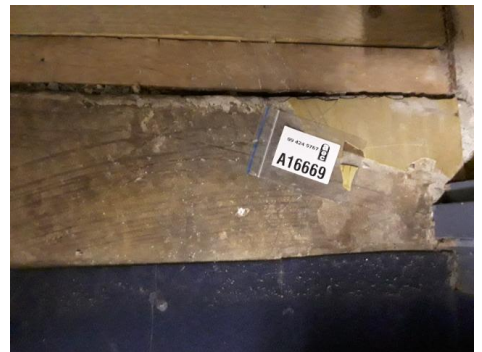
1st Floor 110 (597)

Sample No. A16669

Chrysotile

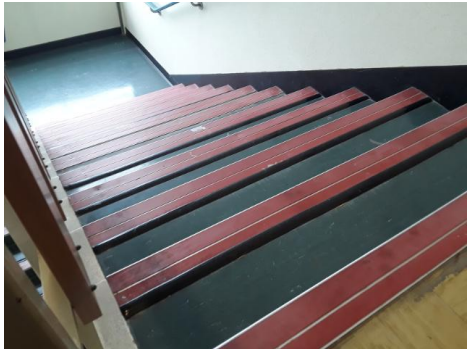
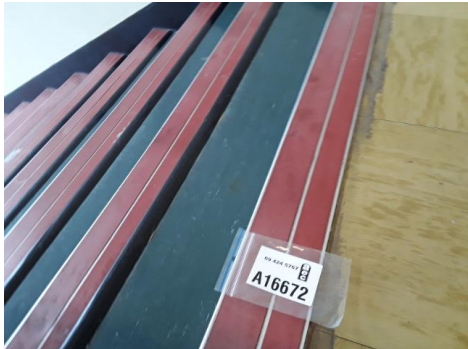
<p>Clinical Services Building, Timaru Hospital</p> <p>5th Floor East Stairwell (659)</p> <p>Vinyl stair nosing - red - Vinyl Products</p> <p>Sample No. A16672</p> <p>Chrysotile</p>

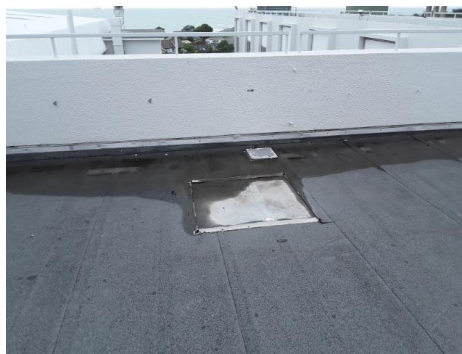
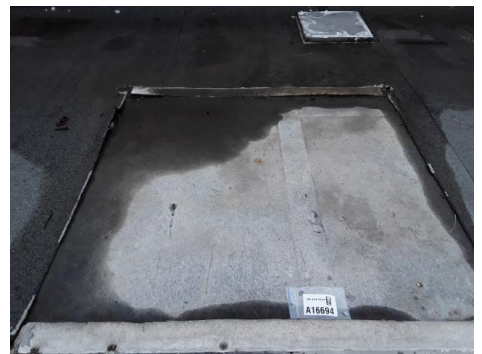
Sample No. A16694

Chrysotile

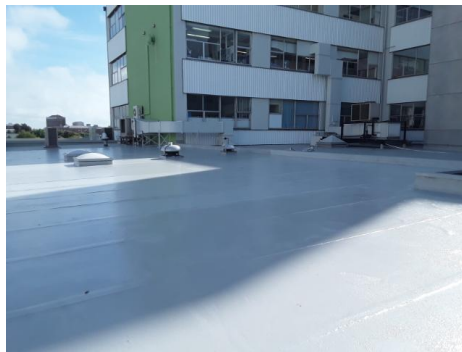
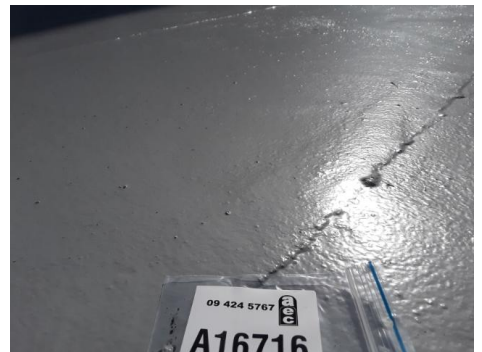
External Flat Roof Above
Emergency Department (694)

Sample No. A16716

Chrysotile

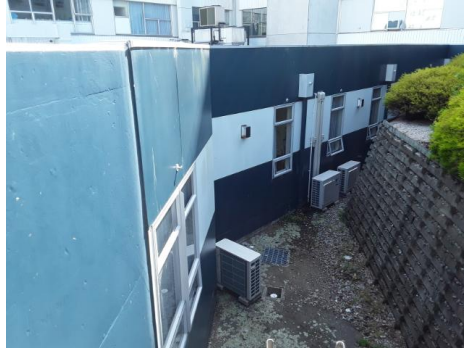
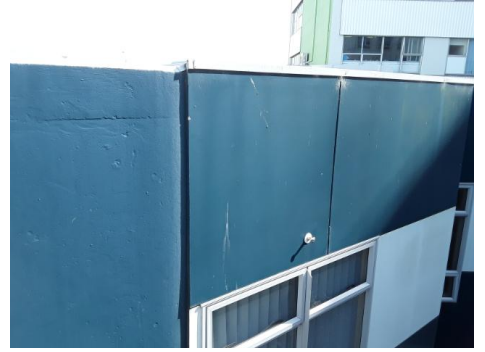
External, External Walls to Rear
Emergency Department (695)

Sample No. A16717

No Asbestos Detected

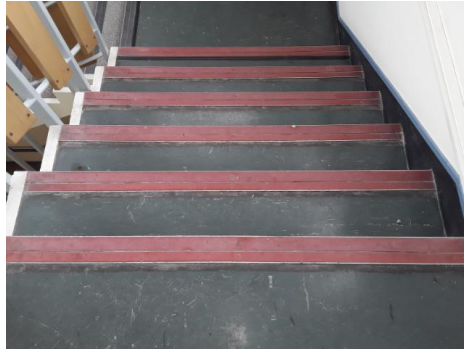
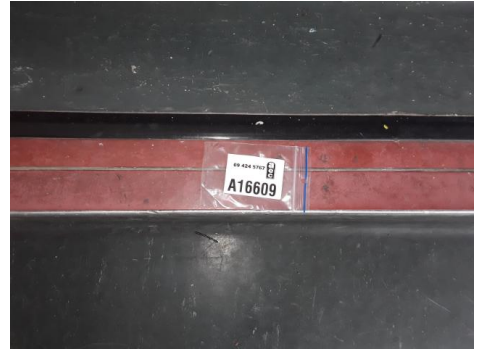
6th Floor Stairwell (696)

Sample No. A16609

Chrysotile

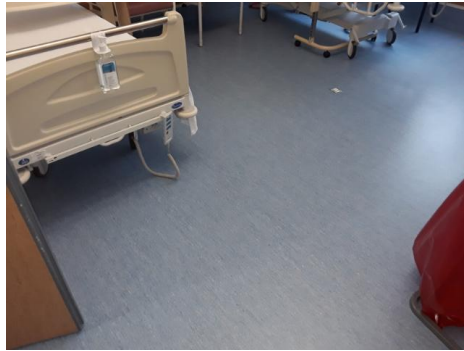
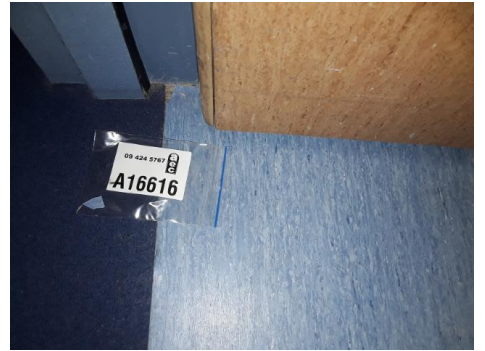
5th Floor 510 (697)

Sample No. A16616

No Asbestos Detected

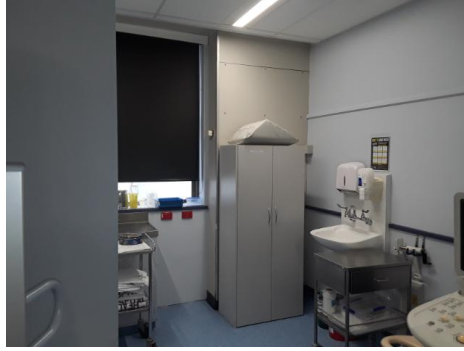
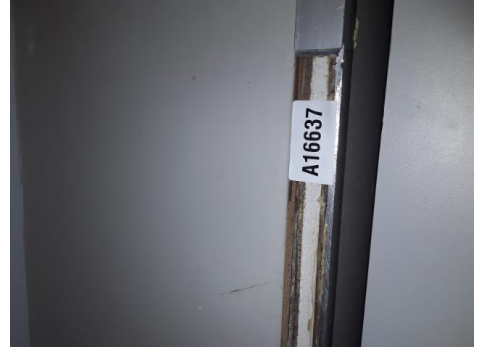
3rd Floor 354 (702)

Sample No. A16637

Amosite & Chrysotile

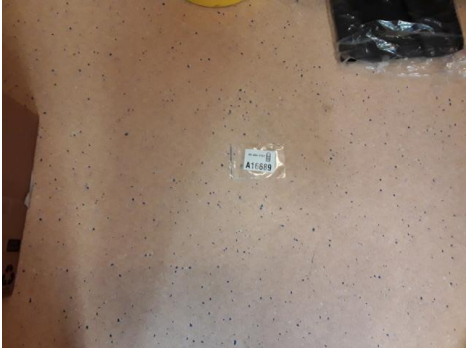
<p>Education Centre, Timaru Hospital</p> <p>Ground Floor Cleaners Room (006)</p> <p>Vinyl floor covering - Salmon - Vinyl Products</p> <p>Sample No. A16689</p> <p>No Asbestos Detected</p>

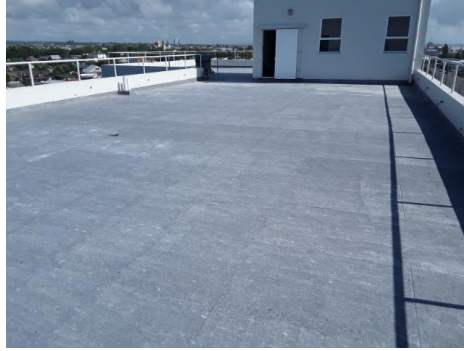
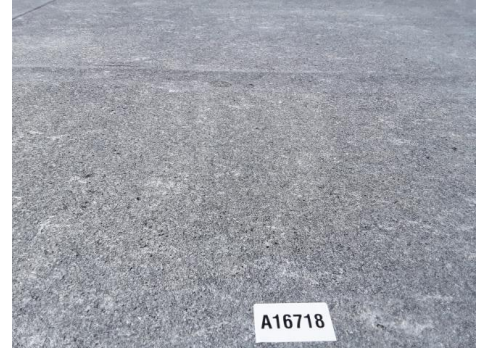
Sample No. A16718

Chrysotile

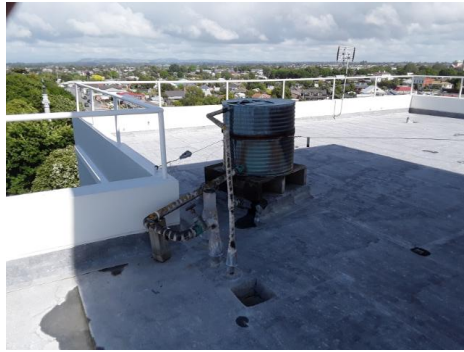
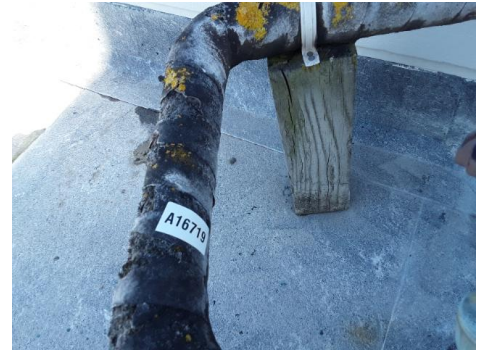
External Flat Roof (002)

Sample No. A16719

No Asbestos Detected

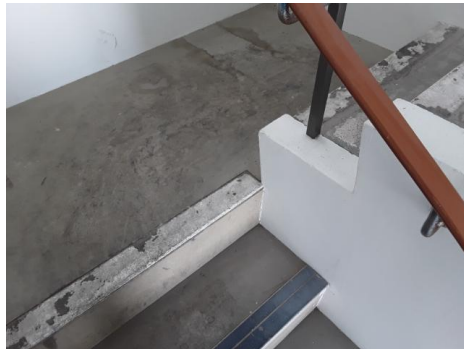
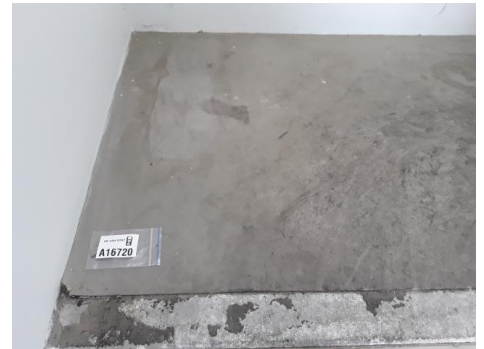
8th Floor North Stairwell (003)

Sample No. A16720

No Asbestos Detected

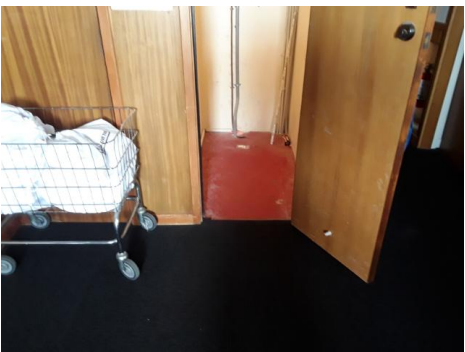
<p>Gardens Block, Timaru Hospital</p> <p>7th Floor 07-N05 Store (008)</p> <p>Vinyl floor covering - Red - Vinyl Products</p> <p>Sample No. A16723</p> <p>No Asbestos Detected</p>

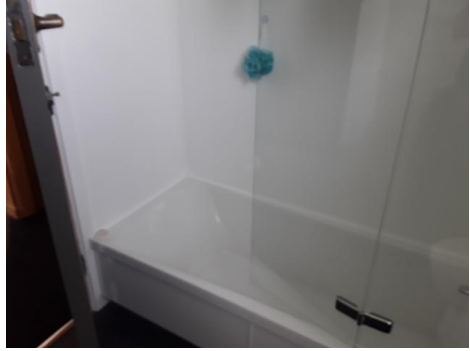
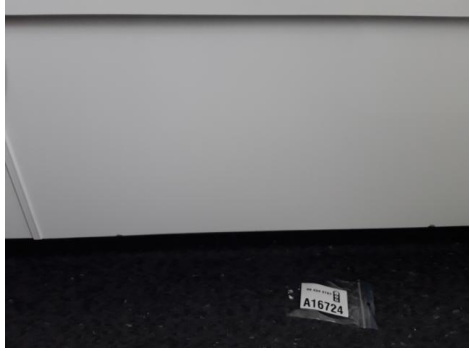
<p>Gardens Block, Timaru Hospital</p> <p>7th Floor 07-N08 Penthouse Bathroom (010)</p> <p>Panels to wall and bath - Cement Product</p> <p>Sample No. A16724</p> <p>No Asbestos Detected</p>

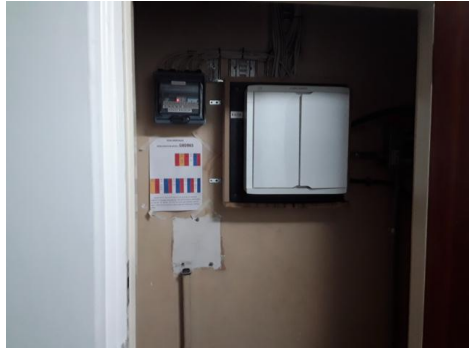
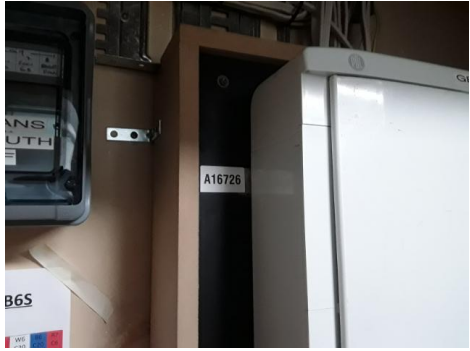
<p>Gardens Block, Timaru Hospital</p> <p>6th Floor Electrics cupboard (049)</p> <p>Electrical Mounting Board - Electrical Mounting Board</p> <p>Sample No. A16726</p> <p>Chrysotile</p>

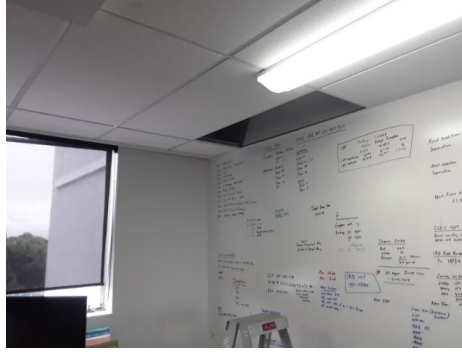
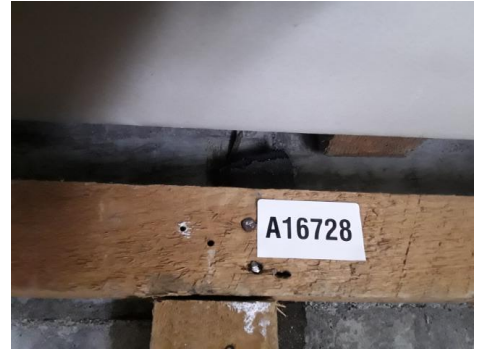
Sample No. A16728

No Asbestos Detected

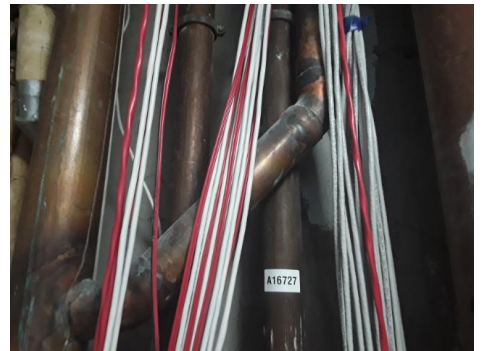
5th Floor 05-N06 Riser Cupboard (066)

Sample No. A16727

No Asbestos Detected

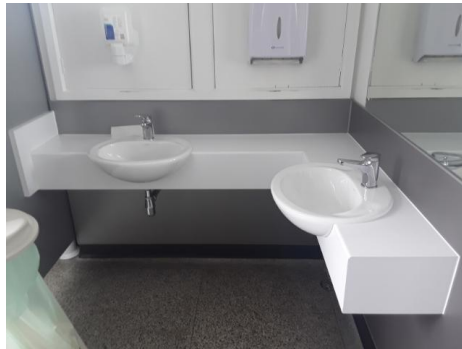
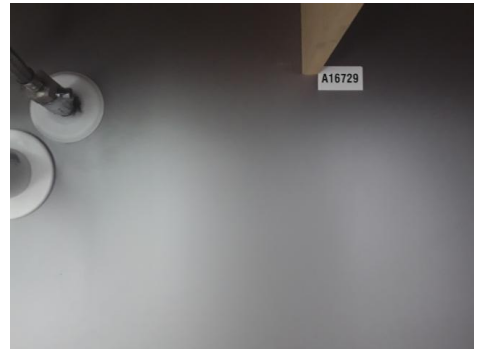
4th Floor 04-N15 Toilet (110)

Sample No. A16729

No Asbestos Detected

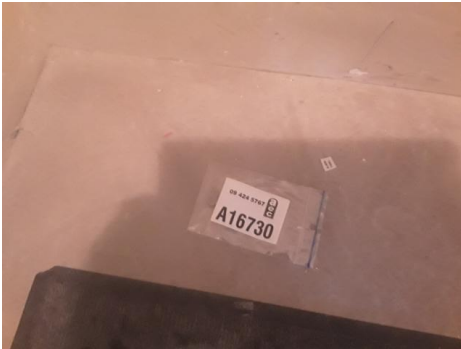
<p>Gardens Block, Timaru Hospital</p> <p>3rd Floor 03-N04 (132)</p> <p>Vinyl floor covering - beige - Vinyl Products</p> <p>Sample No. A16730</p> <p>No Asbestos Detected</p>

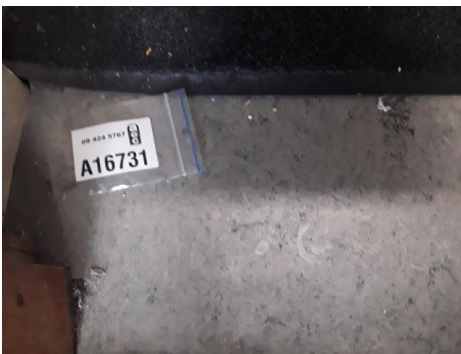
<p>Gardens Block, Timaru Hospital</p> <p>1st Floor 01-N04 Store (207)</p> <p>Vinyl floor covering - Grey - Vinyl Products</p> <p>Sample No. A16731</p> <p>No Asbestos Detected</p>

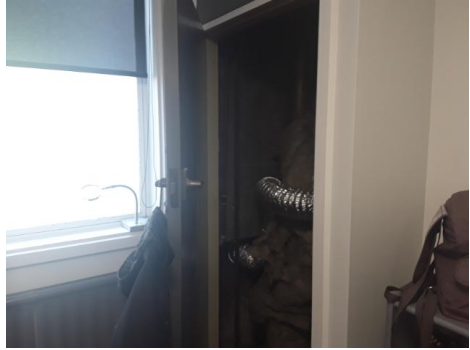
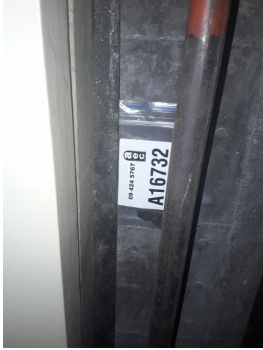
<p>Gardens Block, Timaru Hospital</p> <p>1st Floor 01-N11 SLT, Riser cupboard (219)</p> <p>Bitmastic packer to timberwork adjacent door - Bituminous Product</p> <p>Sample No. A16732</p> <p>No Asbestos Detected</p>

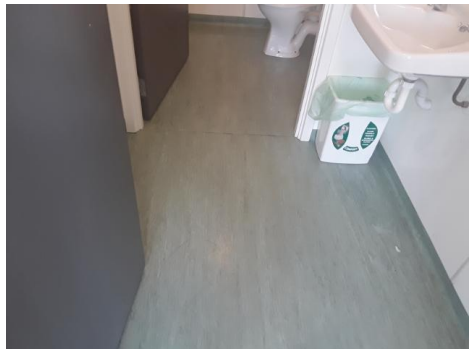
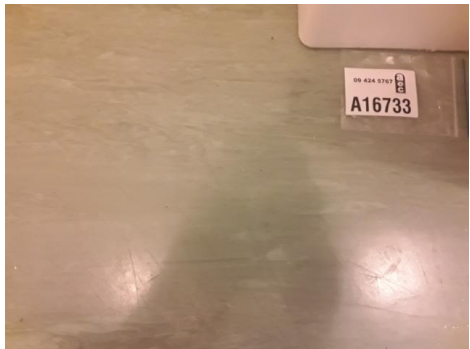
<p>Gardens Block, Timaru Hospital</p> <p>1st Floor 01-N09 Accessible Toilet (220)</p> <p>Vinyl floor covering - Pale Green - Vinyl Products</p> <p>Sample No. A16733</p> <p>No Asbestos Detected</p>

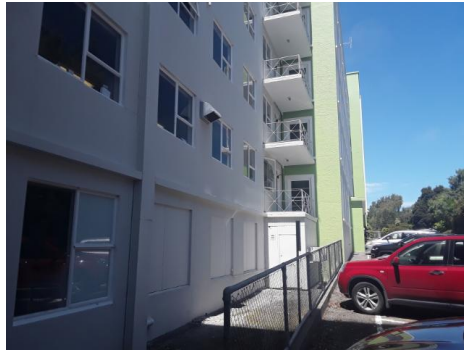
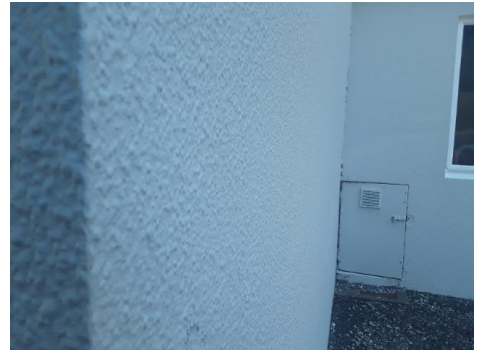
Sample No. A16736

No Asbestos Detected

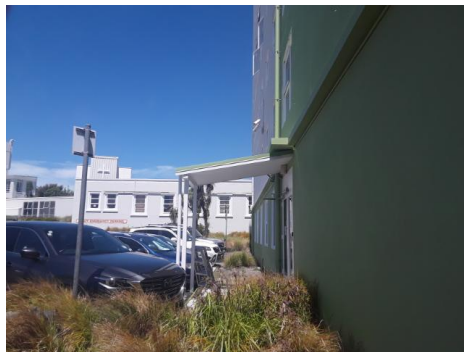
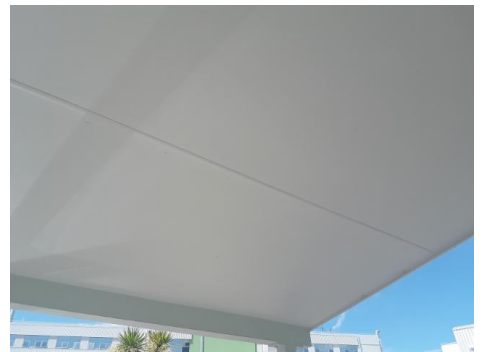
External East side, North end
Porch (224)

Sample No. A16735

No Asbestos Detected

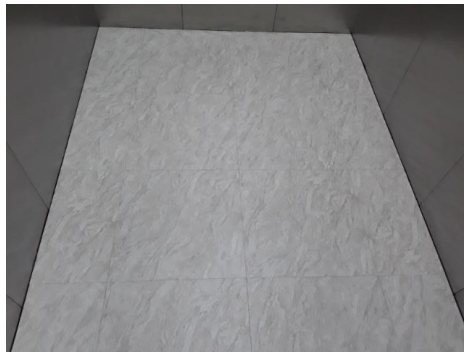
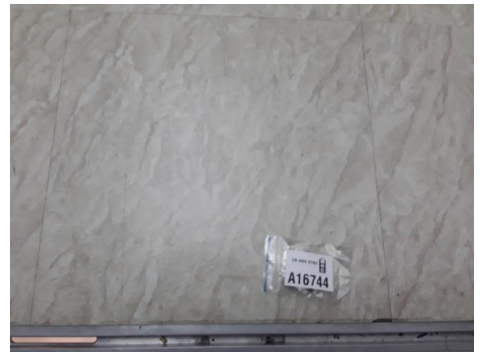
4th Floor North Lift (227)

Sample No. A16744

No Asbestos Detected

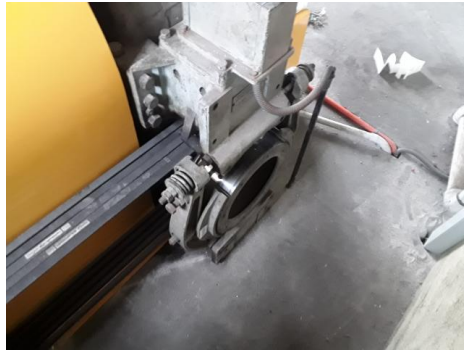
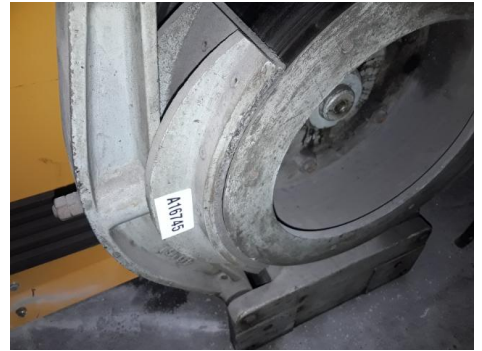
7th Floor South side lift motor room (230)

Sample No. A16745

Chrysotile

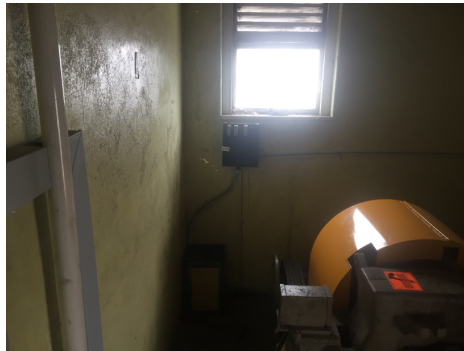
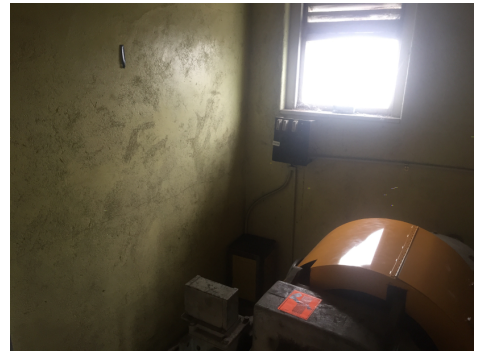
7th Floor South side lift motor room (231)

Sample No. A16746

Chrysotile

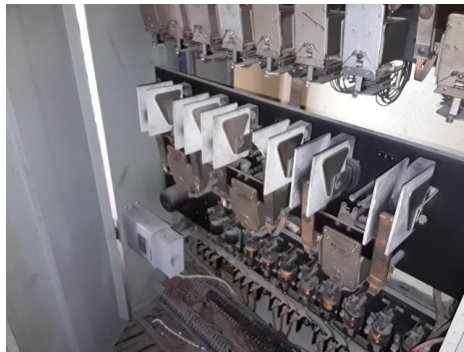
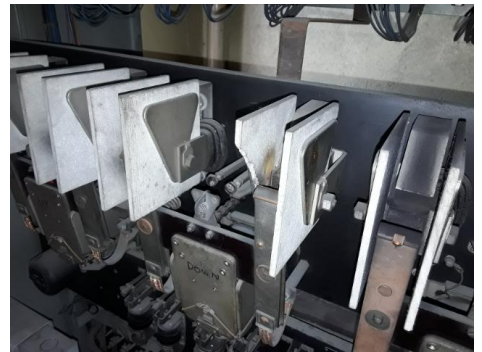
7th Floor South side lift motor room (232)

Sample No. Presumed

Chrysotile

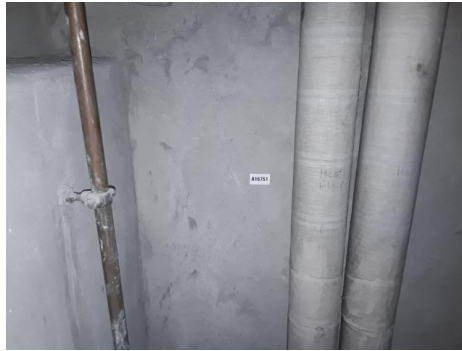
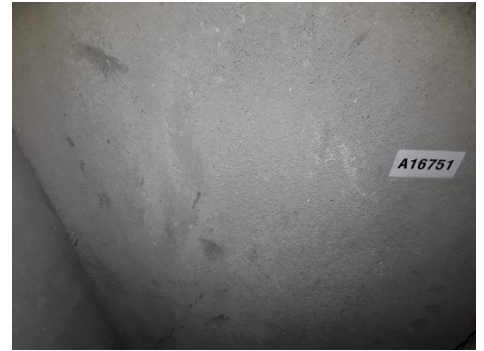
Sample No. A16751

Amosite

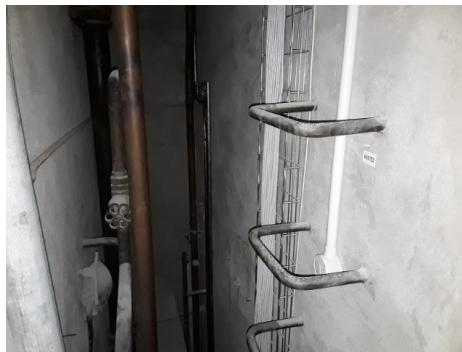
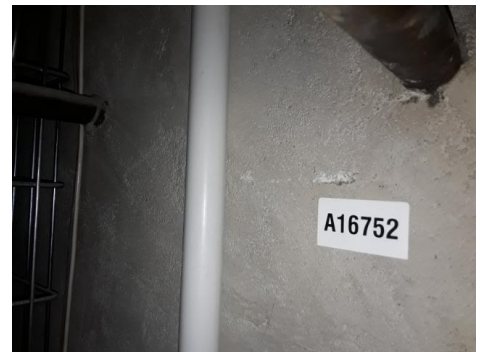
6th Floor 06-N25 Riser (239)

Sample No. A16752

No Asbestos Detected

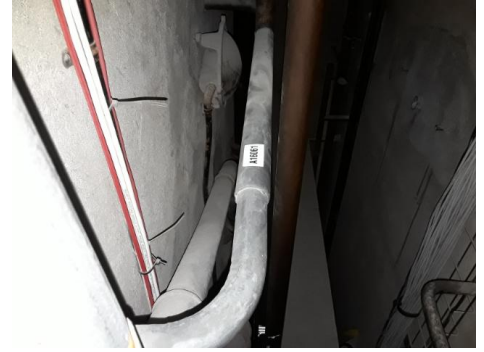
6th Floor South Riser (500)

Sample No. A16061

No Asbestos Detected
