ASBESTOS MANAGEMENT PLAN & SITE MANAGEMENT SURVEYS

Site: South Canterbury DHB
Queen Street, Parkside, Timaru

Prepared for: South Canterbury District Health Board

Project Ref: C-00727

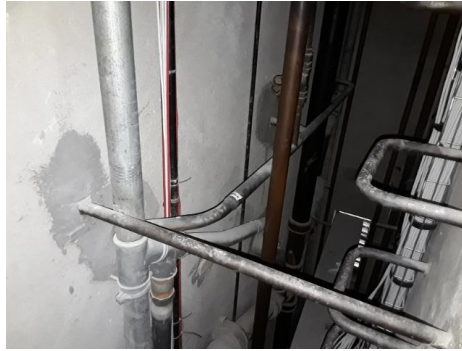
5th Floor South Riser (501)

Sample No. A16062

No Asbestos Detected

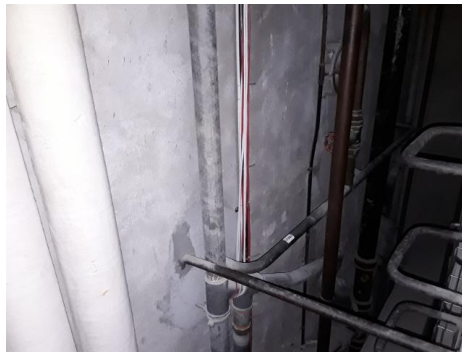
4th Floor South Riser (502)

Sample No. A16063

No Asbestos Detected

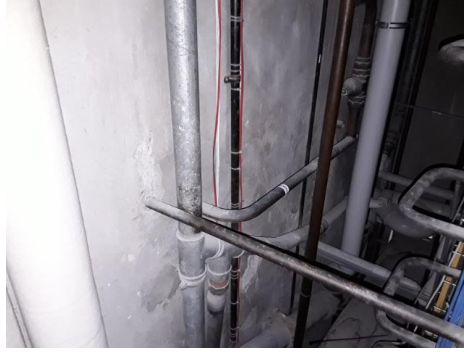
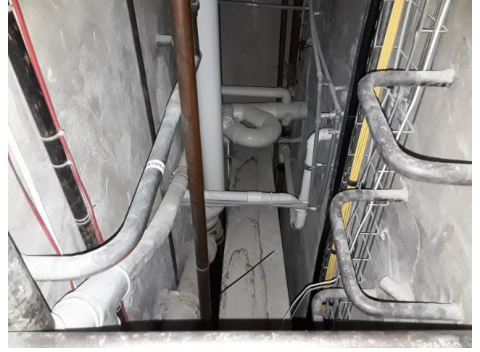
3rd Floor South Riser (503)

Sample No. A16064

No Asbestos Detected

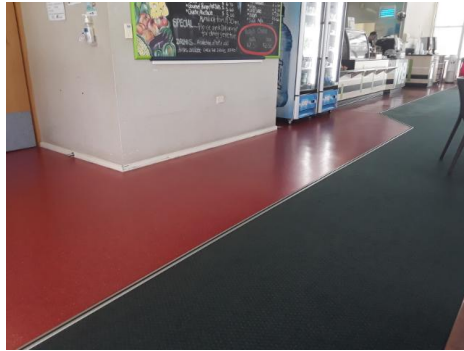
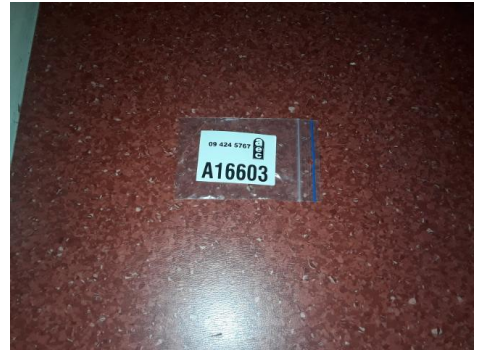
Sample No. A16603

No Asbestos Detected

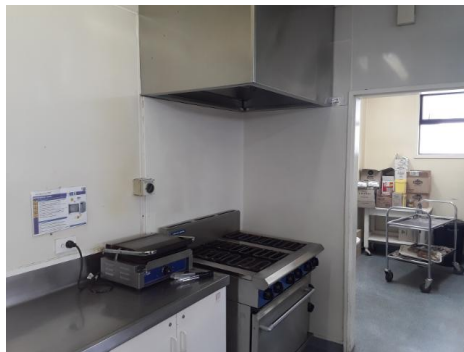
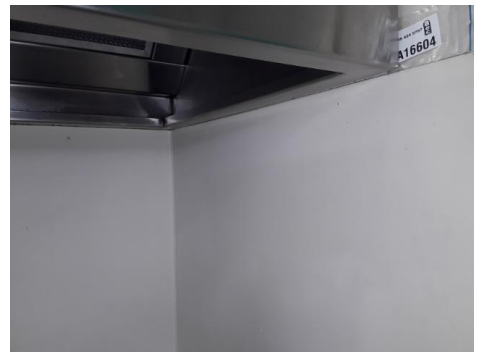
Sample No. A16604

1st Floor Cafe servery (002)

No Asbestos Detected

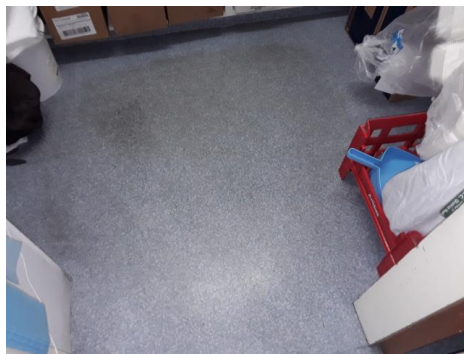
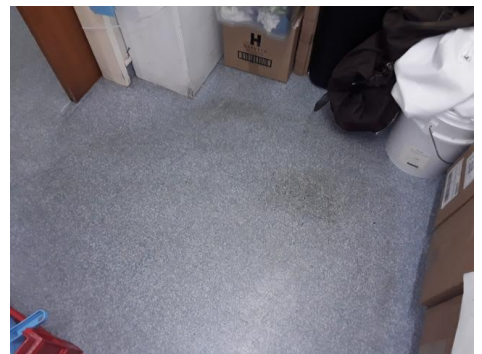
Sample No. A16605

1st Floor Cafe servery (003)

No Asbestos Detected

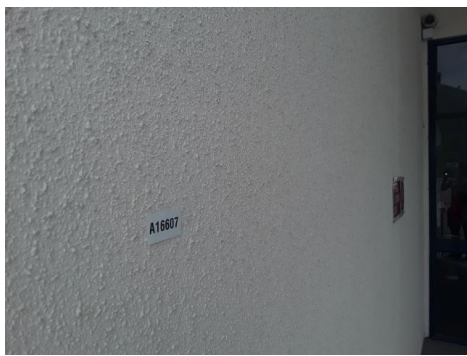
<p>Cafe, Timaru Hospital</p> <p>External Cafe Balcony (008)</p> <p>Textured render to external walls - Decorative Finishes</p> <p>Sample No. A16607</p> <p>No Asbestos Detected</p>

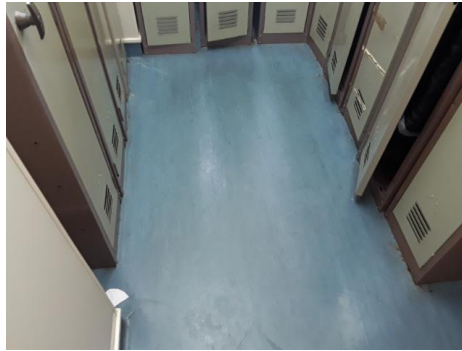
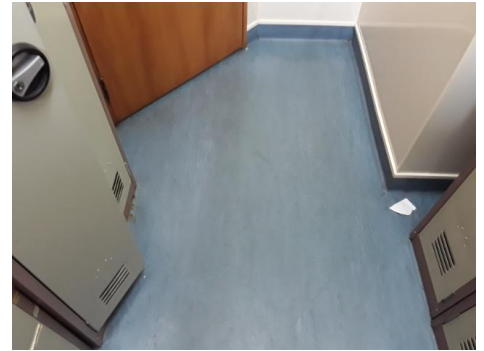
Sample No. A16705

No Asbestos Detected

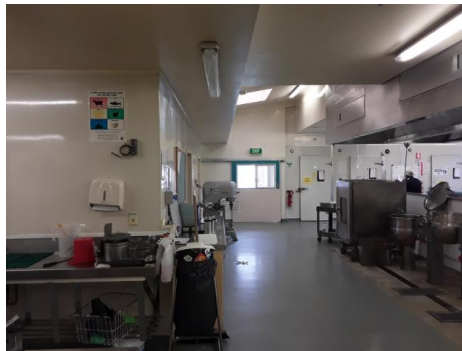
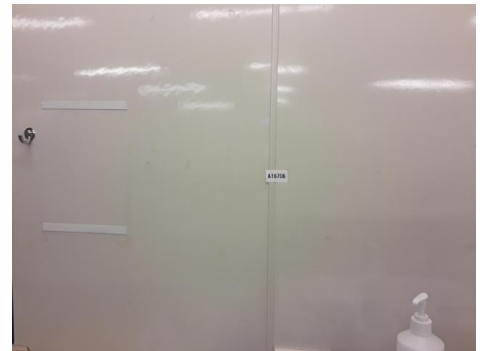
Sample No. A16706

Ground Floor Kitchen (005)

No Asbestos Detected

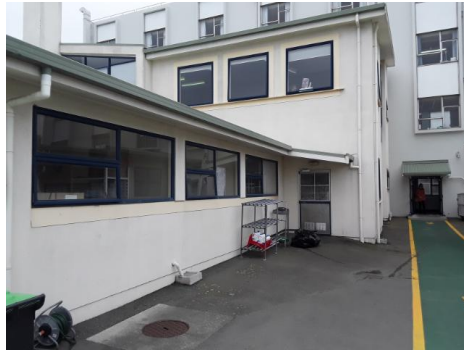
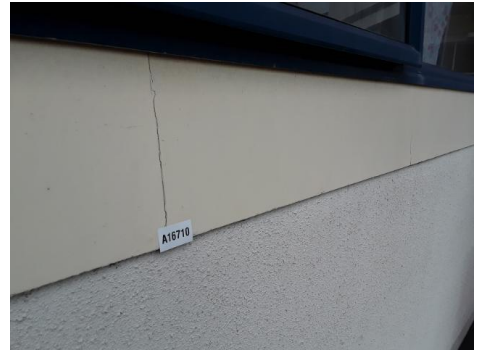
Sample No. A16710

No Asbestos Detected

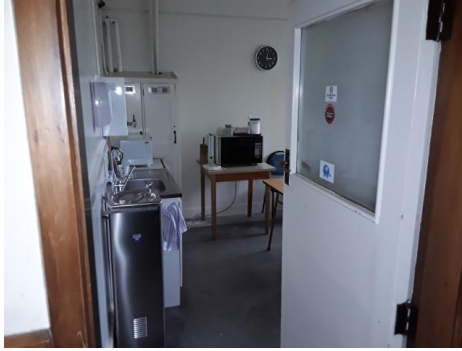
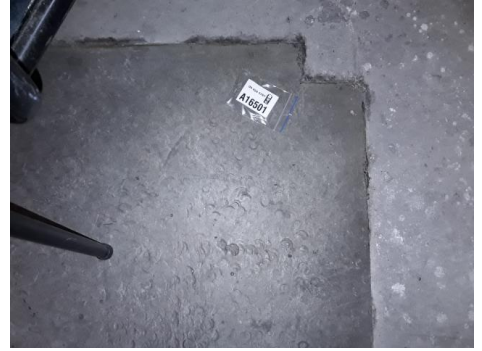
Sample No. A16501

No Asbestos Detected

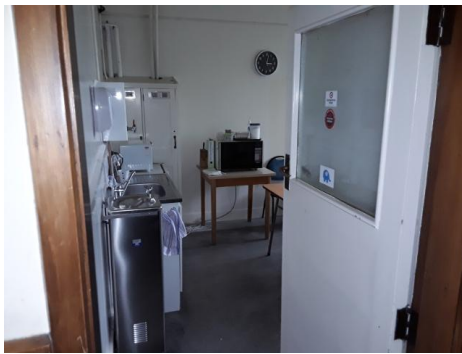
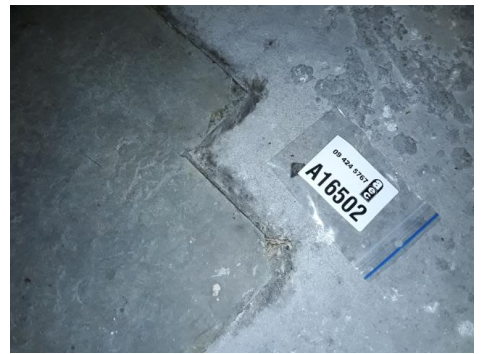
Sample No. A16502

Laundry, Timaru Hospital
1st Floor Lunch Room (003)

Adhesive below Vinyl floor
covering - Vinyl Products

No Asbestos Detected

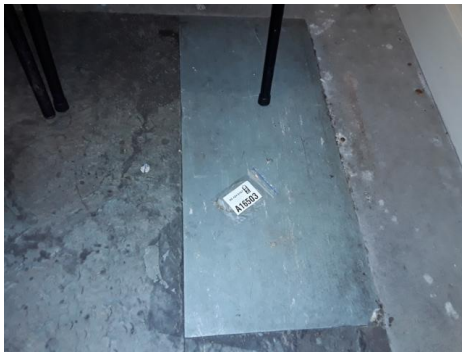
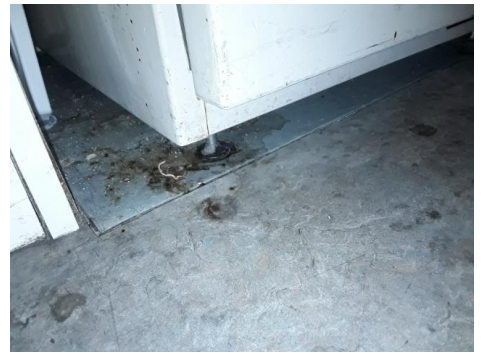
Sample No. A16503

Laundry, Timaru Hospital
1st Floor Lunch Room (004)

Vinyl floor covering - Turquoise -
Vinyl Products

No Asbestos Detected

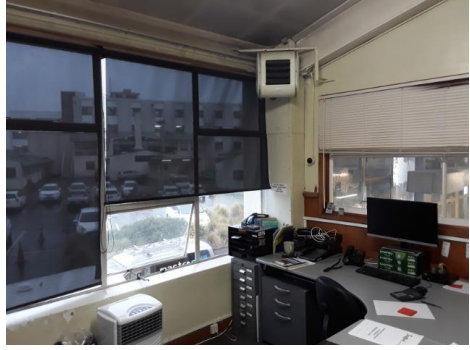
<p>Laundry, Timaru Hospital</p> <p>1st Floor Manager Office (012)</p> <p>Pipe lagging to vertical run within timber boxing to West corner - Insulation</p> <p>Sample No. Presumed</p> <p>Crocidolite, Amosite & Chrysotile</p>

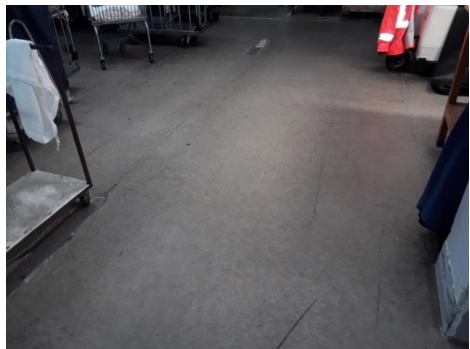
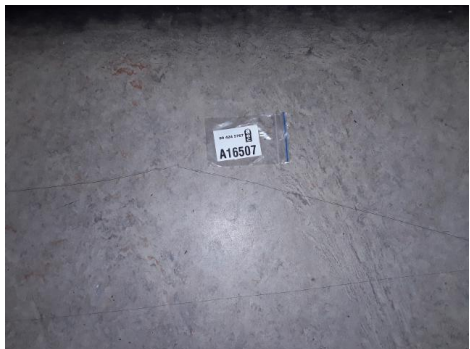
<p>Laundry, Timaru Hospital</p> <p>Ground Floor Dispatch (016)</p> <p>Vinyl floor covering - Beige - Vinyl Products</p> <p>Sample No. A16507</p> <p>No Asbestos Detected</p>

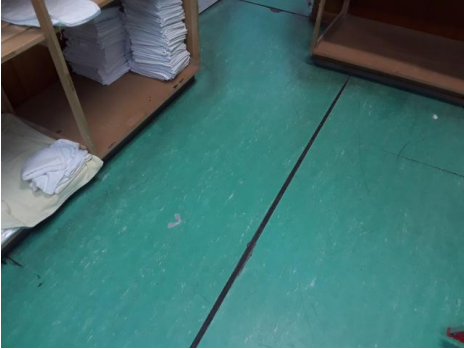
<p>Laundry, Timaru Hospital</p> <p>Ground Floor Oamaru Room (019)</p> <p>Vinyl floor covering - Green - Vinyl Products</p> <p>Sample No. A16509</p> <p>No Asbestos Detected</p>

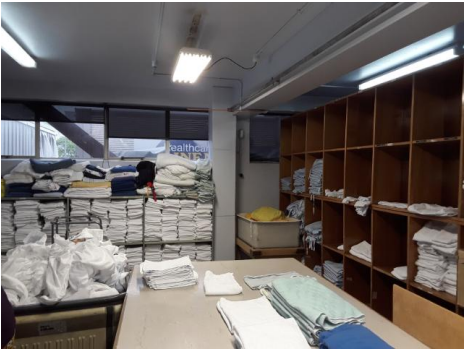
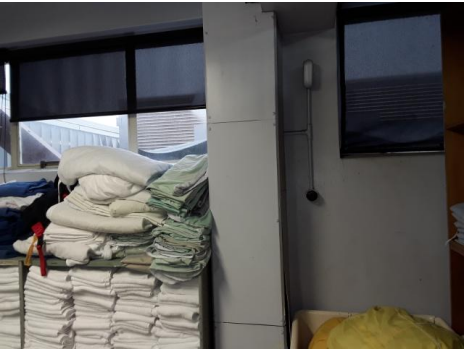
<p>Laundry, Timaru Hospital</p> <p>Ground Floor Stores (022)</p> <p>Pipe lagging to vertical run within timber boxing to North wall - Insulation</p> <p>Sample No. Presumed</p> <p>Crocidolite, Amosite & Chrysotile</p>

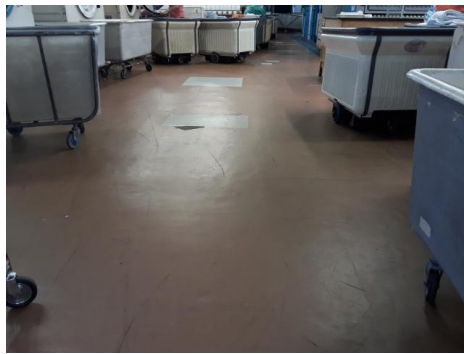
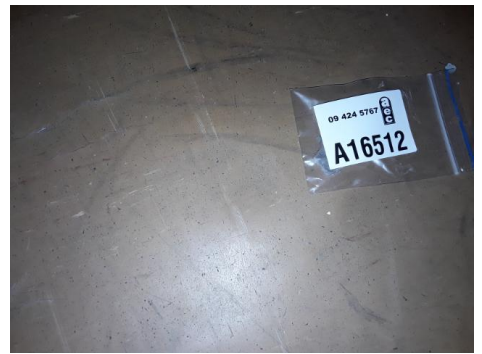
Laundry, Timaru Hospital
Ground Floor Wash and dryer
Room (025)

Vinyl floor covering - Orange -
Vinyl Products

Sample No. A16512

No Asbestos Detected

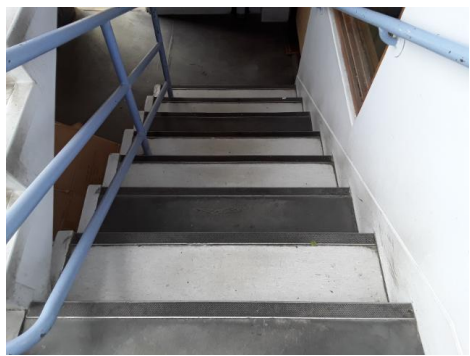
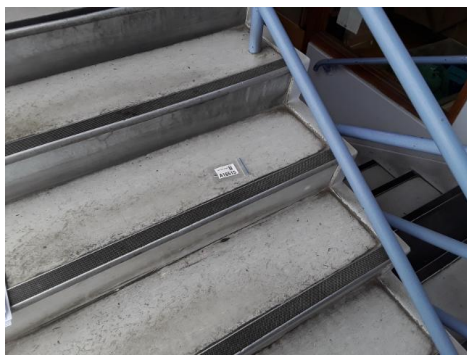
<p>Laundry, Timaru Hospital</p> <p>1st Floor Southeast Stairs (031)</p> <p>Vinyl floor covering to steps - light grey - Vinyl Products</p> <p>Sample No. A16515</p> <p>No Asbestos Detected</p>

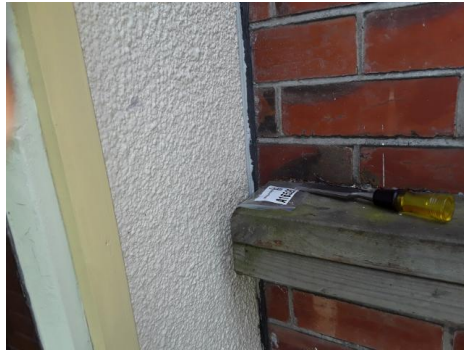
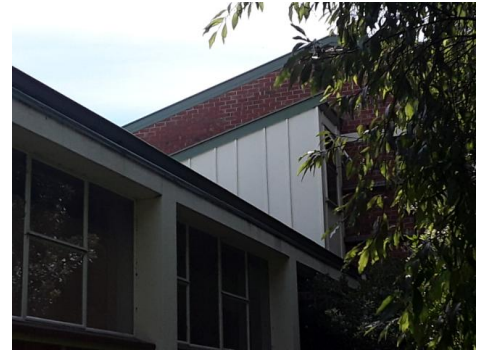
Sample No. A16526

Crocidolite & Chrysotile

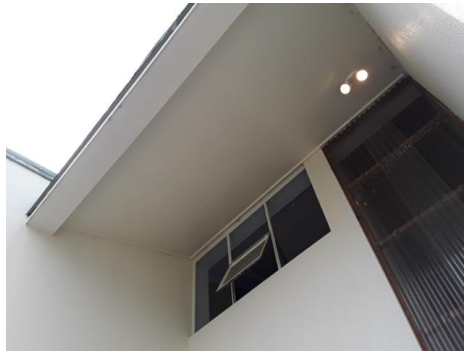
Laundry, Timaru Hospital

Sample No. Presumed

Crocidolite, Amosite & Chrysotile

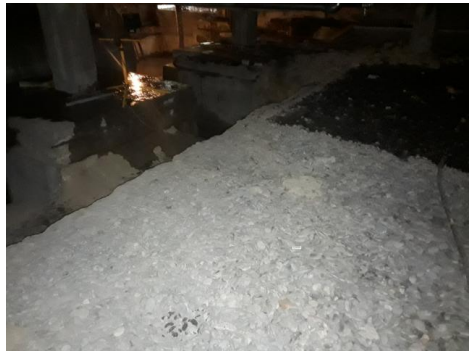
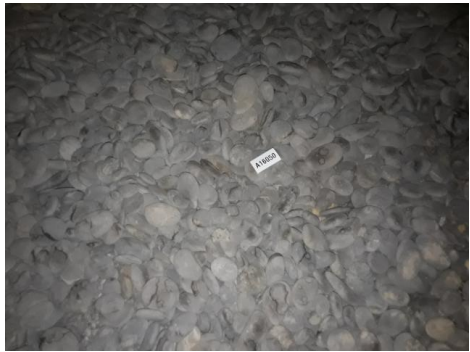
<p>Laundry, Timaru Hospital</p> <p>Basement Pebble ground surface 5m North of metal tanks to South West corner (101)</p> <p>Swap sample from ground surface - Dust Sample</p> <p>Sample No. A16050</p> <p>No Asbestos Detected</p>

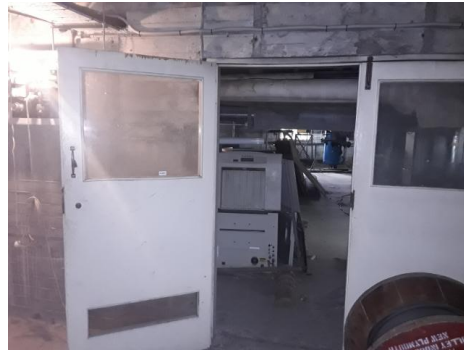
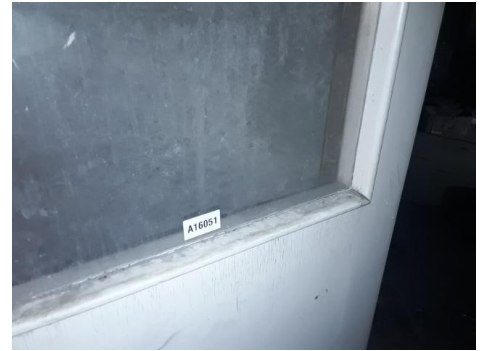
Sample No. A16051

No Asbestos Detected

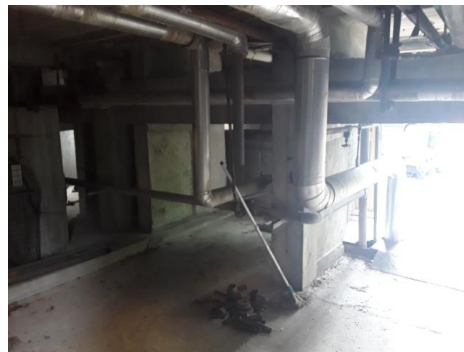
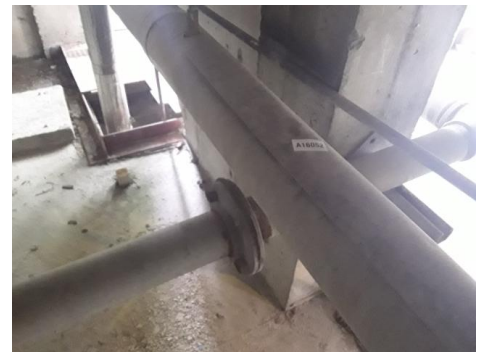
Basement Pipework adjacent to the entrance (103)

Sample No. A16052

No Asbestos Detected

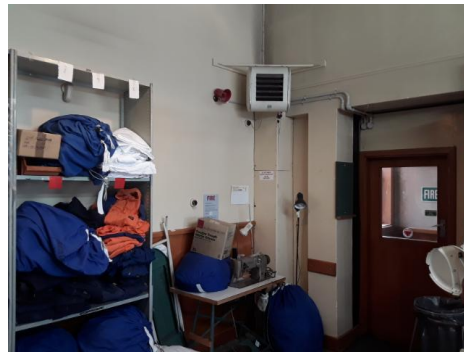
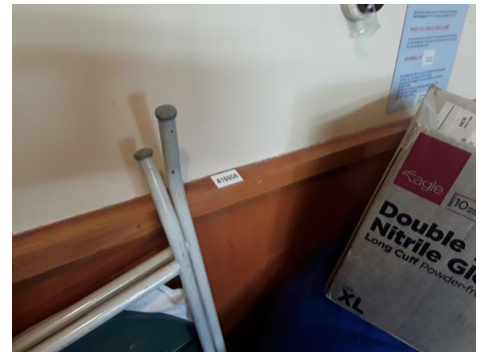
Space / Location	Description	Sample Ref	Asbestos Type	Surface Treatment	Product Type	Condition	Disturbance Potential	Risk Score	Extent	Action	Comments
1st Floor Sewing Room (104)	Dust Sample - Swap sample from timber ledge to wall	A16056	0	-	-	-	-	0	-	A6

Sample No. A16056

No Asbestos Detected

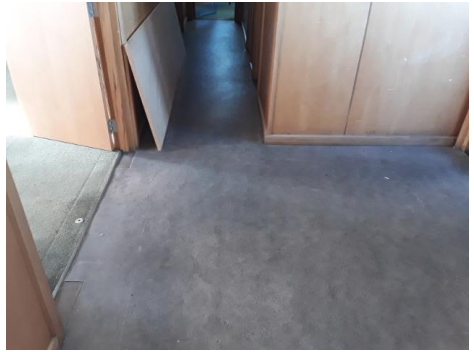
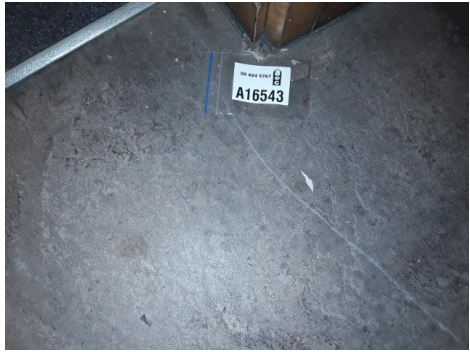
<p>Maintenance and Supply, Timaru Hospital</p> <p>1st Floor Hall Corridor (001)</p> <p>Vinyl floor covering - Brown - Vinyl Products</p> <p>Sample No. A16543</p> <p>No Asbestos Detected</p>

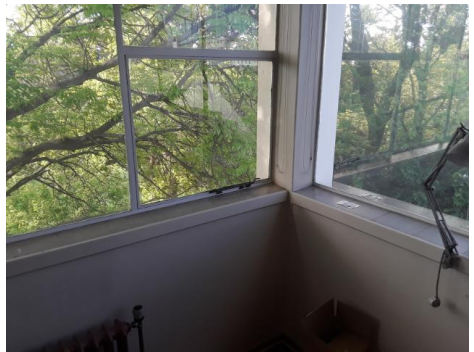
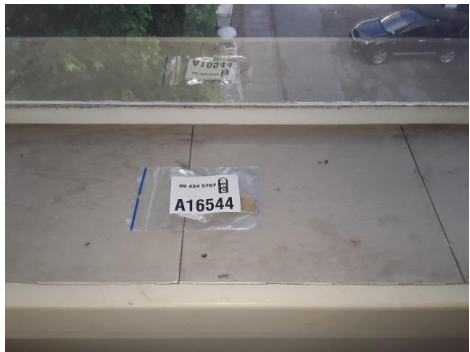
<p>Maintenance and Supply, Timaru Hospital</p> <p>1st Floor Southwest store (007)</p> <p>Vinyl Tiles to window ledge - Vinyl Products</p> <p>Sample No. A16544</p> <p>No Asbestos Detected</p>

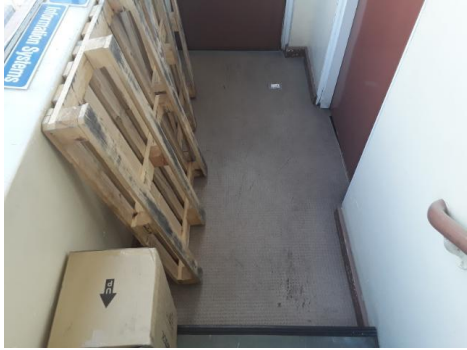
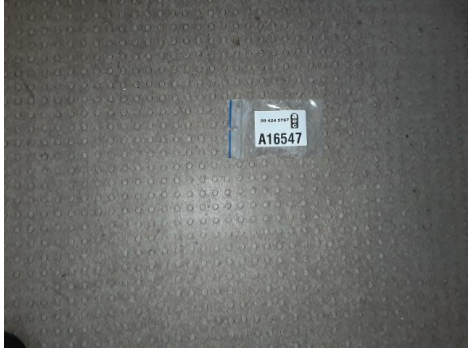
<p>Maintenance and Supply, Timaru Hospital</p> <p>Ground Floor Stairs (011)</p> <p>Vinyl floor covering - salmon - Vinyl Products</p> <p>Sample No. A16547</p> <p>No Asbestos Detected</p>

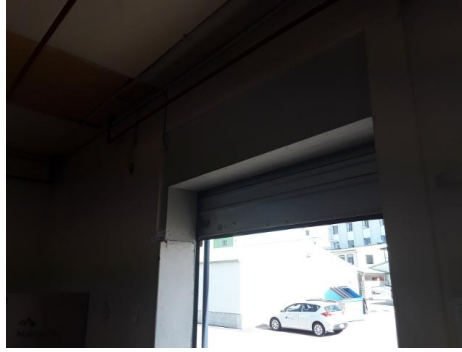
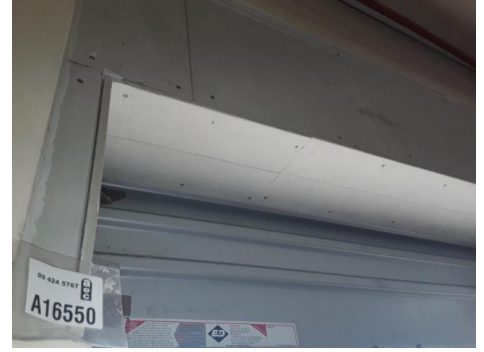
Sample No. A16550

No Asbestos Detected

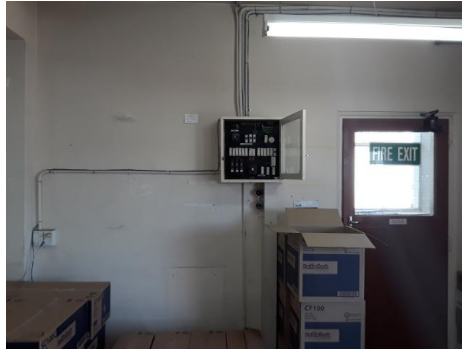
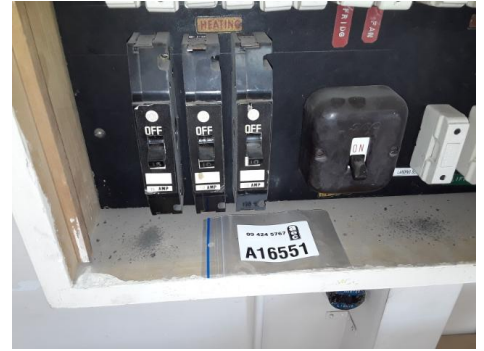
Ground Floor Stores Reception
(016)

Sample No. A16551

No Asbestos Detected

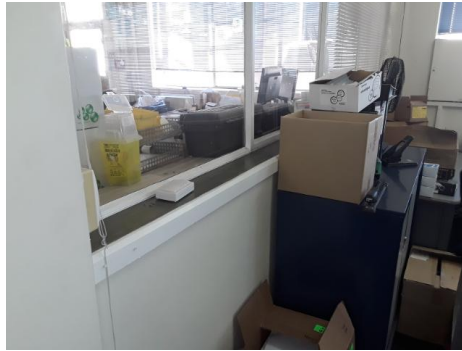
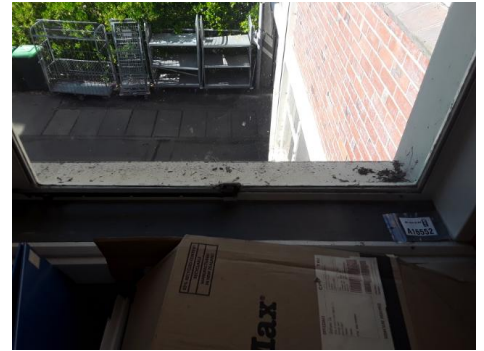
Ground Floor Maintenance
Reception Office (017)

Sample No. A16552

No Asbestos Detected

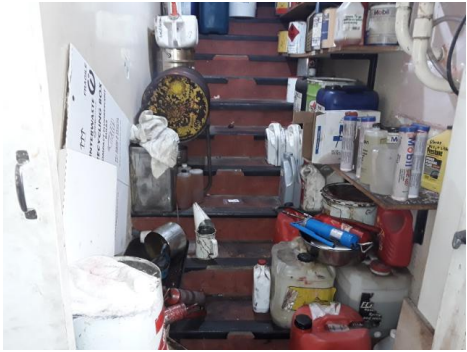
<p>Maintenance and Supply, Timaru Hospital</p> <p>Basement Stair / Cupboard (023)</p> <p>Vinyl floor covering - Red - Vinyl Products</p> <p>Sample No. A16554</p> <p>No Asbestos Detected</p>

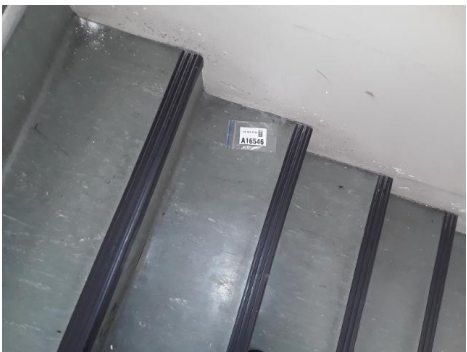
<p>Maintenance and Supply, Timaru Hospital</p> <p>1st Floor Stairs (027)</p> <p>Vinyl floor covering - Grey greens - Vinyl Products</p> <p>Sample No. A16546</p> <p>No Asbestos Detected</p>

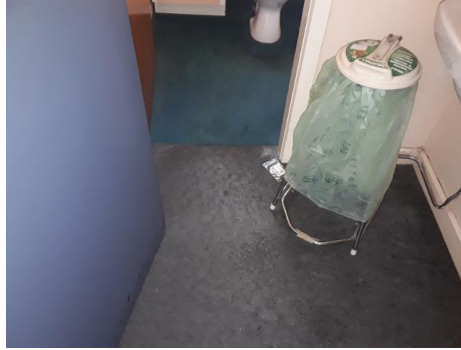
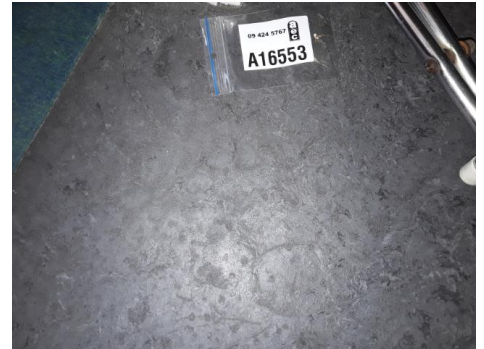
Sample No. A16553

No Asbestos Detected

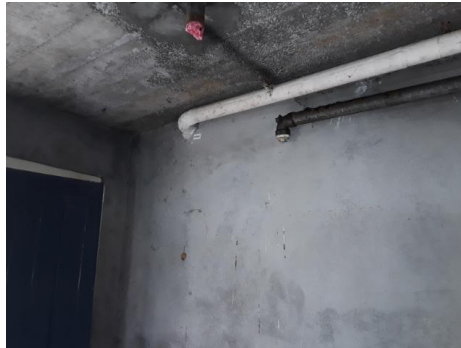
Sample No. Reference
A16541

Amosite & Chrysotile

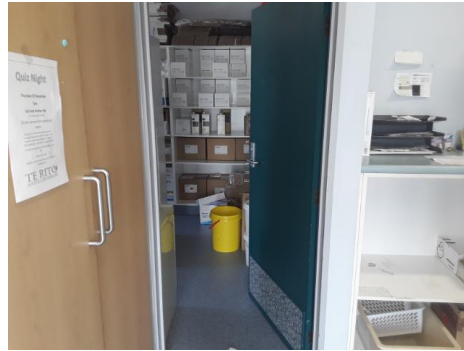
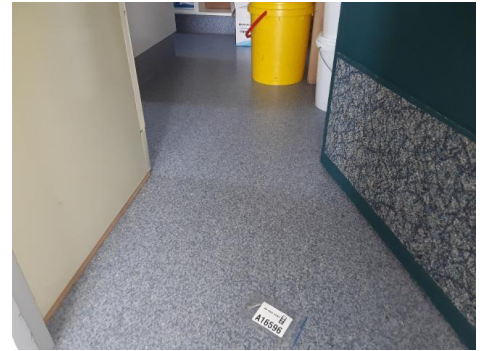
Sample No. A16596

No Asbestos Detected

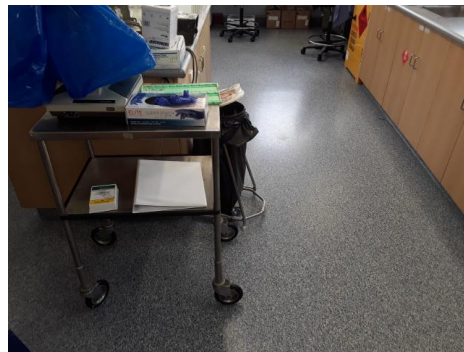
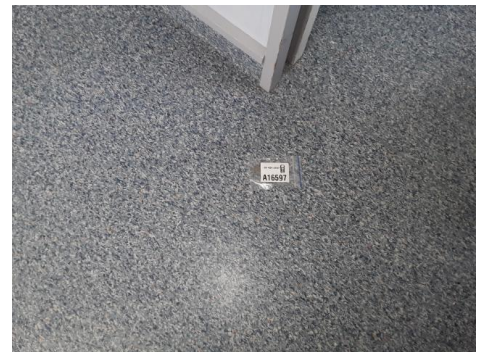
Sample No. A16597

No Asbestos Detected

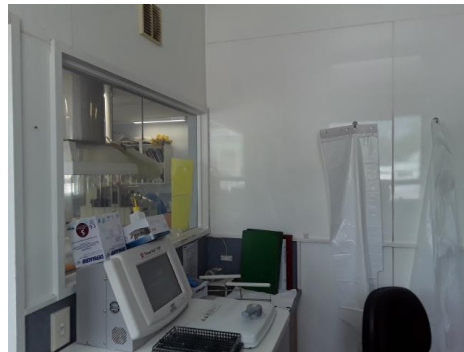
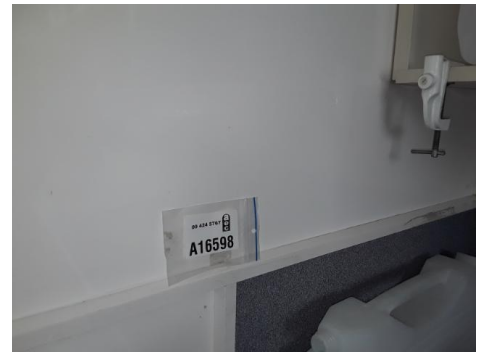
Sample No. A16598

No Asbestos Detected

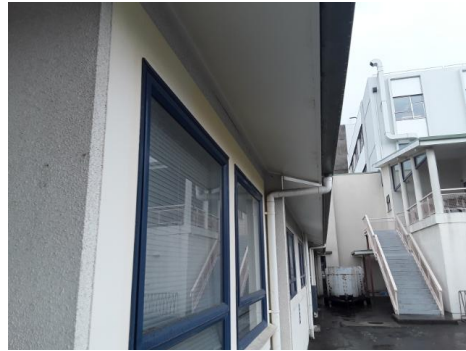
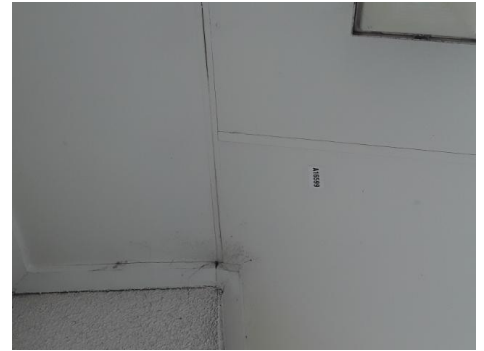
Sample No. A16599

Eaves - Cement Product

No Asbestos Detected

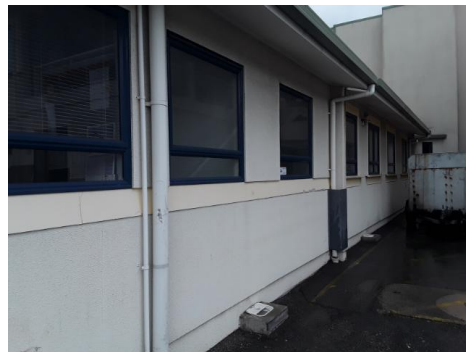
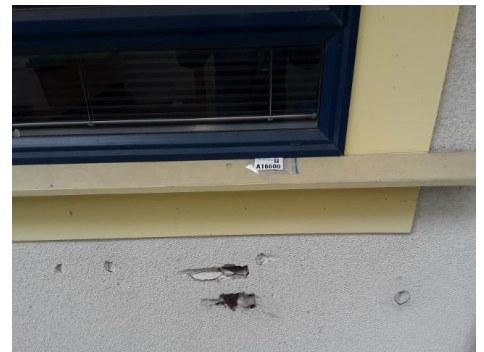
Sample No. A16600

Cement (pink) to rear of render -
Cement Product

No Asbestos Detected

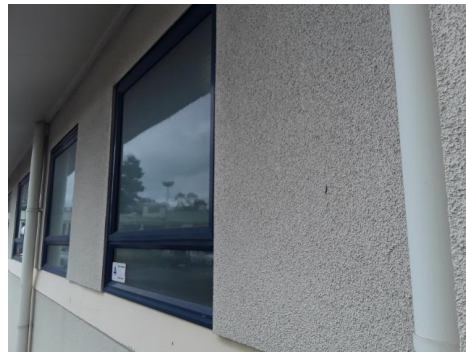
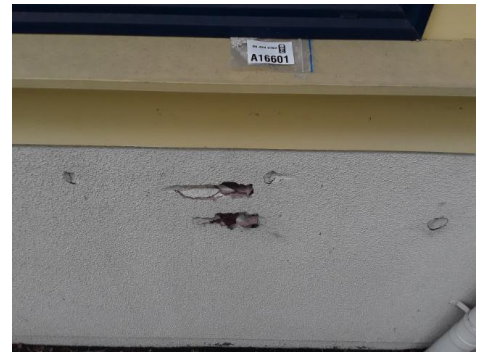
Sample No. A16601

Textured render to cement wall
lining - Decorative Finishes

No Asbestos Detected

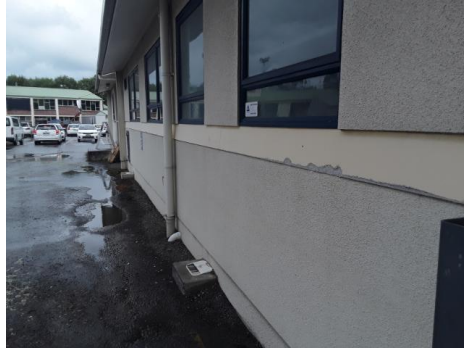
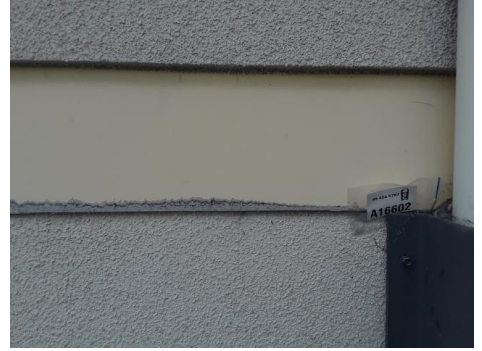
Sample No. A16602

No Asbestos Detected

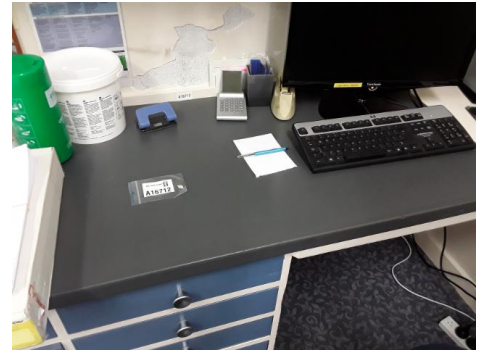
Sample No. A16712

Chrysotile

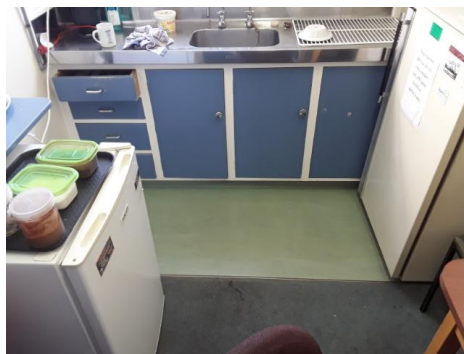
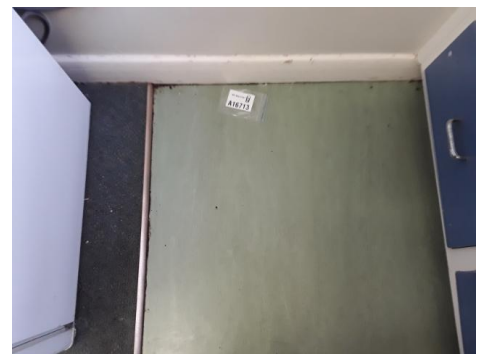
Sample No. A16713

No Asbestos Detected

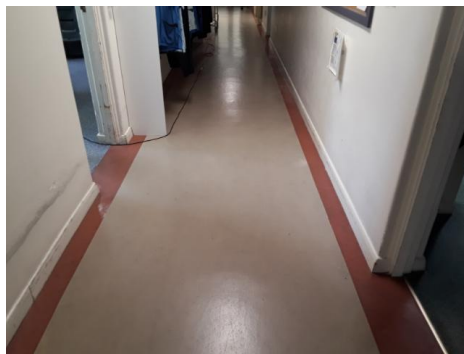
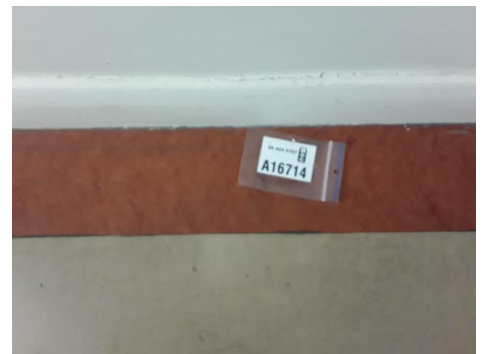
Sample No. A16714

No Asbestos Detected

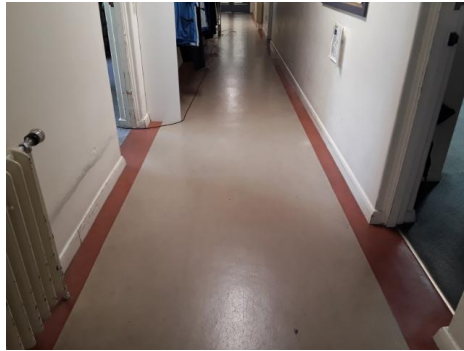
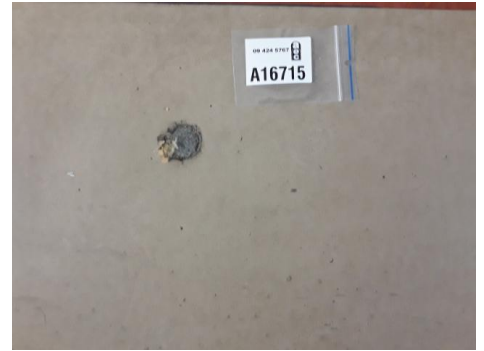
Sample No. A16715

No Asbestos Detected

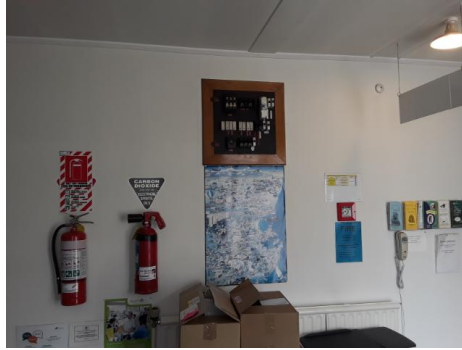
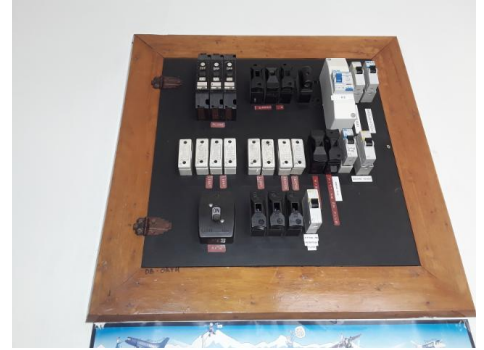
Ground Floor Store Room (003)

Sample No. A16527

No Asbestos Detected

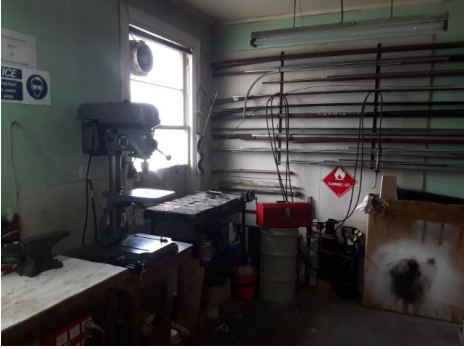
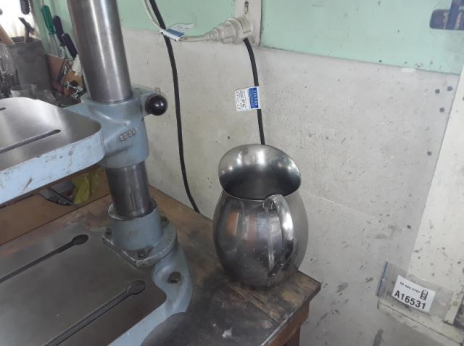
<p>Orthotic Department, Timaru Hospital</p> <p>Ground Floor Workshop (012)</p> <p>Panels to walls - Low Density Board</p> <p>Sample No. A16531</p> <p>Amosite & Chrysotile</p>

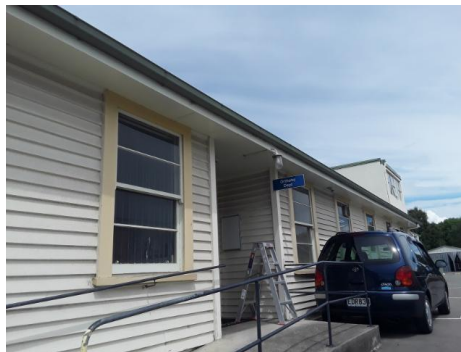
<p>Orthotic Department, Timaru Hospital</p> <p>External East Wall (016)</p> <p>Wall panels - Cement Product</p> <p>Sample No. A16535</p> <p>No Asbestos Detected</p>	 	 
----------------------------------------------------------------------------------------------------------------------------------------------------------------------	-----------------------------------------------------------------------------------	-------------------------------------------------------------------------------------

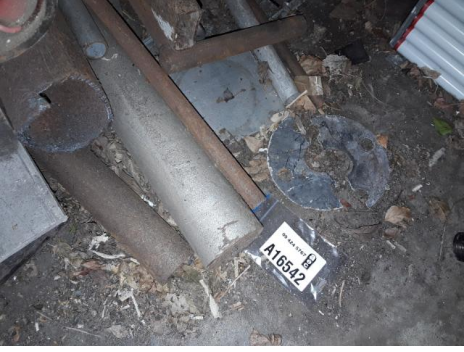
<p>Orthotic Department, Timaru Hospital</p> <p>Basement Garage 8 (026)</p> <p>Gasket debris to floor - Gaskets (compressed)</p> <p>Sample No. A16542</p> <p>Chrysotile</p>

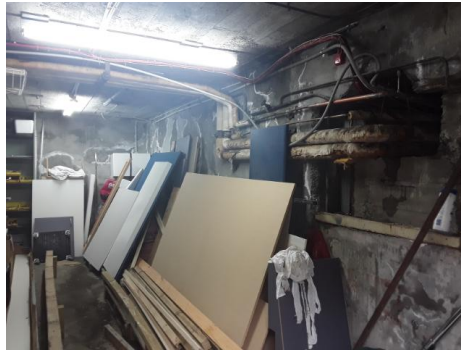
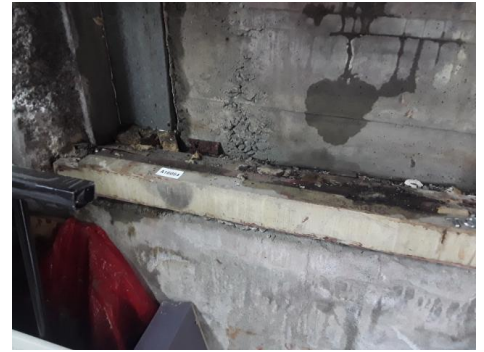
Ground Floor Workshop adjacent bench drill (102)

Sample No. A16055

No Asbestos Detected

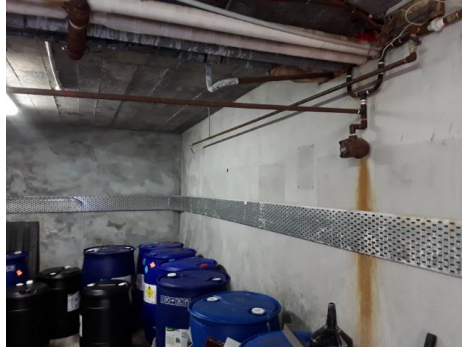
Basement Garage 2 (106)

Sample No. A16802

No Asbestos Detected

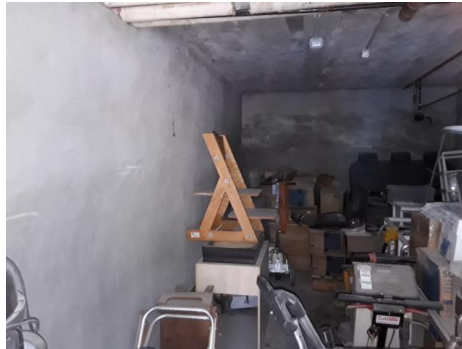
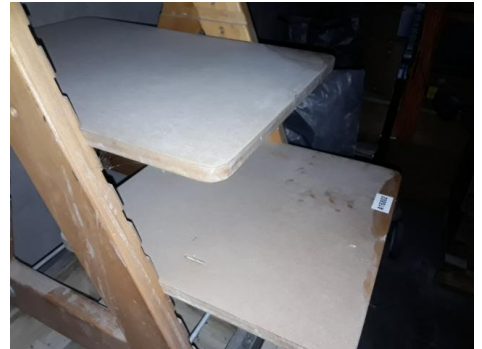
Basement Garage 3 (107)

Sample No. A16801

No Asbestos Detected

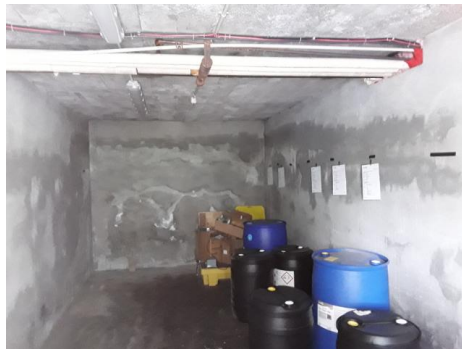
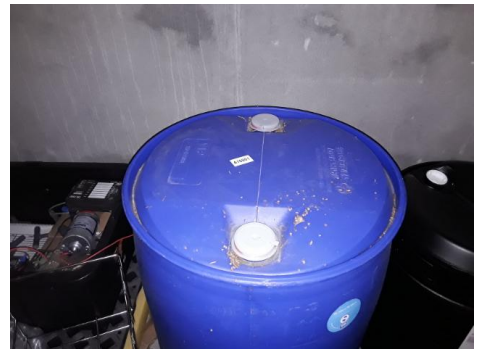
Basement Garage 4 (108)

Sample No. A16800

No Asbestos Detected

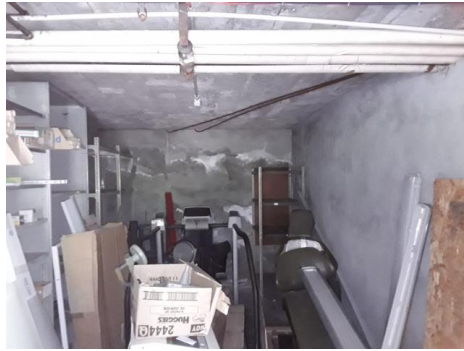
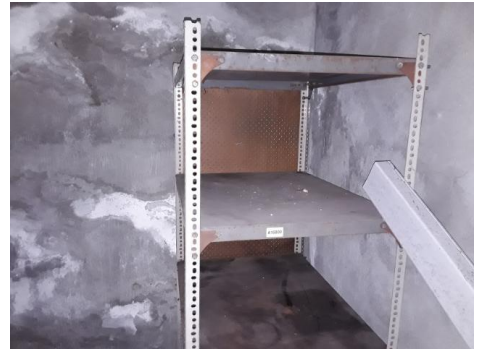
Basement Garage 5 (109)

Sample No. A16799

No Asbestos Detected

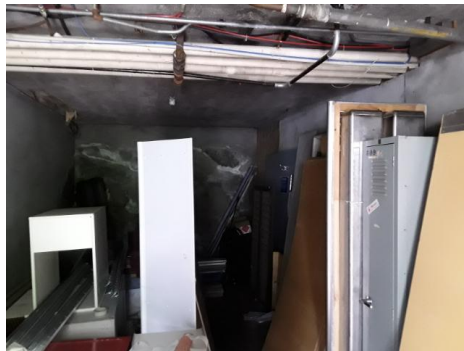
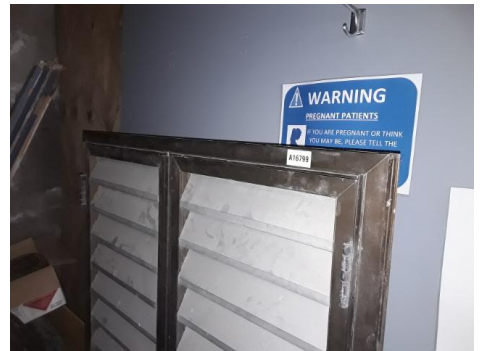
Basement Garage 6 (110)

Sample No. A16798

No Asbestos Detected

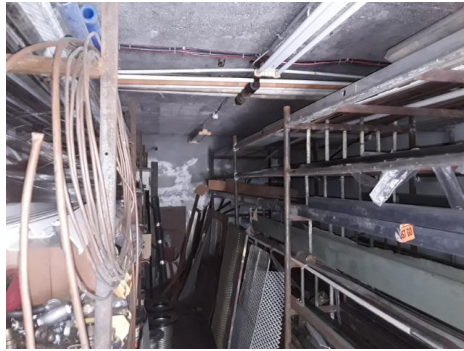
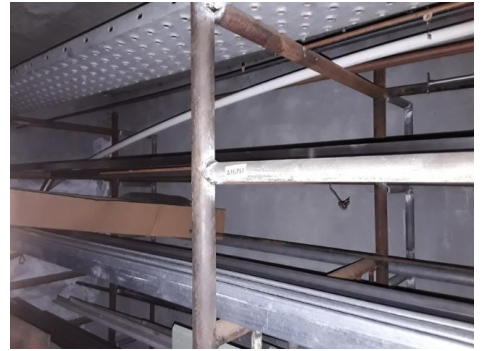
Sample No. A16797

No Asbestos Detected

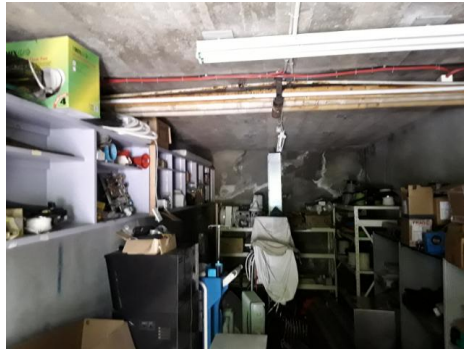
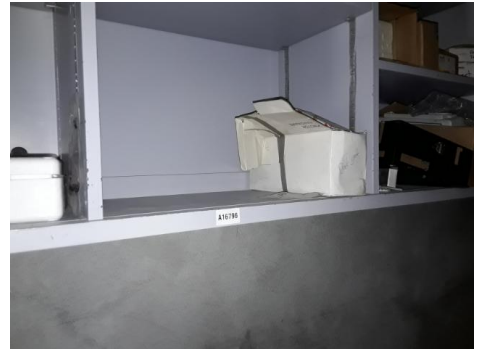
Basement Garage 9 (112)

Sample No. A16796

No Asbestos Detected

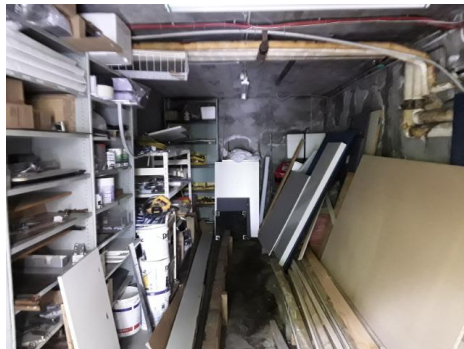
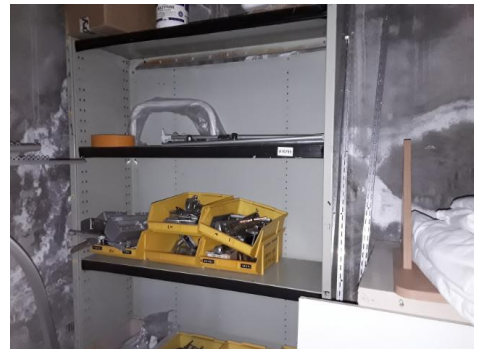
Basement Garage 10 (113)

Sample No. A16795

No Asbestos Detected

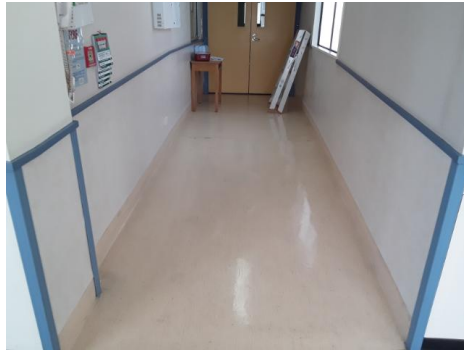
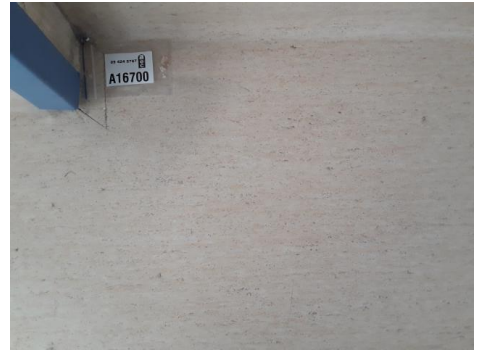
Sample No. A16700

No Asbestos Detected

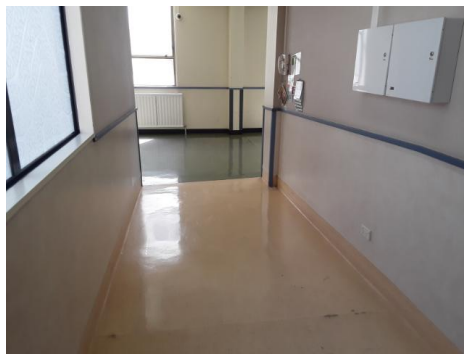
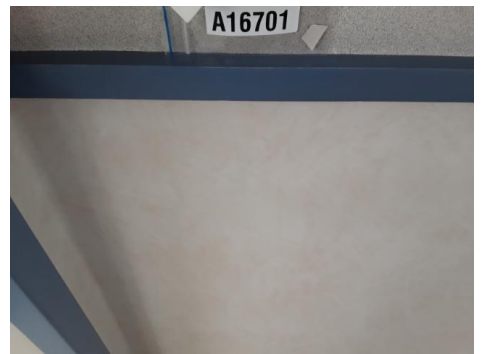
Ground Floor Corridor 17 (002)

Sample No. A16701

No Asbestos Detected

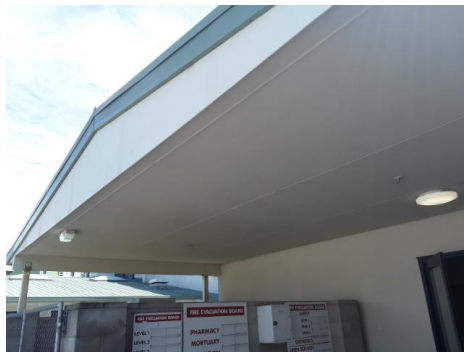
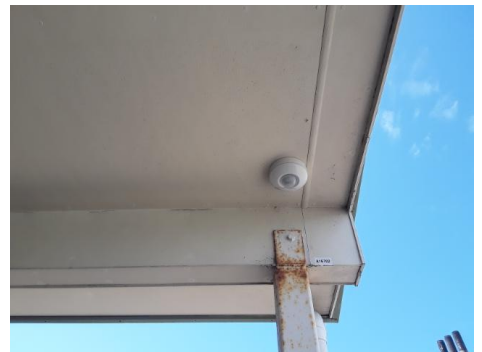
External Rear Canopy (006)

Sample No. A16702

No Asbestos Detected

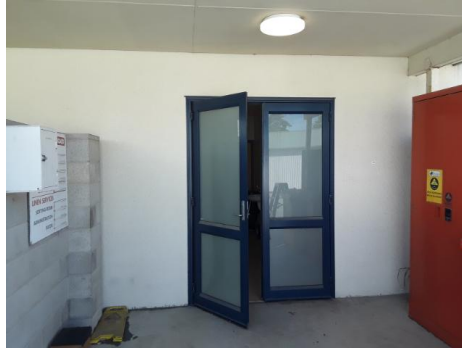
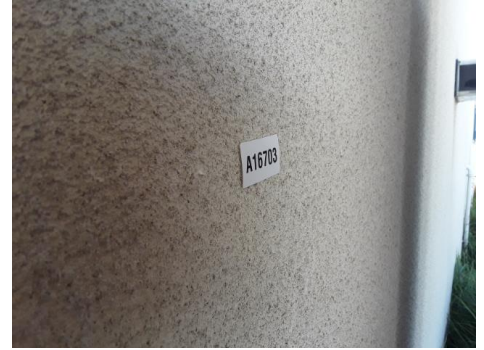
External Walls (009)

Sample No. A16703

No Asbestos Detected

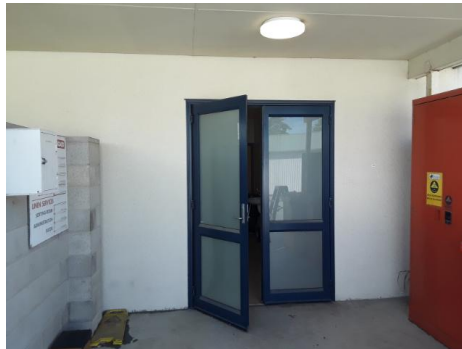
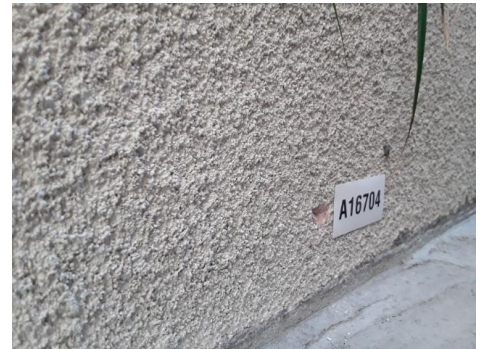
External Walls (010)

Sample No. A16704

No Asbestos Detected

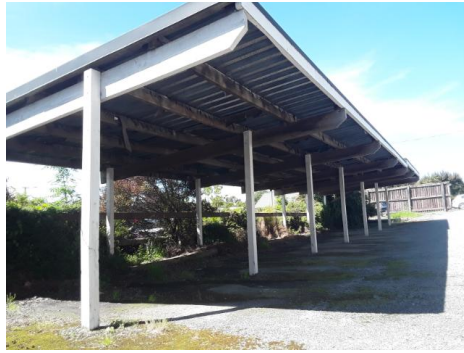
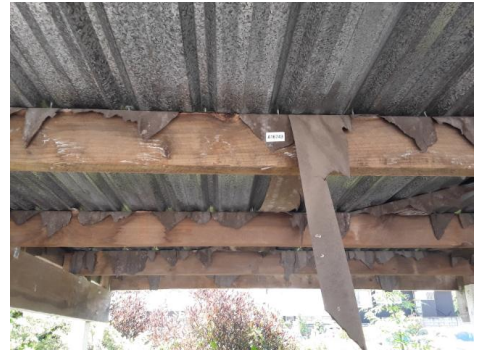
Sample No. A16743

No Asbestos Detected

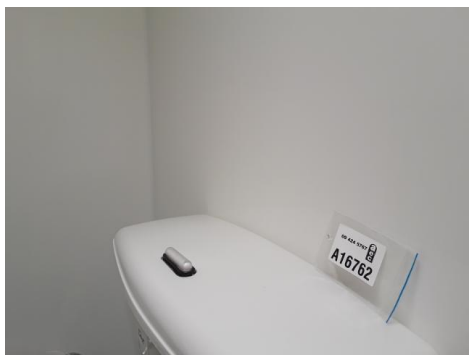
<p>Watlington Wing</p> <p>Ground Floor 98 / 99 Toilet & Shower (070)</p> <p>Flat plastic-coated cement sheet to walls - Cement Product</p> <p>Sample No. A16762</p> <p>No Asbestos Detected</p>

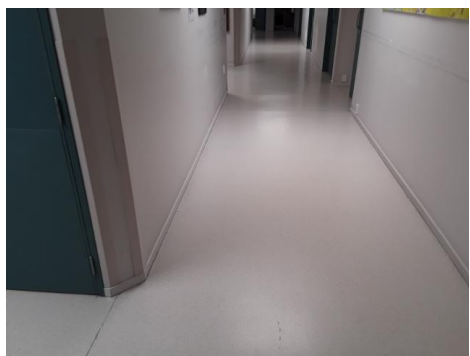
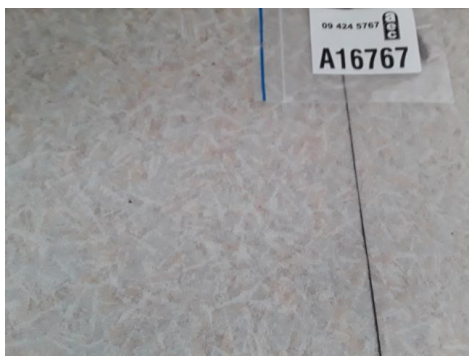
<p>Watlington Wing</p> <p>Ground Floor 133 Corridor (078)</p> <p>Vinyl floor covering - Vinyl Products</p> <p>Sample No. A16767</p> <p>No Asbestos Detected</p>

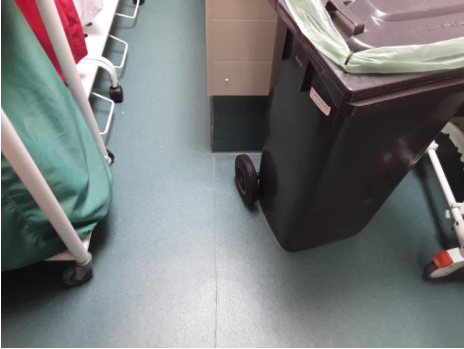
<p>Watlington Wing</p> <p>Ground Floor 150 Shower (080)</p> <p>Vinyl floor covering - Turquoise - Vinyl Products</p> <p>Sample No. A16768</p> <p>No Asbestos Detected</p>

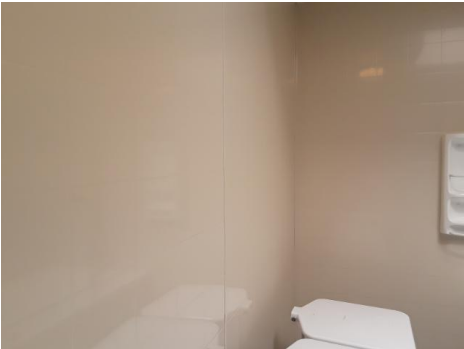
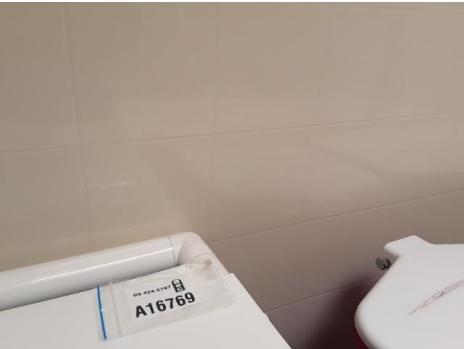
<p>Watlington Wing</p> <p>Ground Floor 150 Shower (081)</p> <p>Tile effect plastic coated cement sheet to walls - Cement Product</p> <p>Sample No. A16769</p> <p>No Asbestos Detected</p>

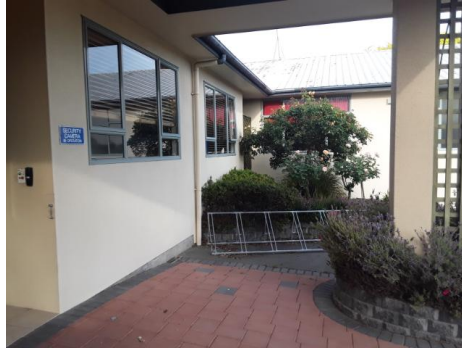
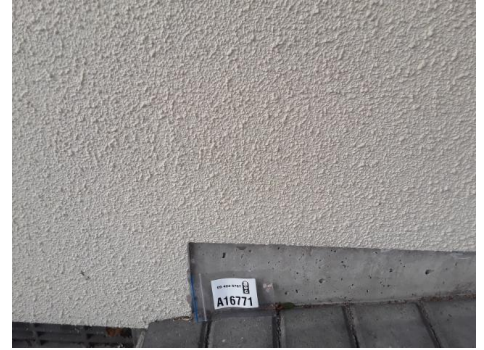
Sample No. A16771

No Asbestos Detected

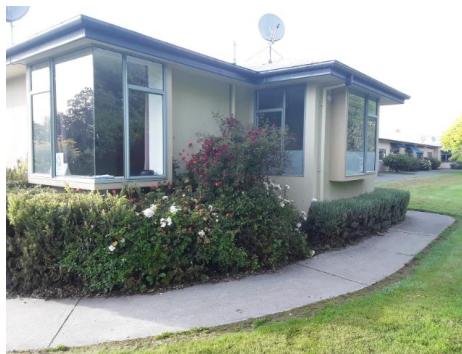
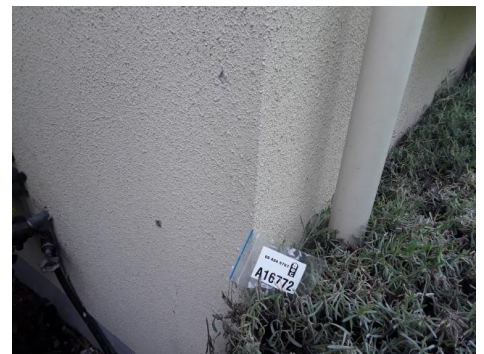
Sample No. A16772

No Asbestos Detected
