ASBESTOS MANAGEMENT PLAN & SITE MANAGEMENT SURVEYS

Site: South Canterbury DHB
Queen Street, Parkside, Timaru

Prepared for: South Canterbury District Health Board

Project Ref: C-00727

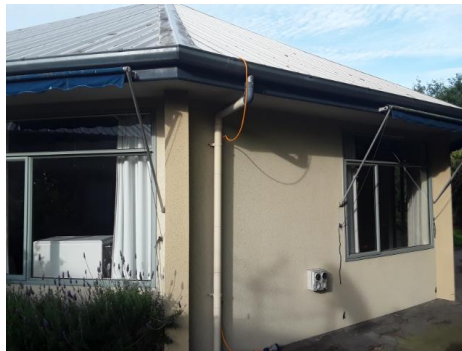
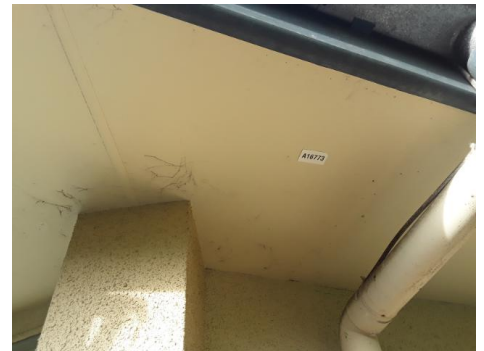
Sample No. A16773

No Asbestos Detected

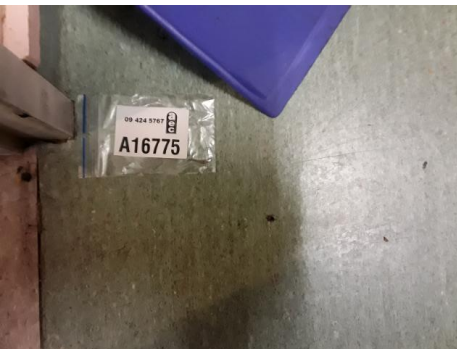
<p>Watlington Wing</p> <p>Ground Floor 106 WC (126)</p> <p>Vinyl floor covering - Green - Vinyl Products</p> <p>Sample No. A16775</p> <p>No Asbestos Detected</p>

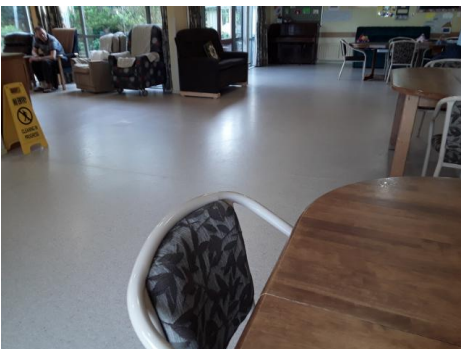
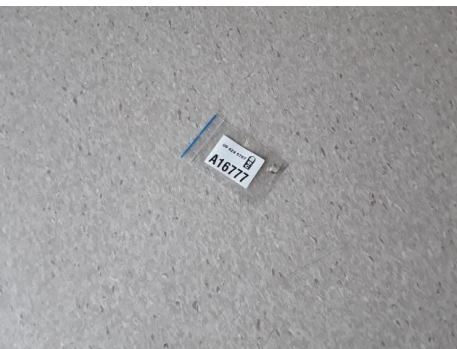
<p>Watlington Wing</p> <p>Ground Floor 108/109/132 Lounge / Dining (128)</p> <p>Vinyl floor covering - Beige - Vinyl Products</p> <p>Sample No. A16777</p> <p>No Asbestos Detected</p>

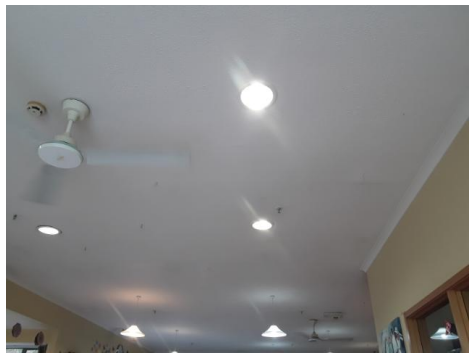
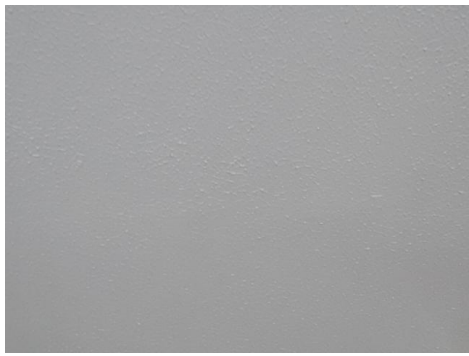
<p>Watlington Wing</p> <p>Ground Floor 108/109/132 Lounge / Dining (129)</p> <p>Textured Coating to ceiling - Decorative Finishes</p> <p>Sample No. A16776</p> <p>No Asbestos Detected</p>

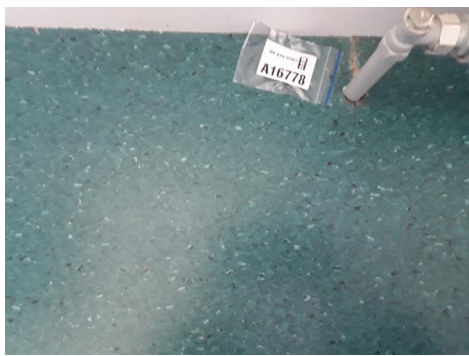
<p>Hunter Wing</p> <p>Ground Floor 67 (142)</p> <p>Vinyl floor covering - Green - Vinyl Products</p> <p>Sample No. A16778</p> <p>No Asbestos Detected</p>

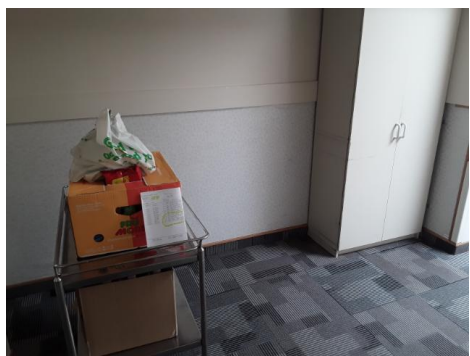
<p>Otipua Wing</p> <p>Ground Floor 73 Corridor (148)</p> <p>Vinyl lower wall covering to alcove - Vinyl Products</p> <p>Sample No. A16779</p> <p>No Asbestos Detected</p>

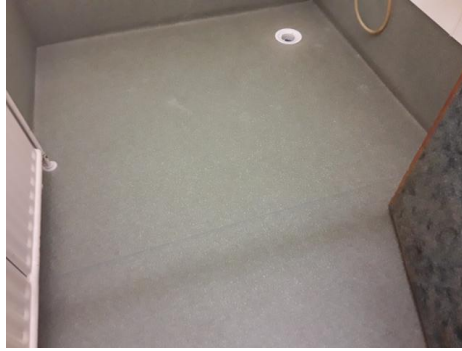
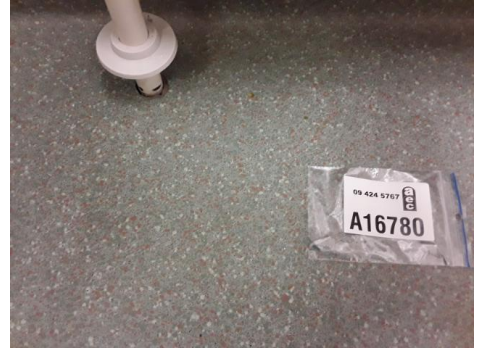
Sample No. A16780

No Asbestos Detected

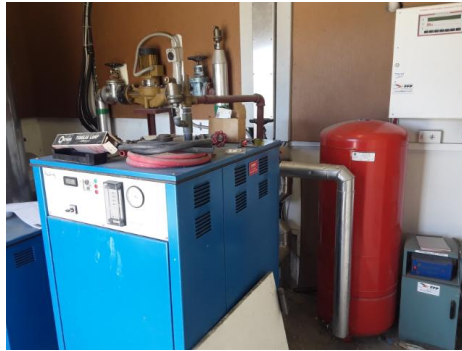
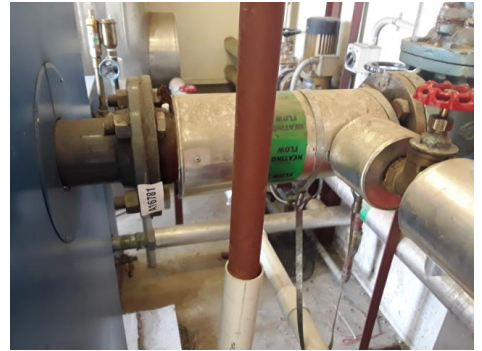
Sample No. A16781

Chrysotile

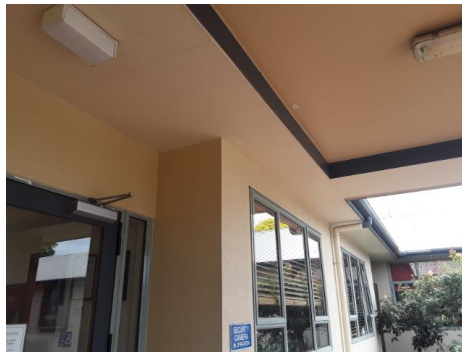
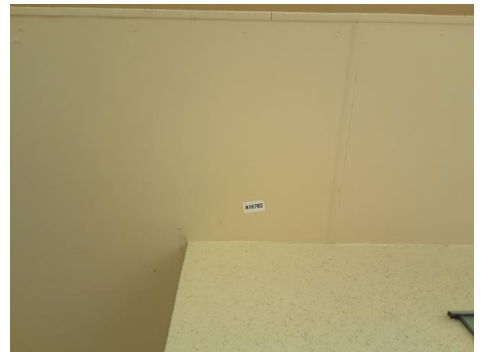
Sample No. A16782

No Asbestos Detected

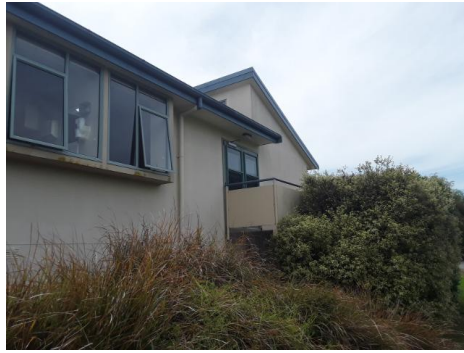
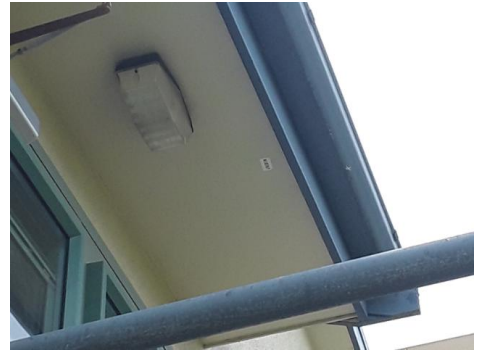
Sample No. A16787

No Asbestos Detected

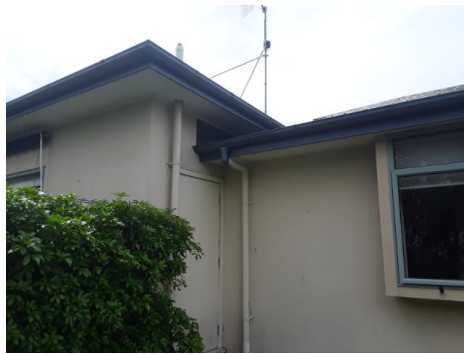
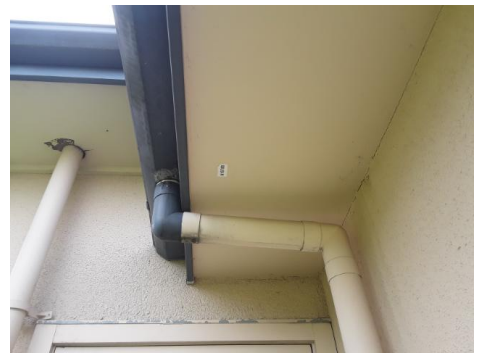
Sample No. A16788

No Asbestos Detected

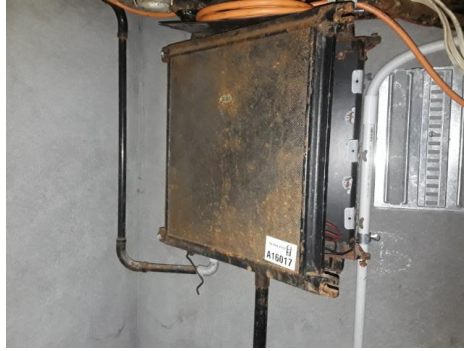
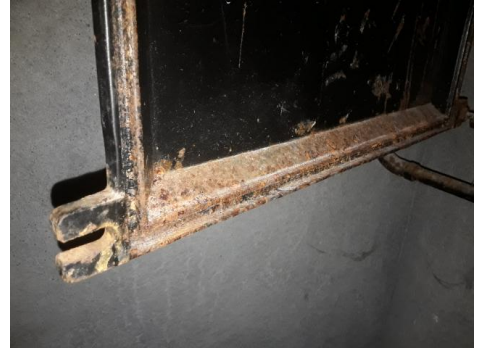
Sample No. A16017

Chrysotile

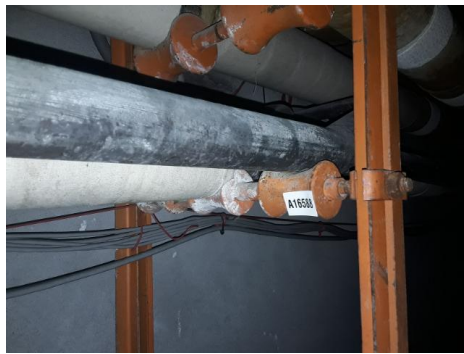
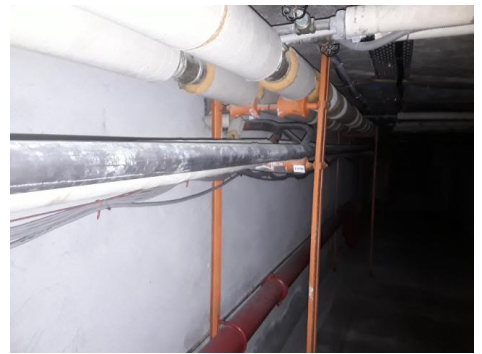
Sample No. A16588

Amosite

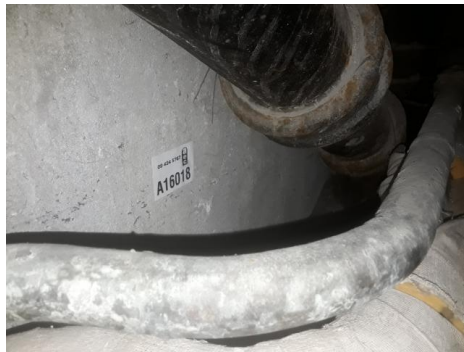
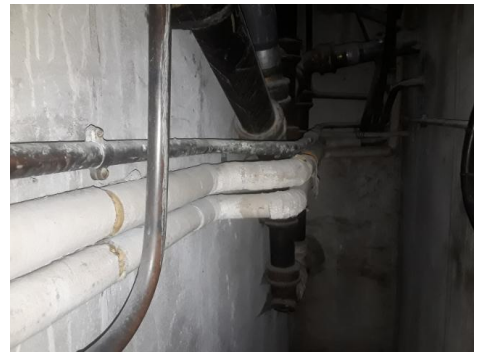
Sample No. A16018

Amosite

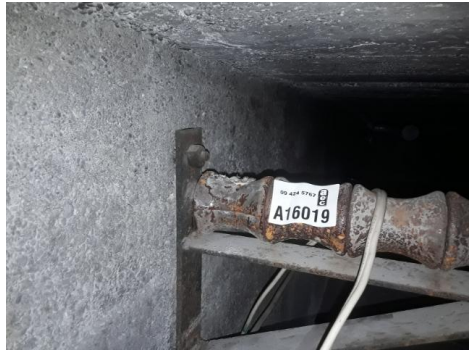
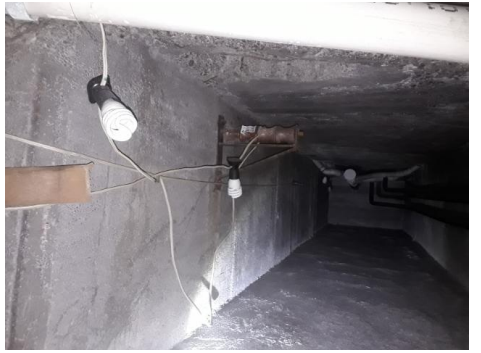
Tunnels
Basement Section 9 (038)
Residue on roller hanger -
Insulation
Sample No. A16019
Amosite

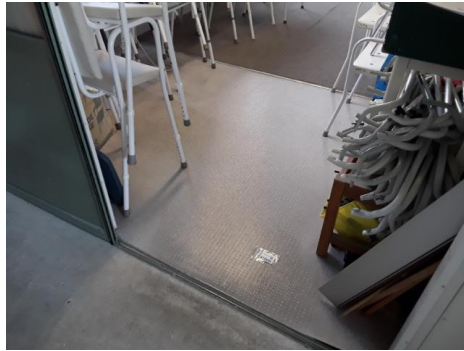
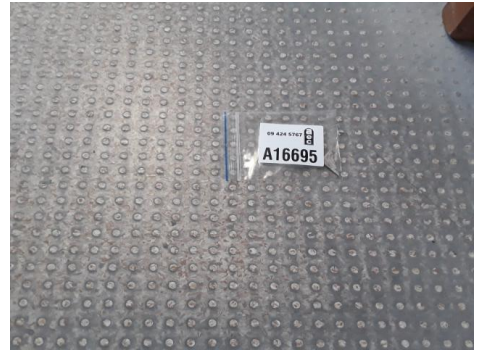
Sample No. A16695

No Asbestos Detected

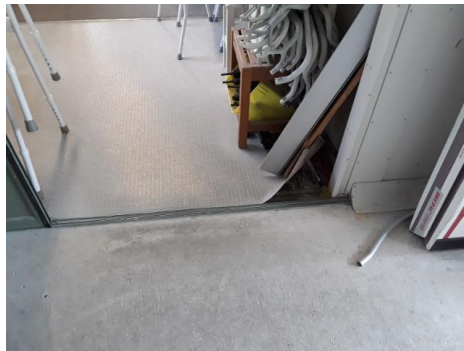
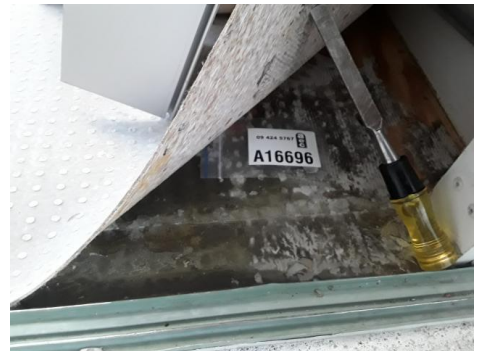
Ground Floor Store 1 (002)

Sample No. A16696

No Asbestos Detected
